National Transportation Safety Board Aviation Accident Final Report

Location:	Bartow, Florida	Accident Number:	CEN18FA061
Date & Time:	December 24, 2017, 07:17 Local	Registration:	N247AT
Aircraft:	Cessna 340	Aircraft Damage:	Destroyed
Defining Event:	Loss of control in flight	Injuries:	5 Fatal
Flight Conducted Under:	Part 91: General aviation - Personal

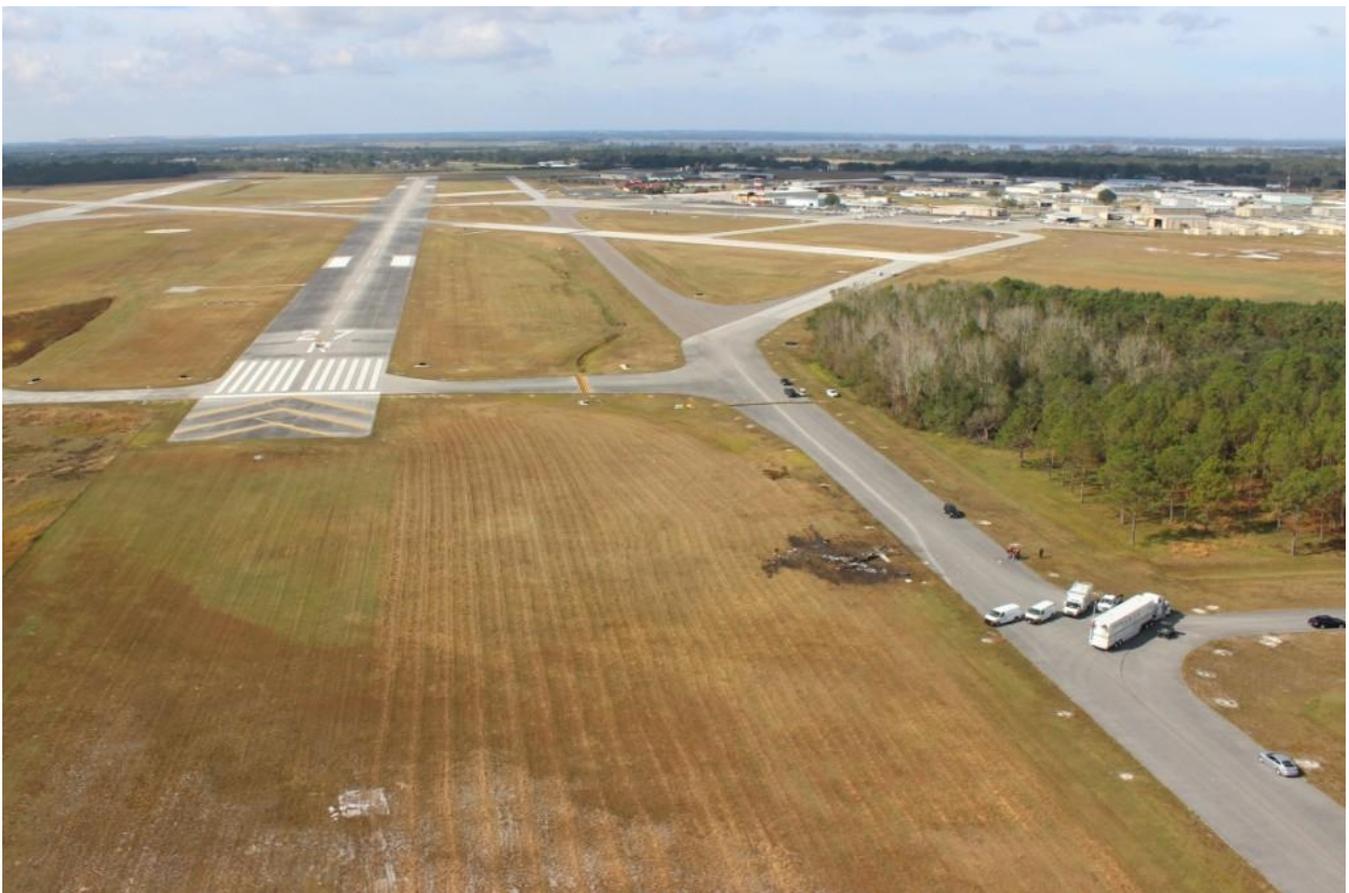
Figure 1 – Aerial View of Accident Site

The accident site was located on airport property about 190 yards east-northeast of the departure end of runway 9L and 10 ft south of taxiway delta (figure 1).

The debris path was about 230 ft long and oriented northeast. The beginning of the debris path was defined by several ground impact craters in a line perpendicular to the debris path and the main wreckage. The middle impact crater contained pieces of the airplane's nose cowling and baggage door. Immediately to the right was the left engine's propeller. To the left of the middle crater was the right engine's propeller. A portion of the left wing tip fuel tank was found on the far right side of the initial impact area, and a portion of the right wing tip fuel tank was found on the far left side of the initial impact area. The main wreckage came to rest upright and oriented southeast about 30 ft from the initial impact craters. The fuselage was mostly consumed by fire and the empennage remained mostly intact with significant thermal damage. Both engines separated from the airplane and came to rest near the main wreckage. Airplane debris was found on the taxiway northeast of the main wreckage. The nose landing gear was separated from the airplane and found about 200 ft northeast of the main wreckage.
