# **GEOLOGIC FAULT INVESTIGATION**

**1045 EAST BROADWAY  
SAN DIEGO, CALIFORNIA**

**JULY 22, 2010  
PROJECT NO. T2439-77-01**

Subject: 1045 EAST BROADWAY  
SAN DIEGO, CALIFORNIA  
GEOLOGIC FAULT INVESTIGATION

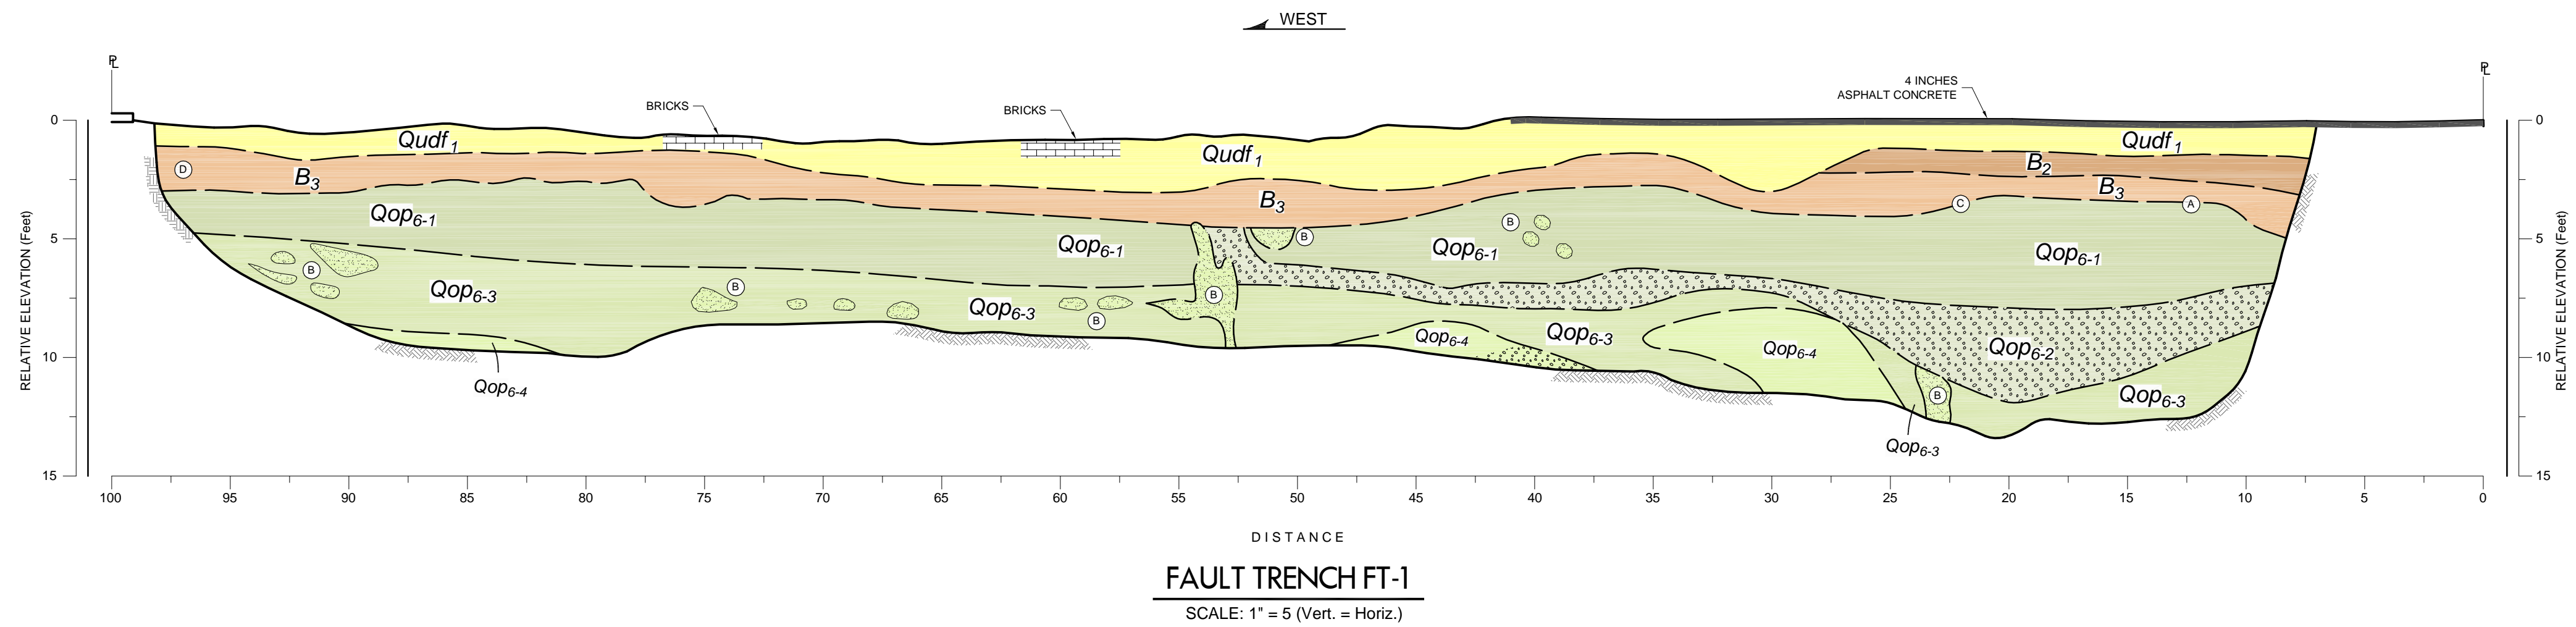
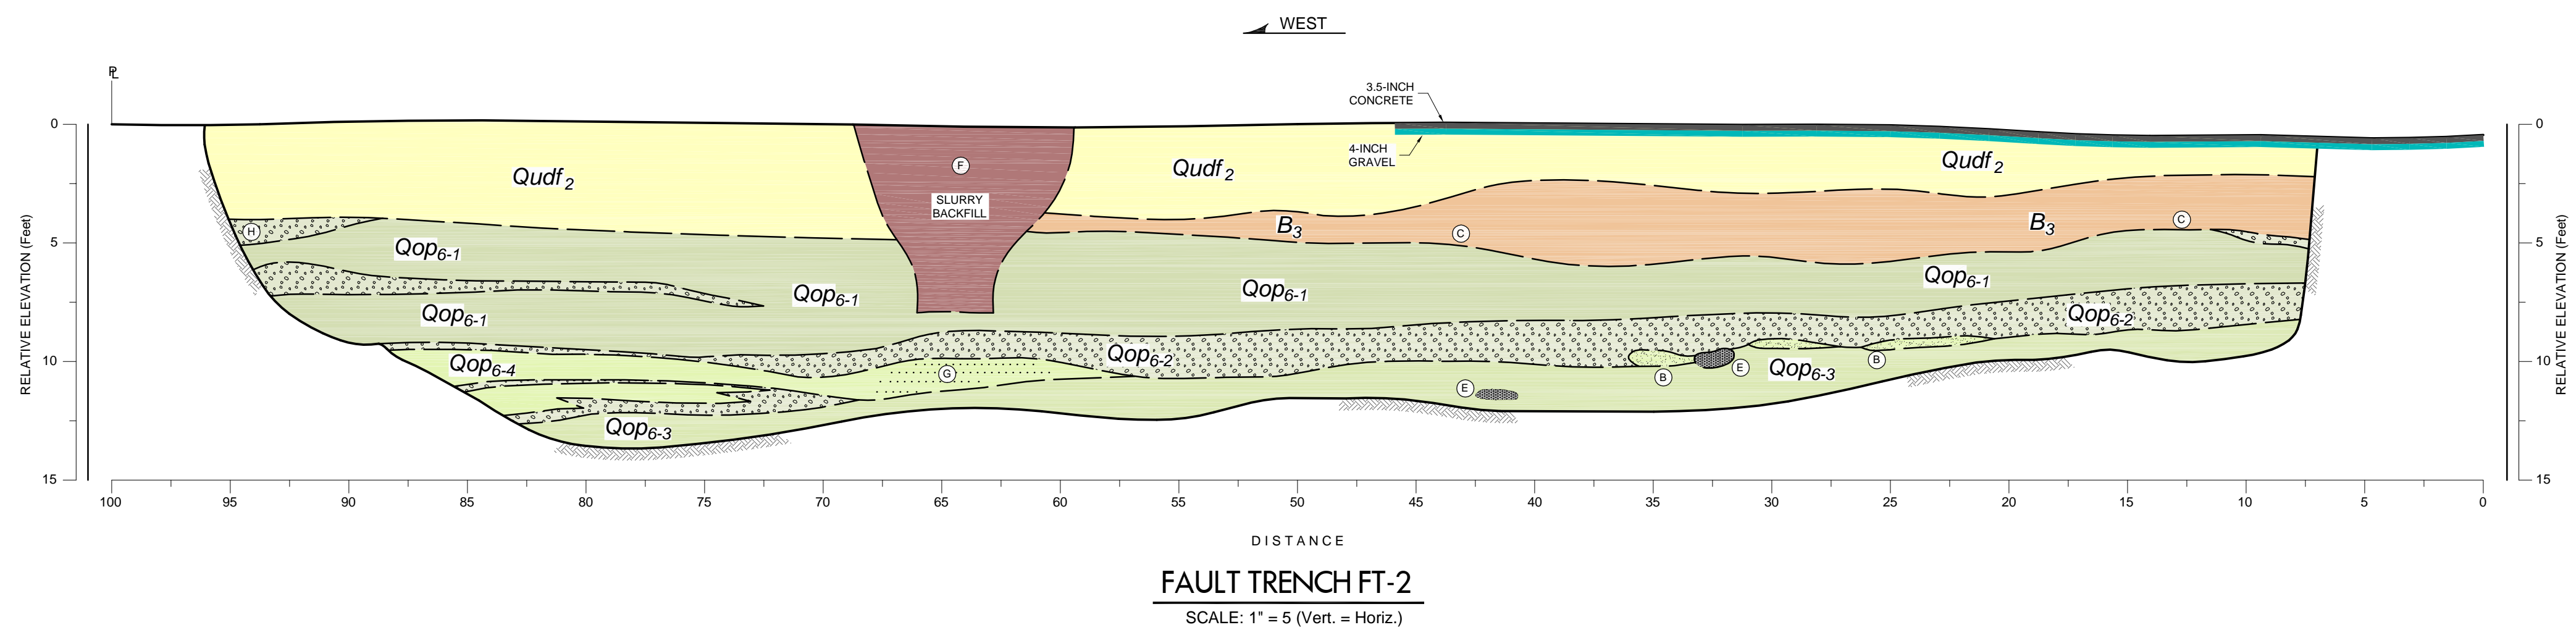
FAULT TRENCH LOGS

We performed two fault trenches to a maximum depth of approximately 13½ feet along the northern and southern property boundaries. The trenches were in a generally east-west direction, approximately perpendicular to the dominantly north-south trend of the faulting within the downtown area. The locations of the fault trenches are shown on Figure 2 and the logs of trenches are included as Figure A-1. Faulting in the southern portion of the Rose Canyon Fault Zone, which includes the downtown area, is predominately dip slip (Treiman, 1993). Relatively large offsets and discordance in the stratigraphy would be expected if active faulting were present. For the purposes of our fault evaluation, the Old Paralic Deposits Unit 6 was divided into separate subunits. The stratigraphic position of the units and their lithologic descriptions are presented on the trench log. Stratigraphic correlation within the fault trench indicates that the relative positions of units within the Old Paralic Deposits Unit 6 are continuous or depositionally pinch out. The conglomerate and sandstone layers in the trench are not offset and are nearly horizontal. We observed lighter color silty sand pockets and veins, perhaps indicative of paleo-liquefaction. At several locations along the trench alignment, we also observed carbonate mineralization and manganese oxide deposits. We did not observe indications of faulting, such as discordant bedding, clay gouge, shearing, or slickensides, in the fault

trenches. In our opinion, active, potentially active, or inactive faults do not traverse the site and building setbacks will not be required.

- 8.2 We did not observe evidence of Holocene-age faulting in the Quaternary-age Old Paralac Deposits Unit 6 (formerly Bay Point Formation) encountered in the trenches. A Fault is mapped by the state within the 13<sup>th</sup> Street, two blocks to the east of the site.
