Horse Camp Trailhead Washout Hannegan Road MP
5.3 FSR 32, Nov 2015 Road washout is now 250' long
from drivable road to paved 60 car parking lot. No
Action taken. Parking is now along the road shoulder
of single lane 12 wide gravel road. Bathroom is
isolated from road . Trail is a major hiking access
point into North Cascades National Park and can
receive 100 plus cars during summer season.

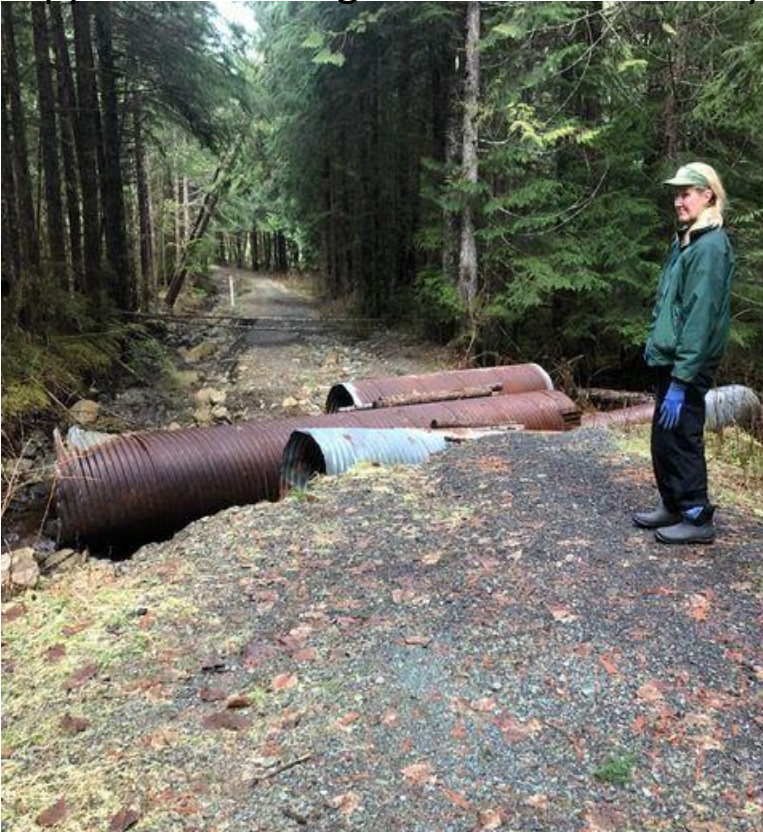
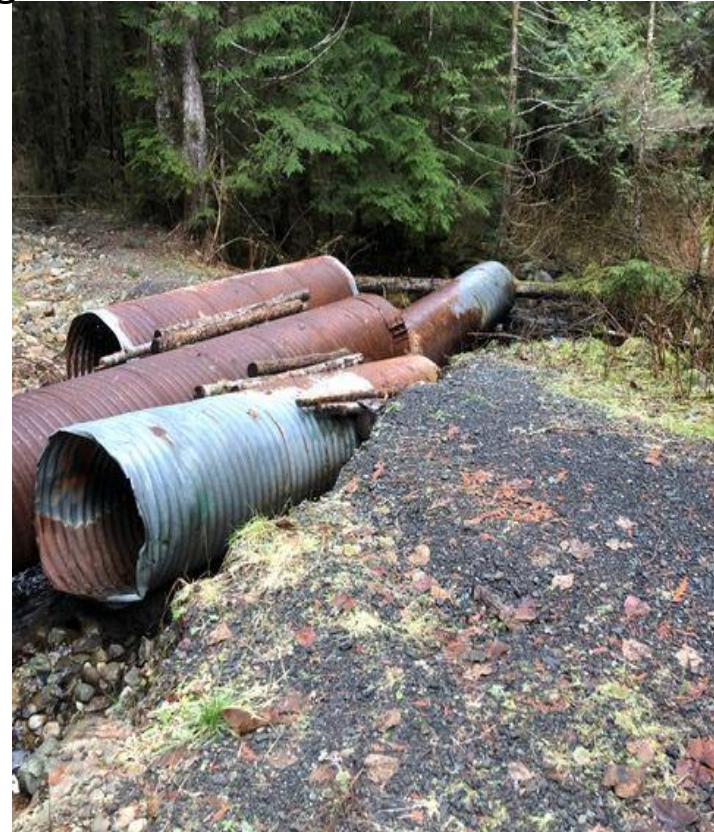
Anderson Road Washout FSR 3071 MP 0.95 (just up the hill from New Anderson Bridge Location

No from FS since 2015 to replace failed culvert. Site has now eroded down the ditch-line. Culvert were hand placed for snow bridge grooming. FS would not approve use for groomed cross country skiing. 30% loss of Nordic Ski club \$'s

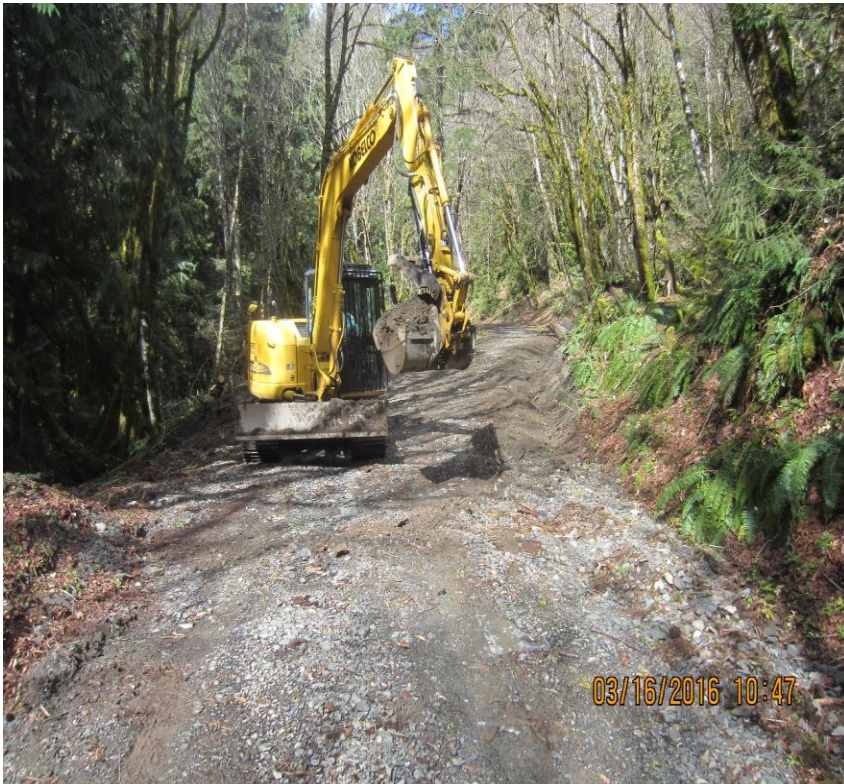
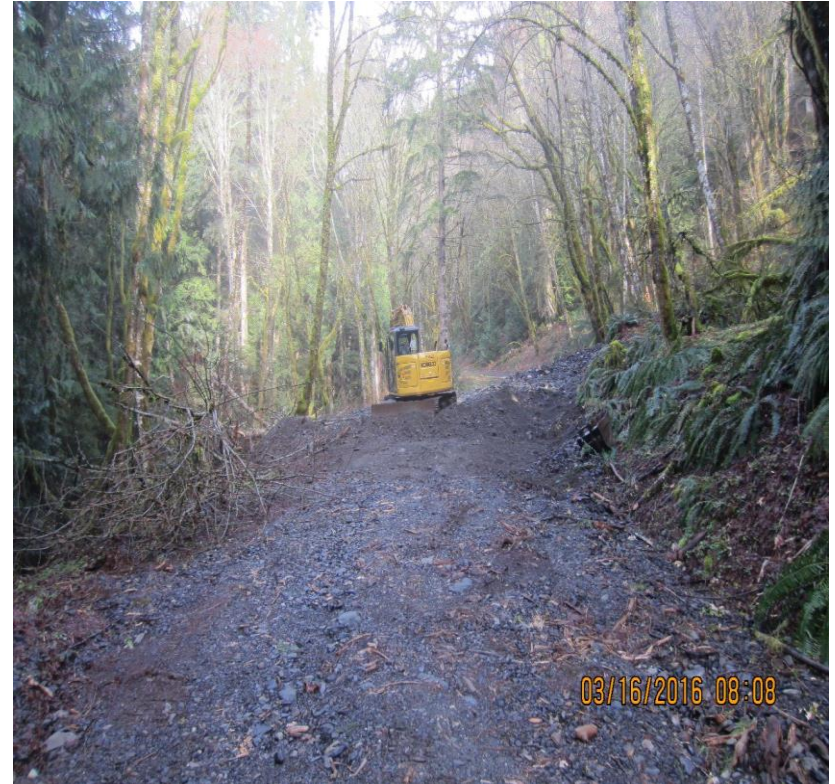
East Church FSR 3040 MP 1.0, 2015 Channel Flush out
Power House Company Cleaning up site to standard.
Prevented road erosion from misdirected water flow.

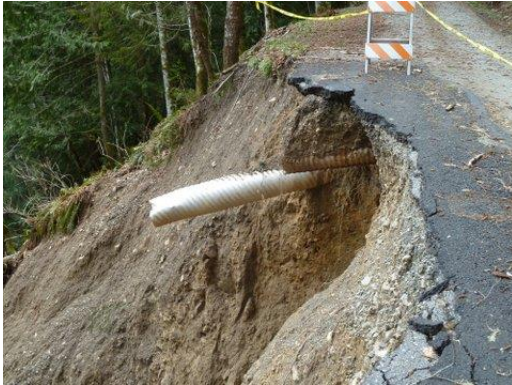
Example of repeated use of undersized culvert

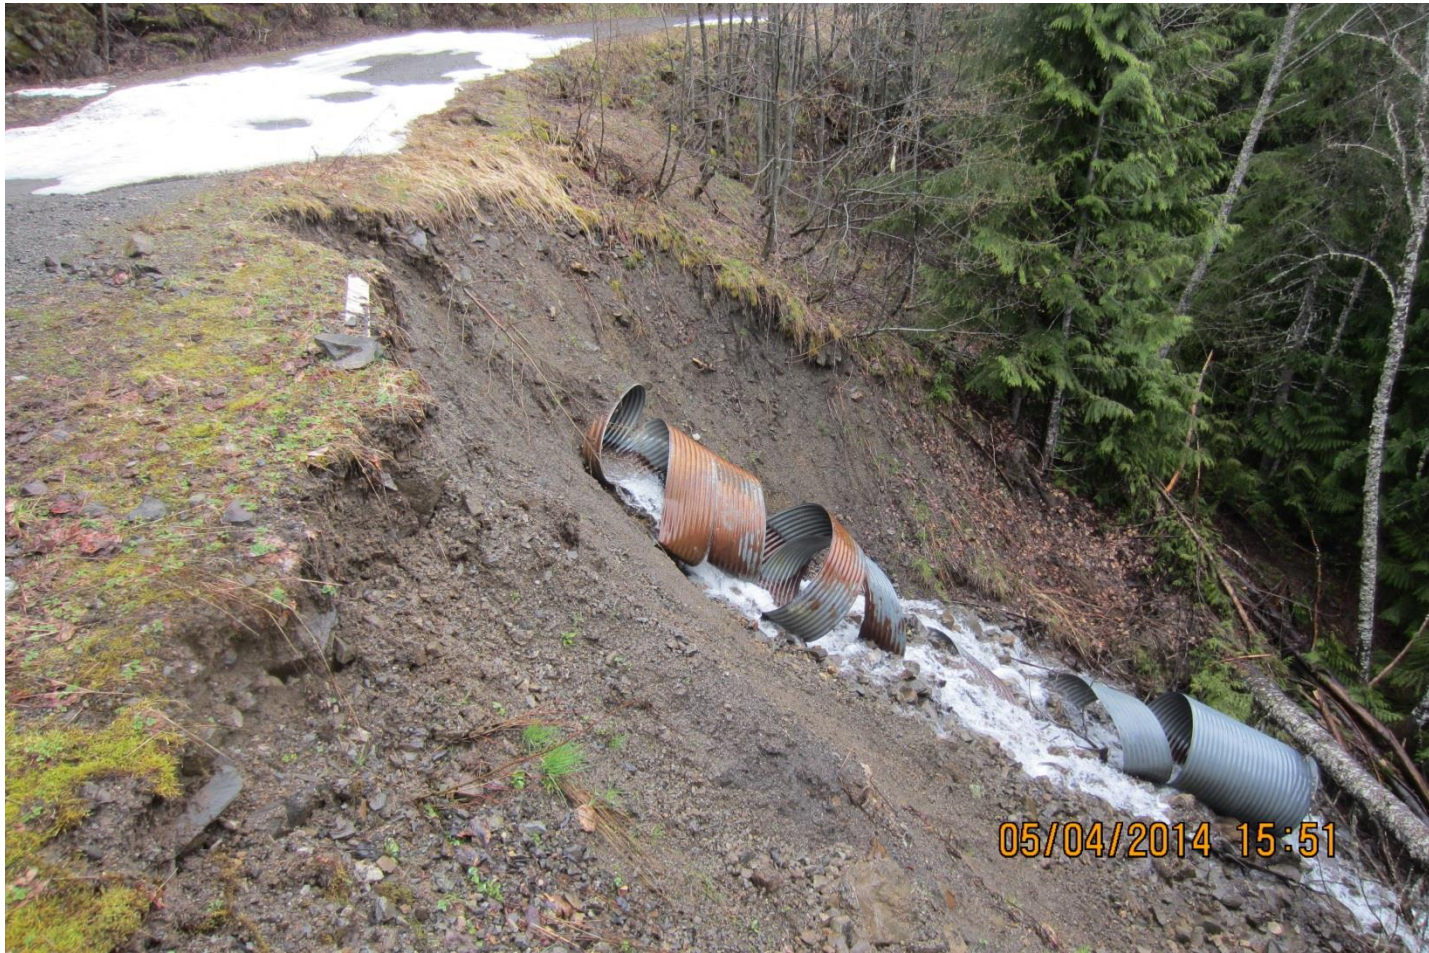
Canyon Creek FSR 31 MP 11.6 Jan 4, 2011
60" Undersized Culvert unraveled

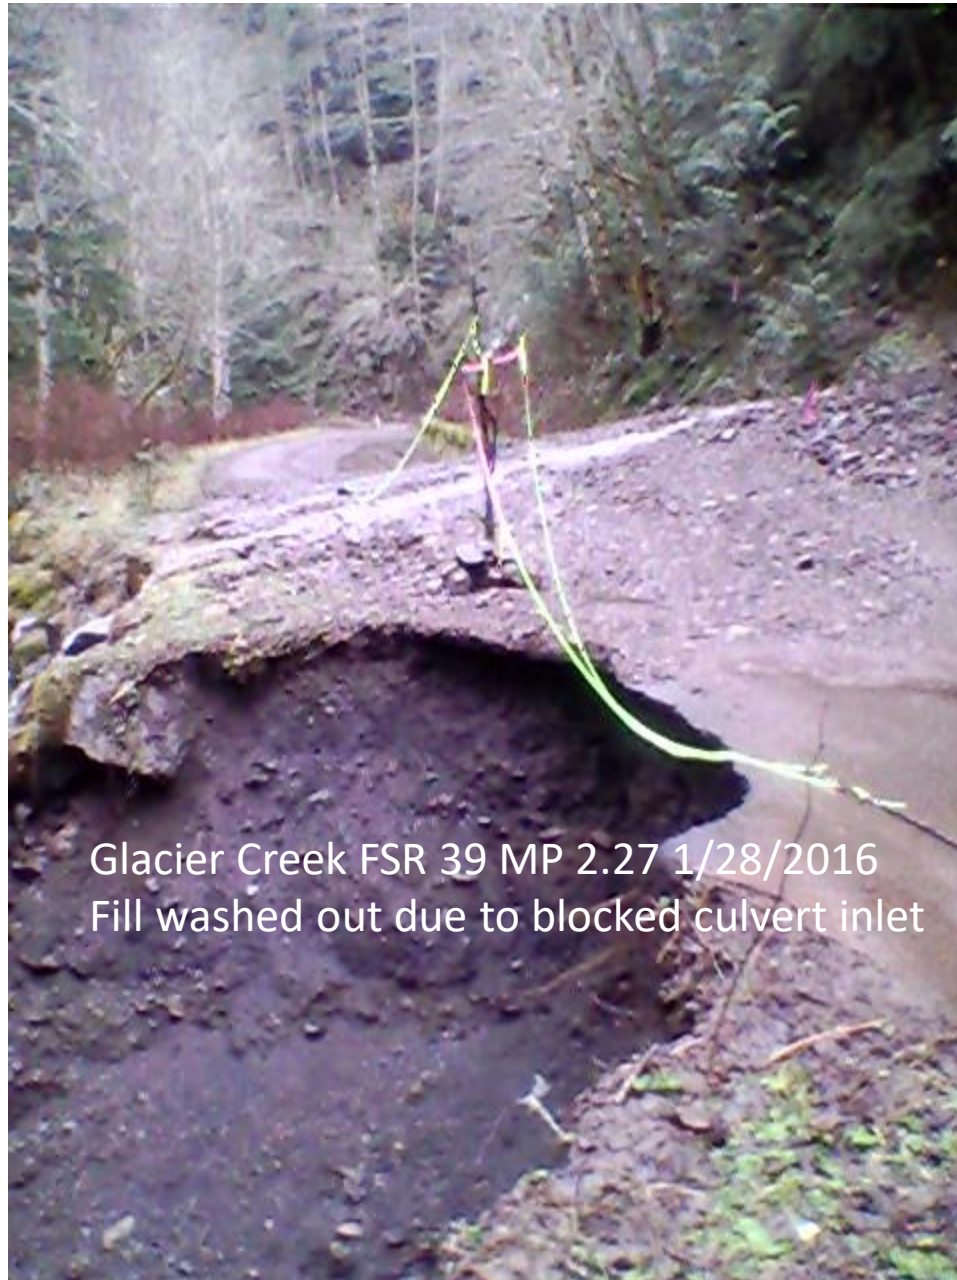
Glacier Creek
FRS 39 MP
2.27
1/28/2016
Culvert
covered over
with debris

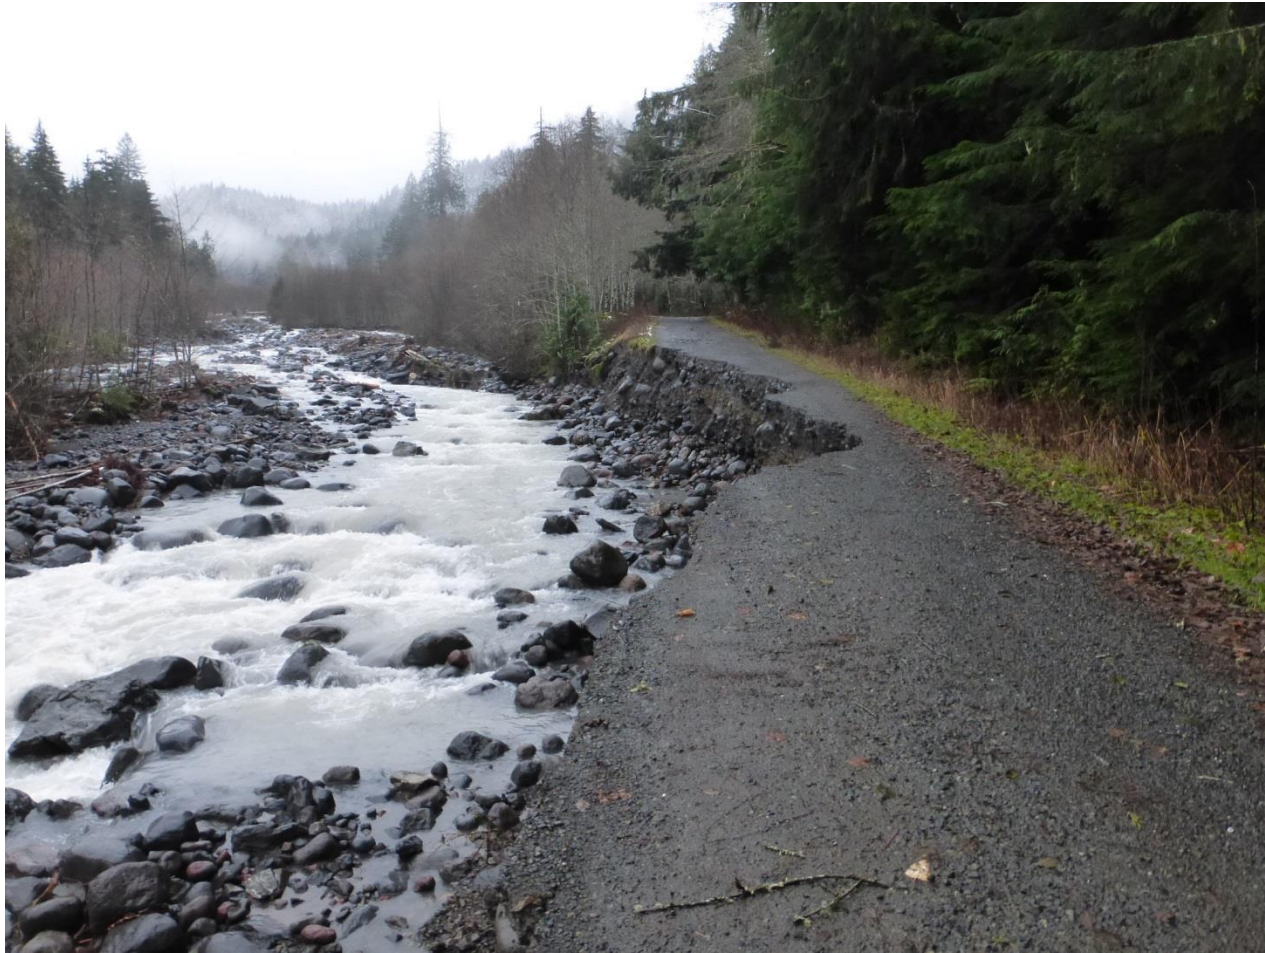
Glacier Creek FSR 39 MP 3.7 Road fill occurred during multi storm events during November 2021, shortly after 11/18/2021 event. 250' of road needs toe roughness, slight shift of alignment into dry ditch and layered placed fill material.
