Summer 2022 CMT Implementation Special Report<sup>1</sup>  
Prepared by: Dr. Lars Anderson

## EXECUTIVE SUMMARY

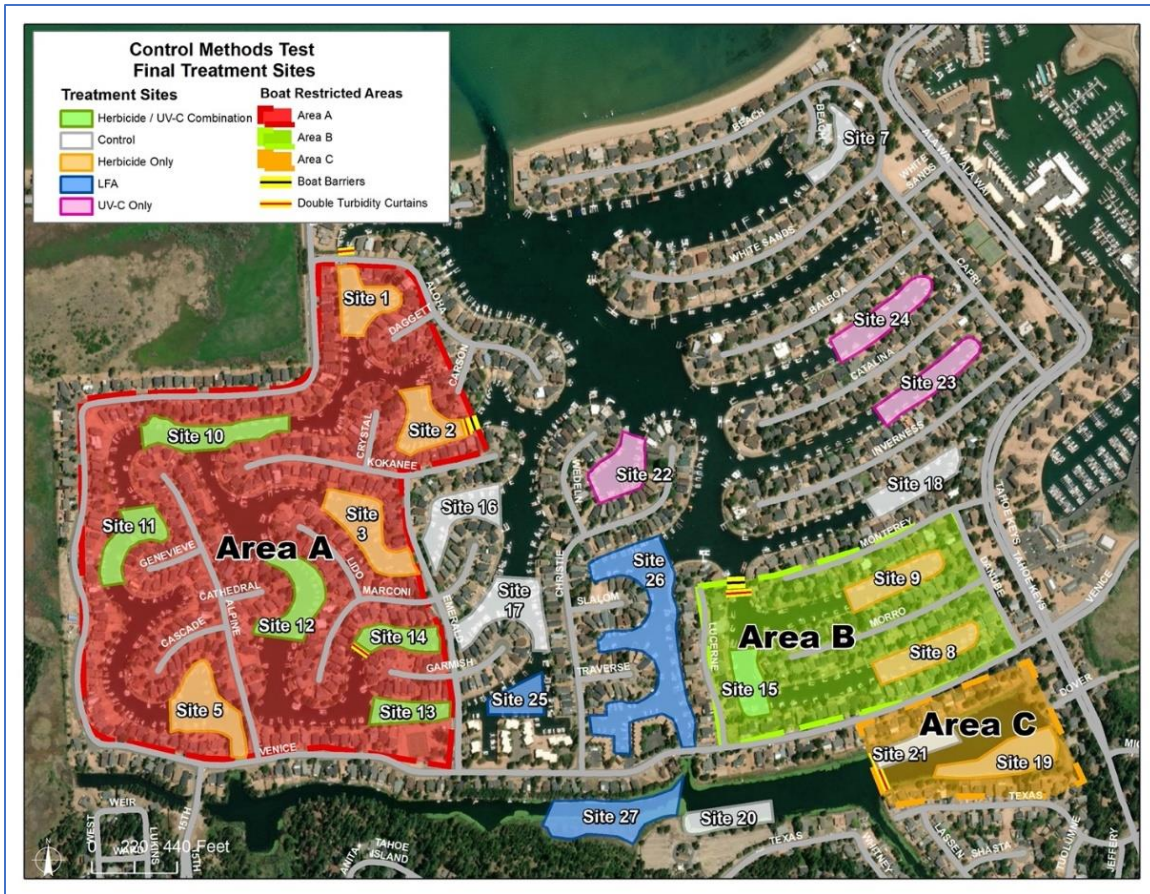
**Figure 3. Map depicting restricted boating areas separated from the West Lagoons by sets of double turbidity curtains (A, B, and C) and boat barriers (A and B). The shaded zones also show where boating entrance and egress was prohibited from pre-herbicide applications (May 25, 2022) until removal of barrier curtains from each area.**

As part of the CMT permit requirements, sites identified for herbicide applications were required to be isolated from the main waterway areas of the West Lagoon, and Lake Tahoe. The use of containment curtains effectively isolated three major boating exclusion zones of the CMT sites: Area A (west side of the West Lagoon behind curtains installed at Site 2); Area B (containing sites 8,9 and 15 in southeast area of the West Lagoon); and Area C (Lake Tallac, all non-motorized boating). Figure 3 shows the boating restricted areas (A, B, and C).

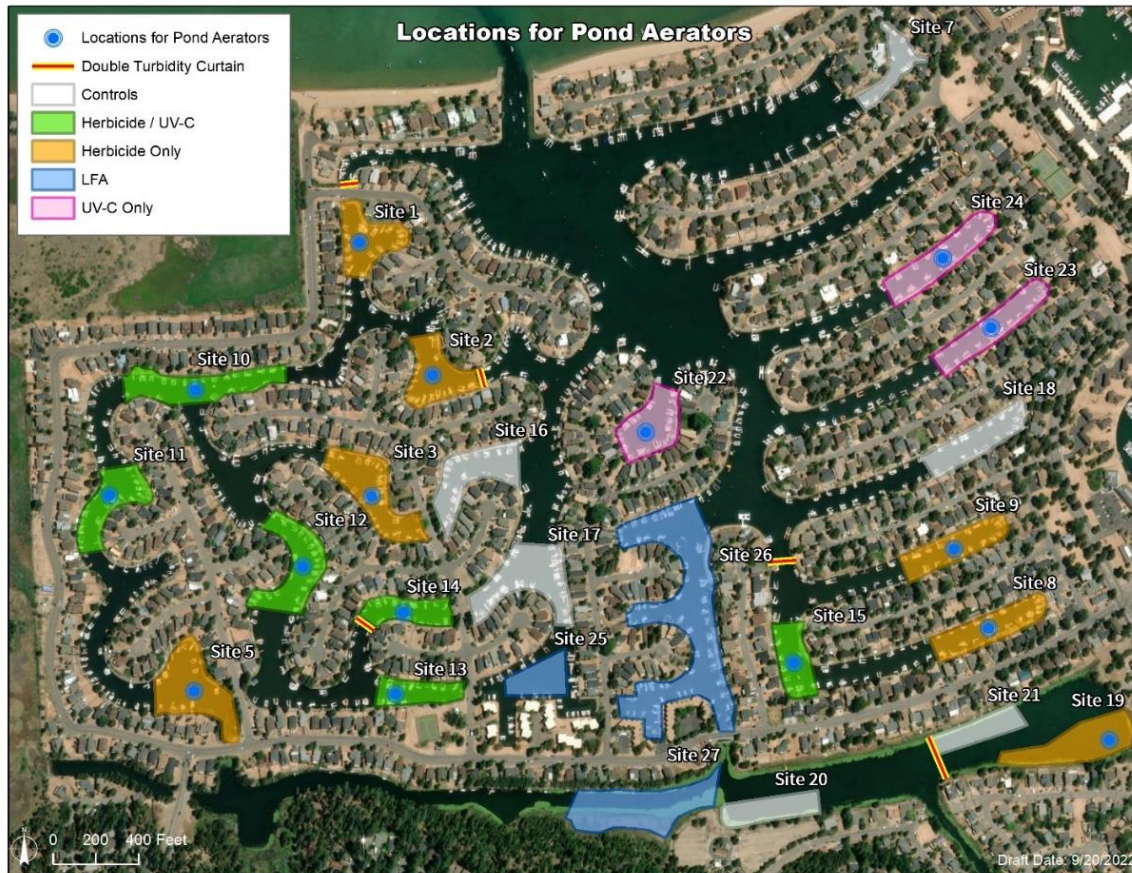
**Figure 4. Locations of aerators (2 per site) installed and activated in CMT herbicide sites.**
