2022 TKPOA Laminar Flow Aeration End of Season Report

**Prepared Pursuant to
California Water Boards General 401 Water Quality Certification Order
(SB14007IN) Requirements and Basin Plan Prohibition Exemption for the
Tahoe Keys Property Owners Association Laminar Flow Aeration Trial
Project, El Dorado County**

2022 Laminar Flow Aeration Report

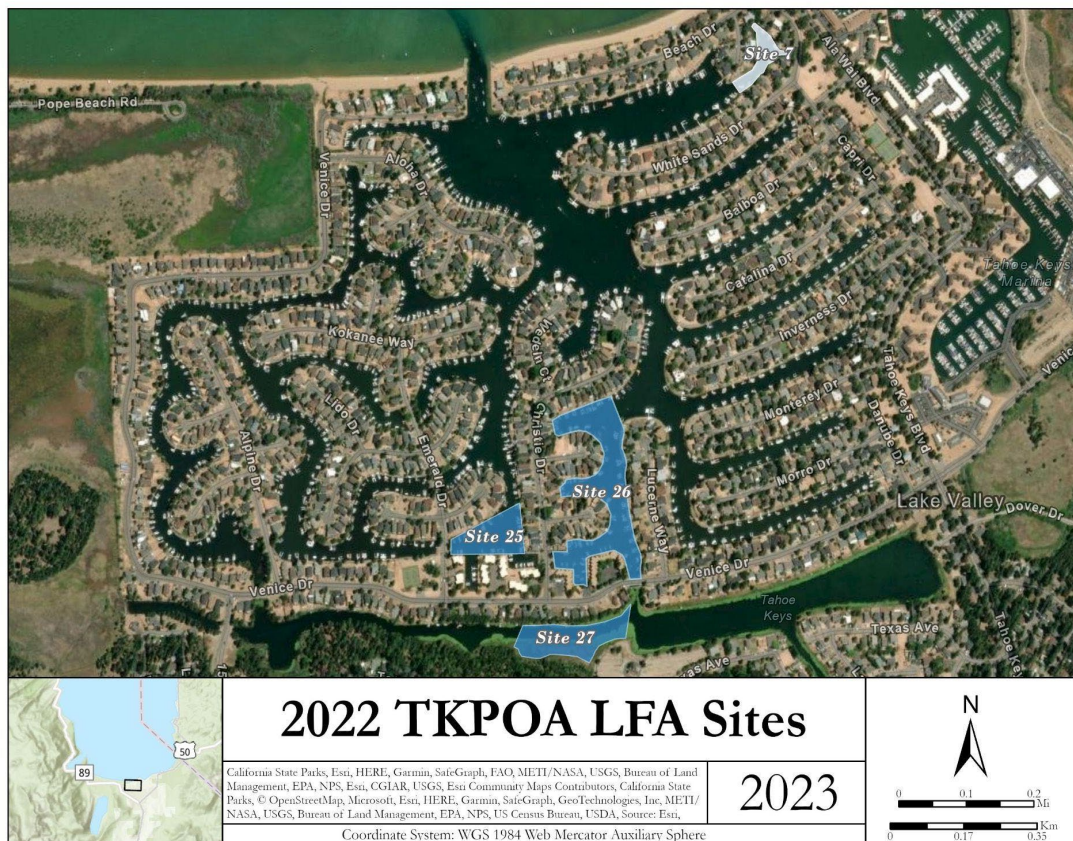
Figure 1. 2022 LFA Project Map

Clean-Flo International was sourced and granted the contract to design the LFA systems for the Tahoe Keys. Each site has been strategically designed based on site area and the air capacity of the system. Each system has a shed that houses a 7.1 horsepower compressor connected to a variable frequency drive which allows for adjustment of air output. A stainless-steel manifold connects the grouping of self-sinking air lines to the compressor. The air lines run from each shed out to the lagoons and are connected to microporous ceramic diffusers that release bubbles in an even distribution at the proper coordinates in accordance with the site design.

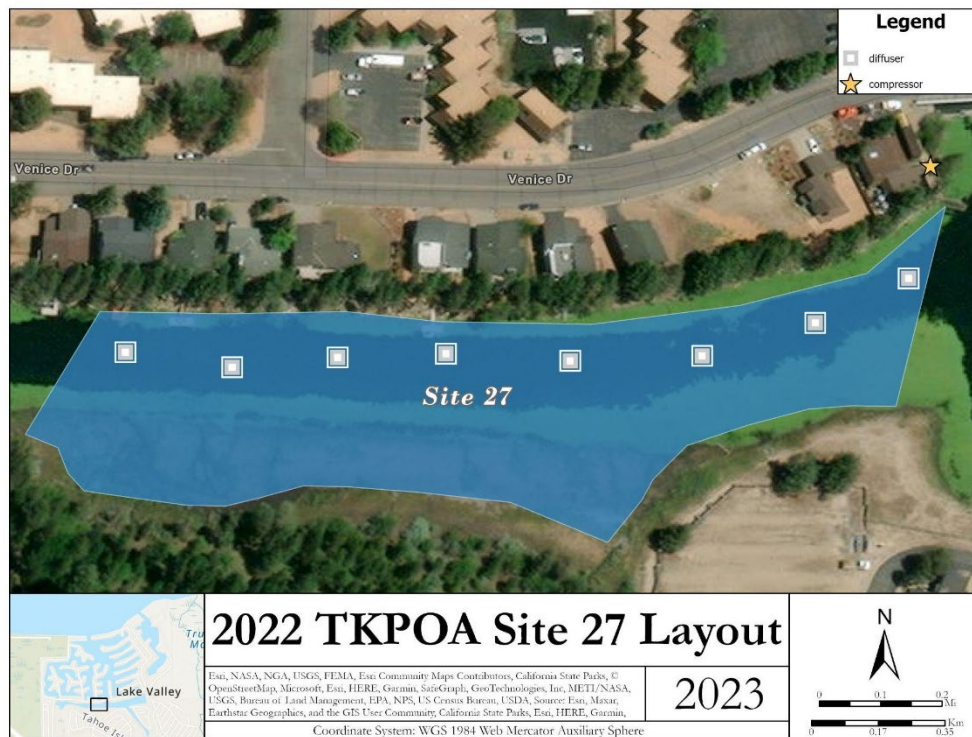
Figure 4. Site 27 Layout

Site 27 is located in Lake Tallac with eight diffusers lined down the lagoon (shown in Figure 4). Since Lake Tallac doesn't have any docks or coves, this location best reflects the optimal location for an LFA system according to Clean-Flo International. The diffusers and air flow will not be inhibited by anything in the water, giving the most efficient treatment possible with this type of set up. This site has been running continuously since November 17, 2022. The compressor for Site 27 is located in a shed behind the TKPOA groundwater well #2 building. The airlines run a short distance down the bank into the water. Sampling stations have not yet been established using GPS. The coordinates will be noted before monitoring takes place in spring 2023.

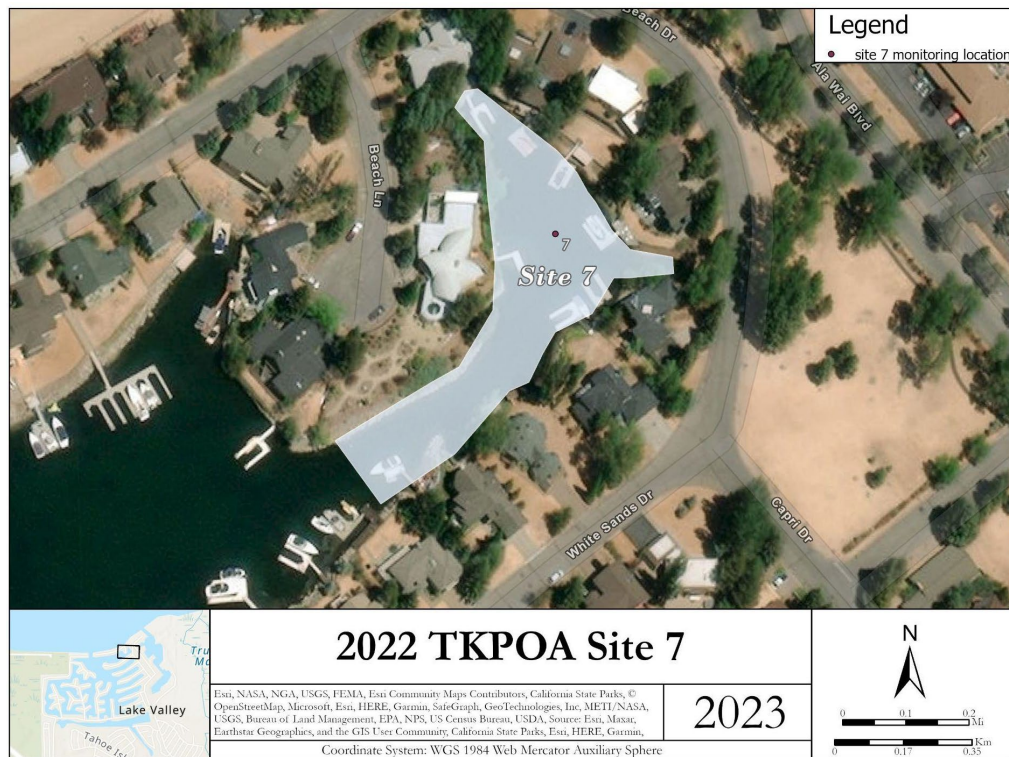
Figure 5. Control Site 7 Monitoring Location

Site 7 is the new control site established in the 2022 season. It is located in Spinnaker Cove around the corner of Beach Lane (shown in Figure 5). The lack of movement and volume of aquatic weeds in this area perfectly reflect the issues that the LFA system is meant to address. There is no compressor or diffuser located on this site. A sampling station has been established in the center of the lagoon (LFA-7).

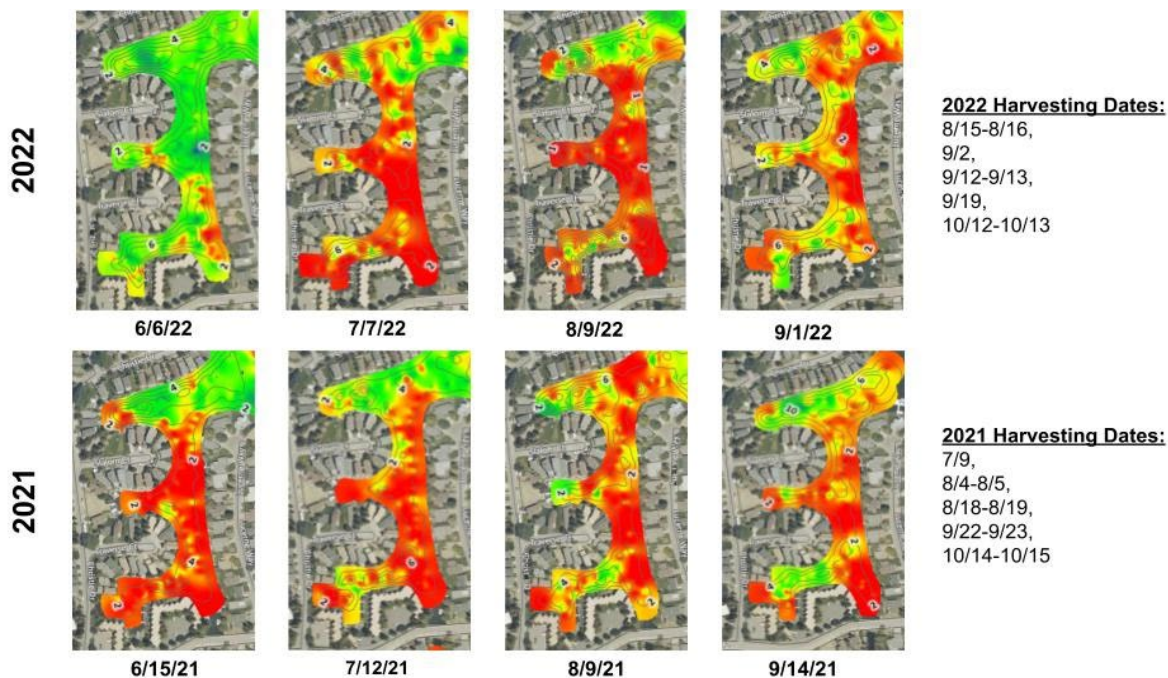
Hydroacoustic scans were used to determine percent biovolume and plant height. Due to dense vegetation, the scans are decided to host inaccurate results for muck depth. A new method will be tested in 2023 using metal plates to help validate the scans for a more consistent reading of muck depth.

Figure 12. LFA Site 26 Biovolume Percent Storyboard for 2021 and 2022.

Results for 2022, in the macrophyte survey and hydroacoustic scans, indicate there are not any significant reductions in macrophyte growth when compared against the control site. More years of data will be needed to determine the real efficacy of LFA, as it is expected to take time for an LFA type process to make noticeable changes in the environment. Several factors could account for the biovolume seen in 2022. First, there was an overall decrease in mechanical harvesting with the ongoing CMT project. Secondly, there were several distinct tears in the LFA tubing. This resulted in reduced airflow in the diffusers, meaning decreased efficiency altogether in the test site. Thirdly, the 2022 season was a lower water year in comparison to the 2021 season, though it should be noted that both seasons were considered low water years. Shallow water depths in dead end areas – like in Site 26 – create an environment where plants easily fill the available water column.

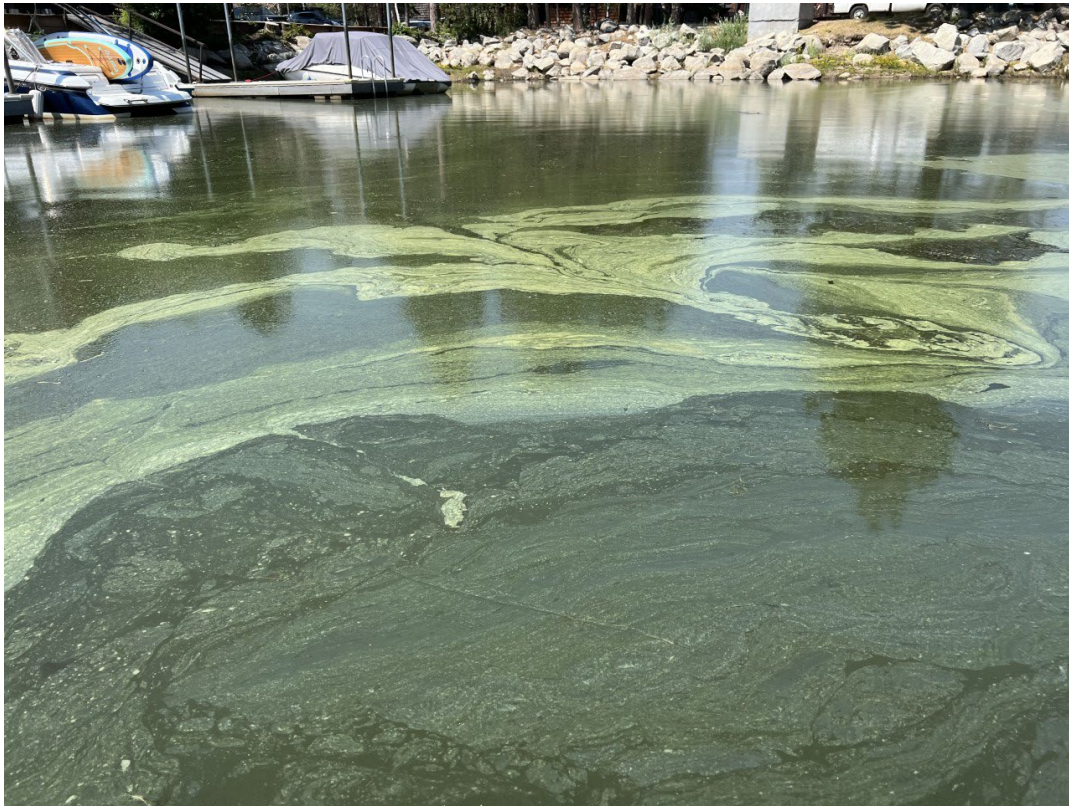
Based on the California Cyanobacteria and HAB Network trigger levels for posting HAB advisory signs, Site 26 triggered a “caution” level on July 12, 2022, in LFA-H and LFA-I. Lahontan Water Boards was immediately notified of the lab results and AIS technicians posted the appropriate signage around Site 26. See Appendix B for Caution Sign and Appendix C trigger levels for posting HAB signage.

Figure 14. Cyanobacteria ‘paint’ near site LFA-I on July 12, 2022

Overall HAB levels throughout the West Lagoon were increased for the 2022 season. This is thought to be due to setbacks during the first year of the CMT. HABs were detected at the “caution” level in Site 26 during July, but not again for the rest of the season. HABs were not detected in the now established Sites 25 and 27. Monitoring in 2023 will help determine if there are any changes in HAB levels and whether the LFA sites improve or maintain lower levels of HABs than seen throughout the rest of the lagoons. There is also an effort to determine if an increase in HABs is due to the new site installations or if the LFA system could in fact facilitate HAB growth in dead end areas.
