Subject: TKPOA 2022 Annual Report for Tahoe Keys Lagoons Aquatic Weed Control Methods Test; Lahontan Regional Water Quality Control Board Order No. R6T-2022-0004, NPDES No. CA6202201, WDID No. 6A091701001

This document reports on the specific regulatory compliance actions and the results as part of implementation of the requirements of Lahontan Regional Water Quality Control Board National Pollutant Discharge Elimination System (NPDES) Permit Order R6T-2022-0004 (Lahontan Order) and required Amendments to the Aquatic Pesticide Application Plan (APAP). Additionally, Tahoe Regional Planning Agency (TRPA) Permit EIPC2018-0011, Special Condition #2 incorporates Mitigation Monitoring and Reporting Program (MMRP) requirements, Special Condition #3 incorporates Waste Discharge Requirements (WDR) and Lahontan Order permit requirements.

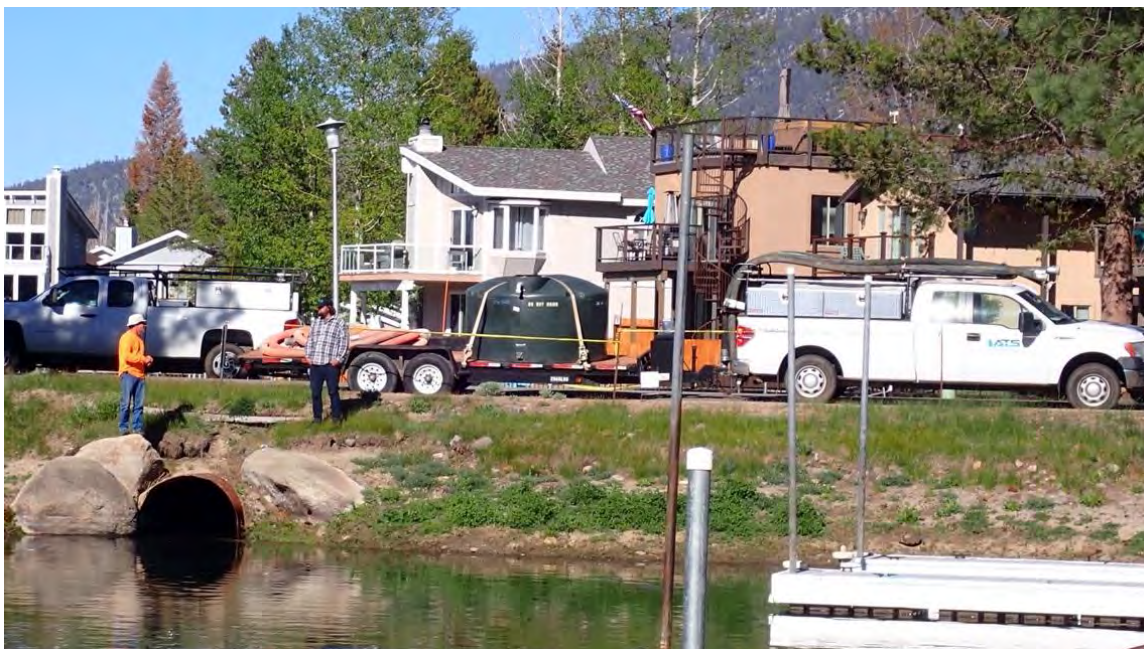
**Figure 2-2. Example of Spill Prevention and Contingency Pumping Equipment Deployed During Herbicide Applications**

As part of the mitigation and contingency planning, a professional certified hazardous waste removal team was deployed during all applications of herbicides. Preventative protocols are provided in the QAPP (Appendix F). During herbicide applications, the spill contingency team maintained mobile pumping and storage systems adjacent to each treated site until the application was finished. The spill contingency contractor information is provided in Appendix L. As planned, no spills occurred during any of the CMT herbicide applications (see Appendix M). An example of the deployed spill response equipment is shown in Figure 2-2 below. The equipment was moved to each site prior to herbicide application at the site. (Note: storage tank and hoses as well as the black culvert plug at the water's edge.)

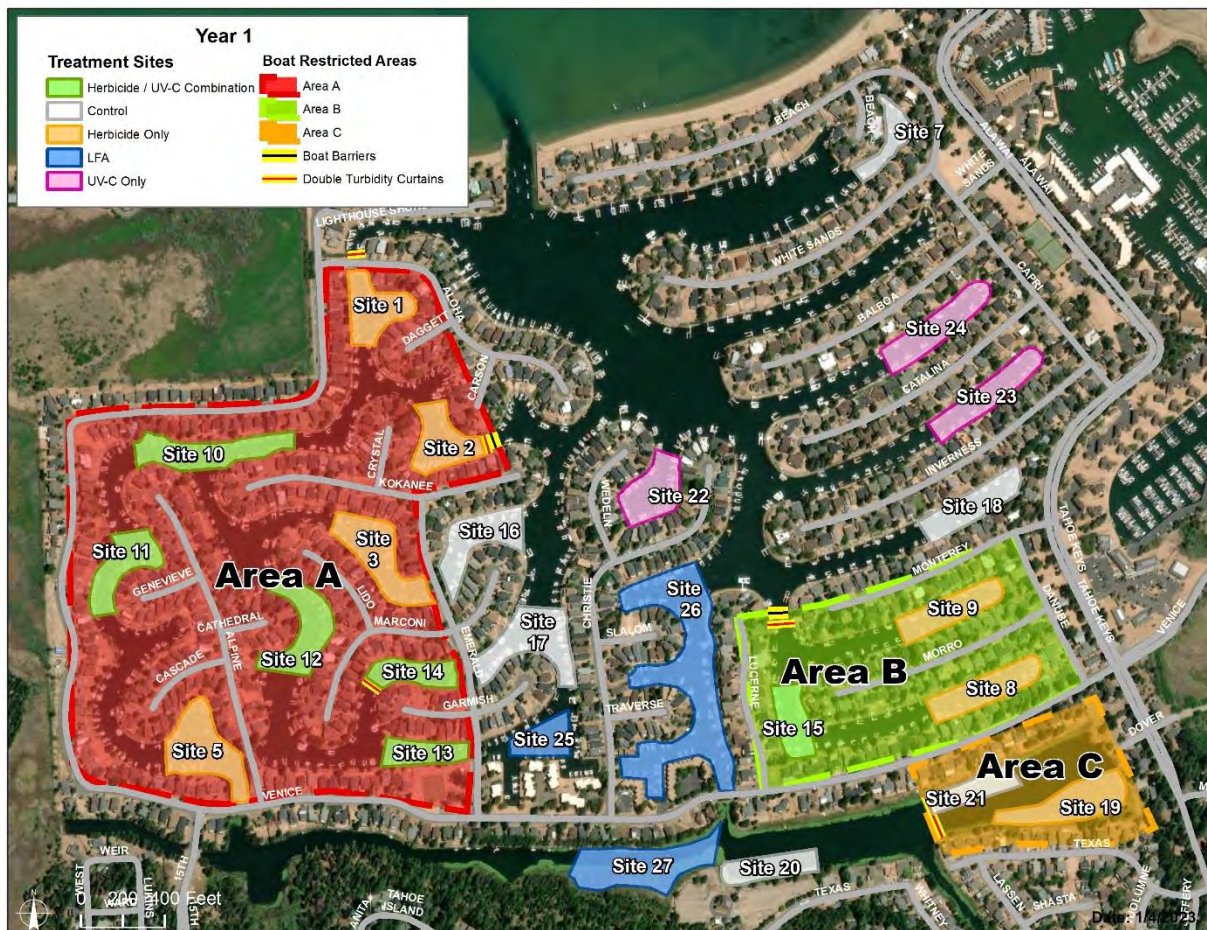
**Figure 2-3. Designated Boating Restricted Areas (A, B, C) Separated by Double Turbidity Curtains and Barriers**

As part of the CMT permit requirements, sites identified for herbicide applications were required to be isolated from the main waterway areas of the West Lagoon and Lake Tahoe. The use of containment curtains effectively isolated three major boating exclusion zones of the CMT sites: Area A (west side of the West Lagoon behind curtains installed at Site 2); Area B (containing sites 8, 9 and 15 in southeast area of the West Lagoon); and Area C (Lake Tallac, all non-motorized boating). Figure 2-3 shows the boating restricted areas (A, B, and C).

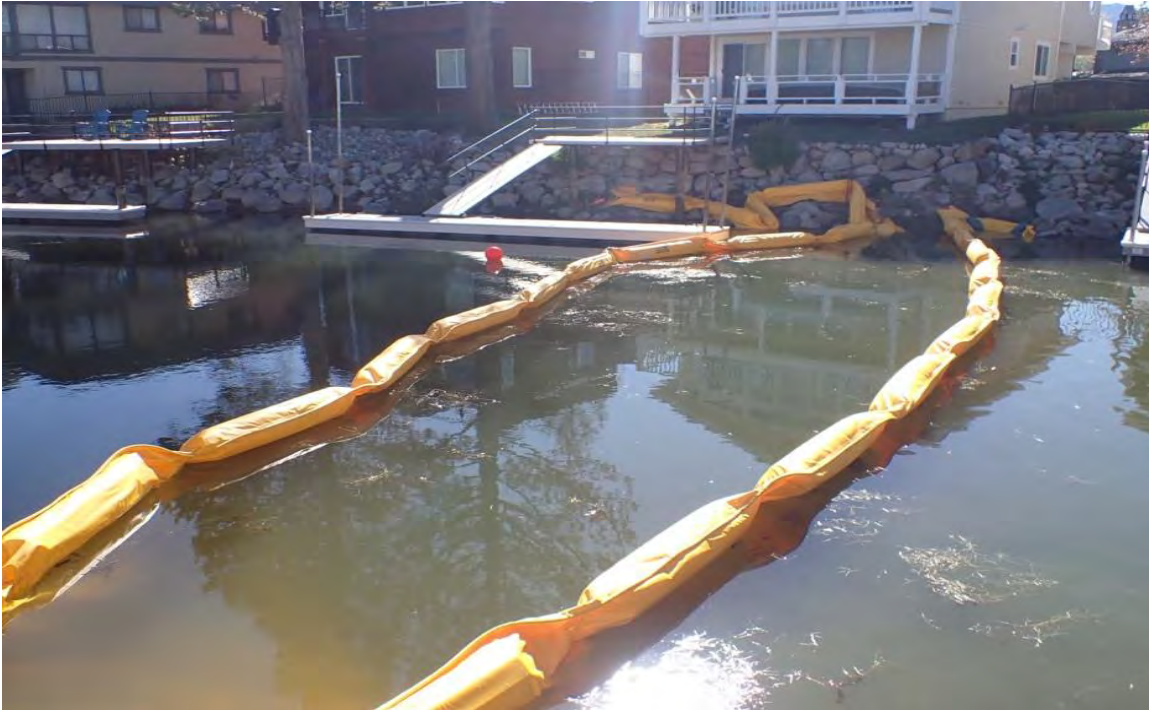
**Figure 2-4. Double Curtain in the West Lagoon**

To protect the integrity of the curtains, and to prevent boats from breaching the curtains, physical metal barriers (pilings) and plastic fencing were installed outside the curtains for Areas A and B. Figures 1-1 and 2-3 show where the curtains were installed prior to applications of herbicides. During installation and removal of curtains, turbidity was monitored to ensure disturbance was minimized (Appendix R). Examples of the double turbidity curtain installations are shown in Figures 2-4 and 2-5.

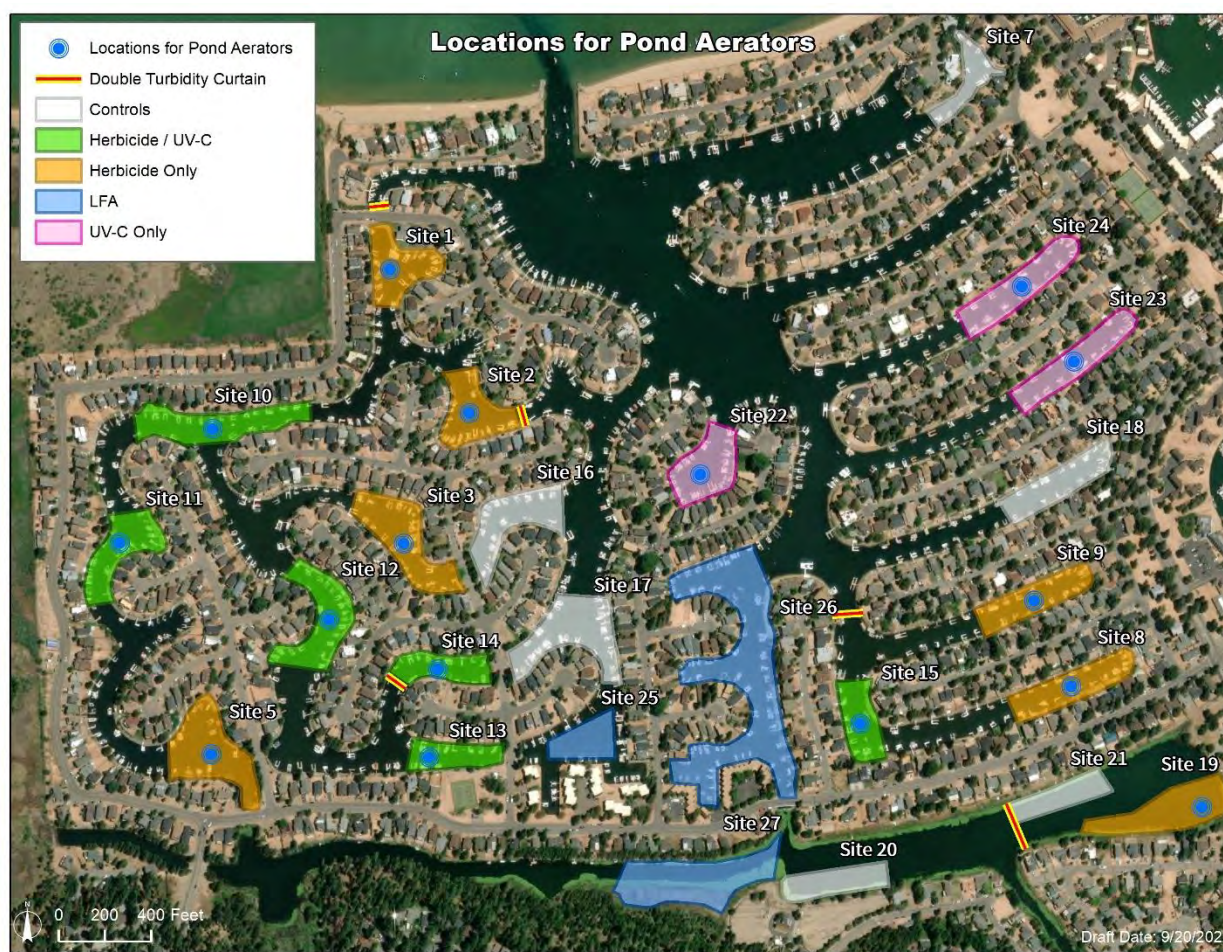
**Figure 2-6. Location of Contingency Sub-Surface Aerator Systems in each CMT Treatment Site (except LFA Site 26)**

At each CMT site, power access for contingency aeration systems was identified and aeration systems were assigned and staged (Figure 2-6). Use of the aeration was intended to mitigate potential reductions in DO and increase water-column mixing. Table 2-3 provides aeration activation dates. No aeration systems were installed in control sites.

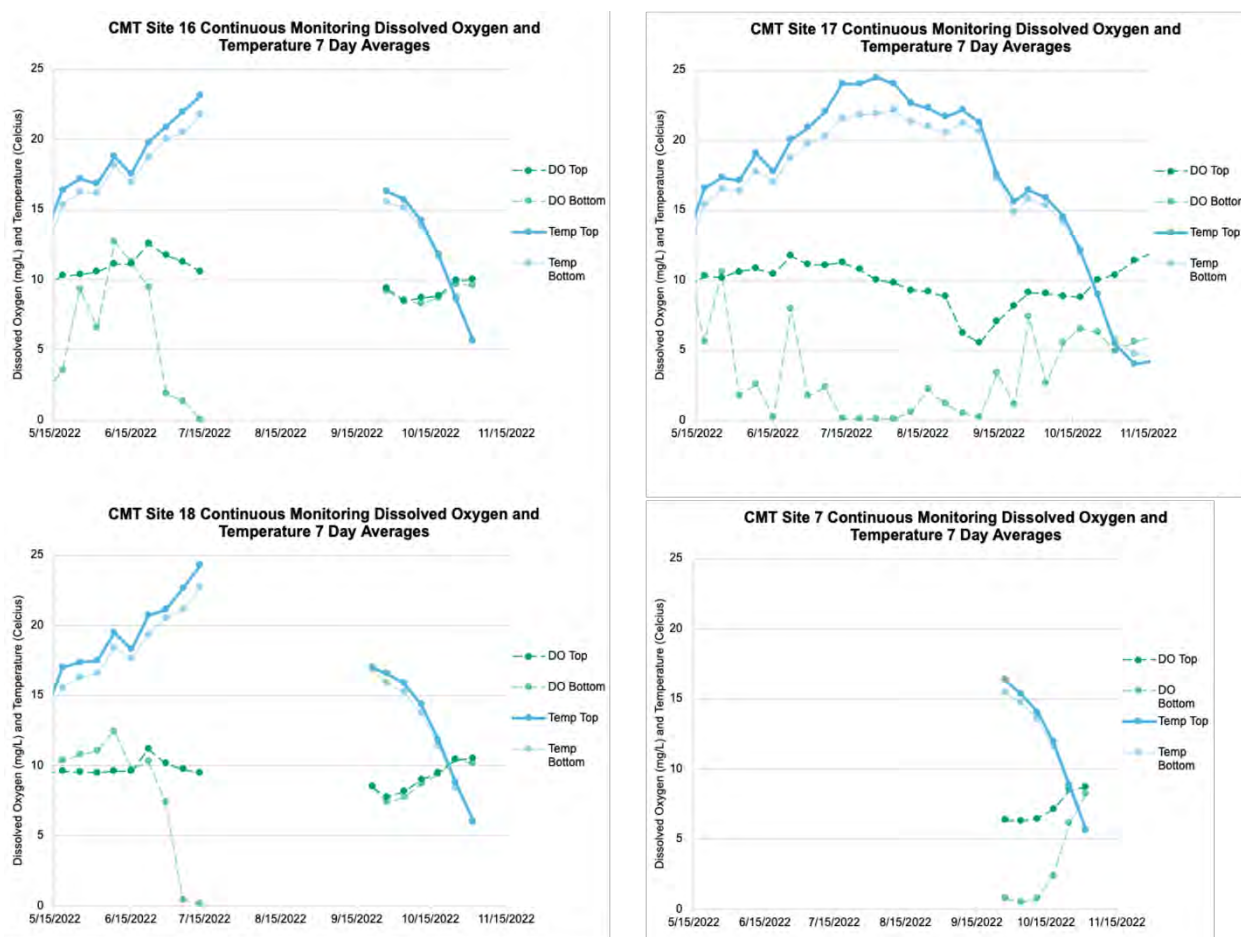
**Figure 4-8. DO and Water Temperature in Control Sites 16,17,18,7 Derived from Hourly Data Used to Generate Weekly Averages**

In Figure 4-8, gaps in Sites 16 and 18 are due to lost miniDOTs. The location of control Site 7 (for LFA comparison) was established late.
