# Performance Solution Scenario

## Ambulant Toilet Width

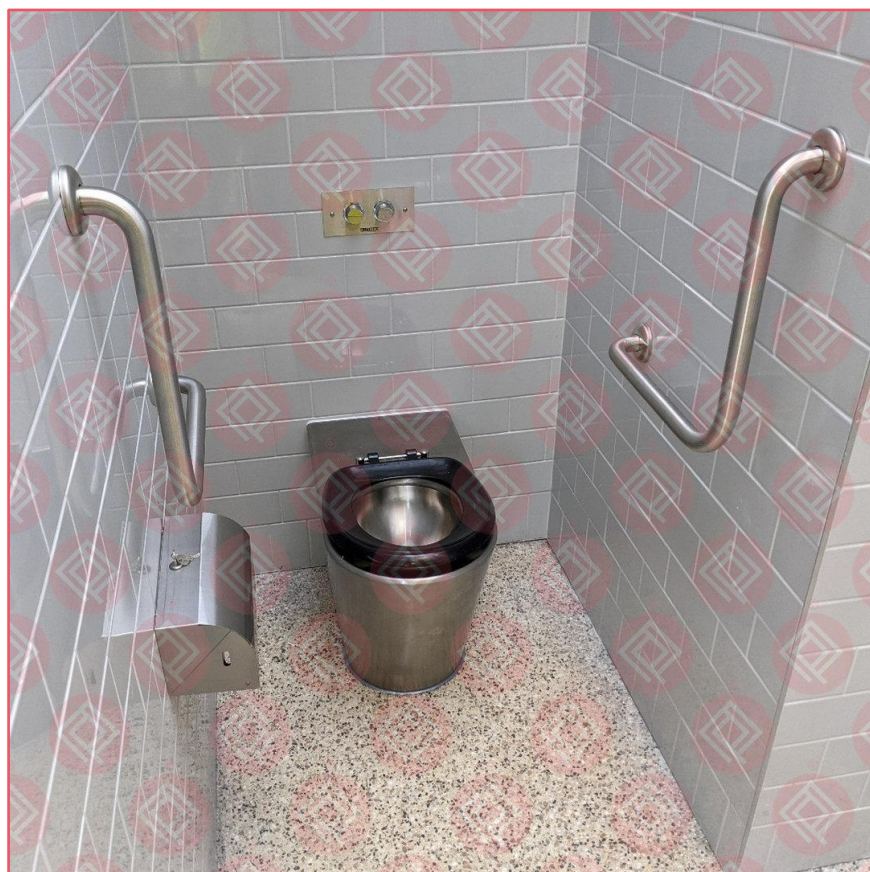
Existing conditions result in a clearance of 890mm, instead of 900mm to 920mm.

Using a 30mm or 32mm grabrail will help to maximise the clearance in the toilet area and maintain the relationship between the pan location and each grabrail.
