# TKPOA Aquatic Invasive Species Program

## 2023 End of Season Report

Tahoe Keys Property Owners Association  
South Lake Tahoe, California

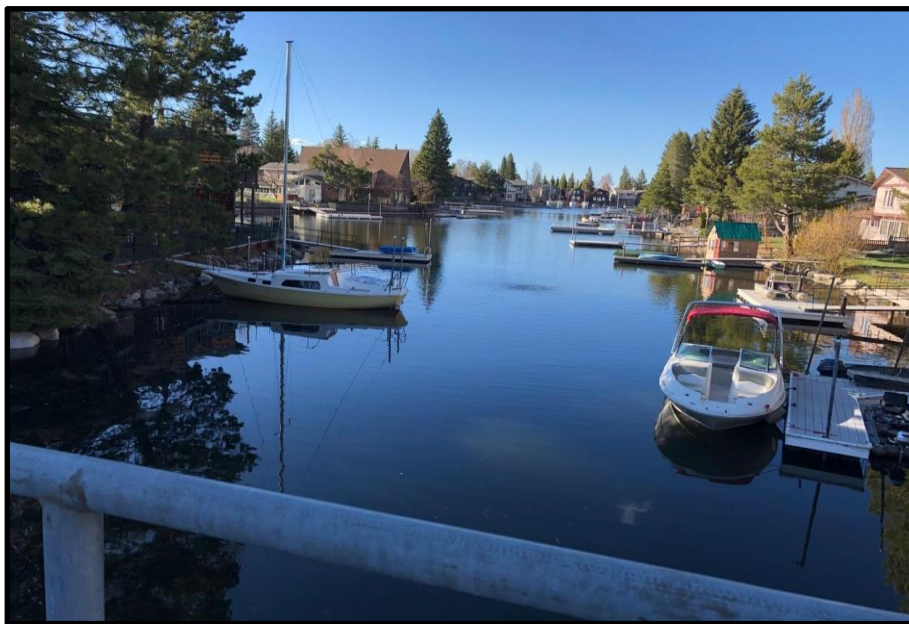
Figure 4. LFA project area view from Venice Drive bridge looking North.

In 2023, the existing LFA project (Site 26) and the two new LFA treatment sites (25 and 27) were monitored in accordance with the CMT Requirements, and the project permits in accordance with the procedures instructed by Lahontan Regional Water Quality Control Board (LRWQCB). Refer to the 2023 Laminar Flow Aeration End of Season Report for more details (TKPOA 2024c).

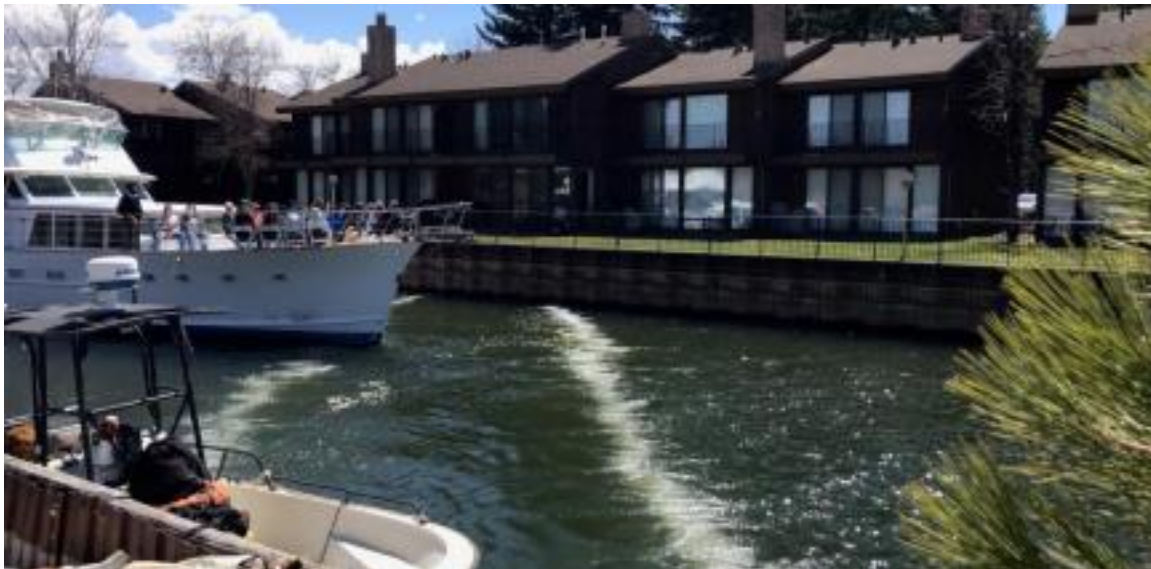
*Figure 7. East Channel Double Bubble Curtain*

This Bubble Curtain (BC) is powered by one large compressor and consists of tubing running along the length of the entrance channels in the East and West lagoons. The tubing releases a wall of bubbles that function as a permeable wall to prevent weed fragments from leaving the Lagoon, while also safely allowing boaters to pass.

In 2022, a second bubble curtain was installed in the West Channel (WC) to improve its functionality. Four 10` x 25` bottom barriers were installed underneath the additional bubble curtain to limit plant growth around the air tubing.

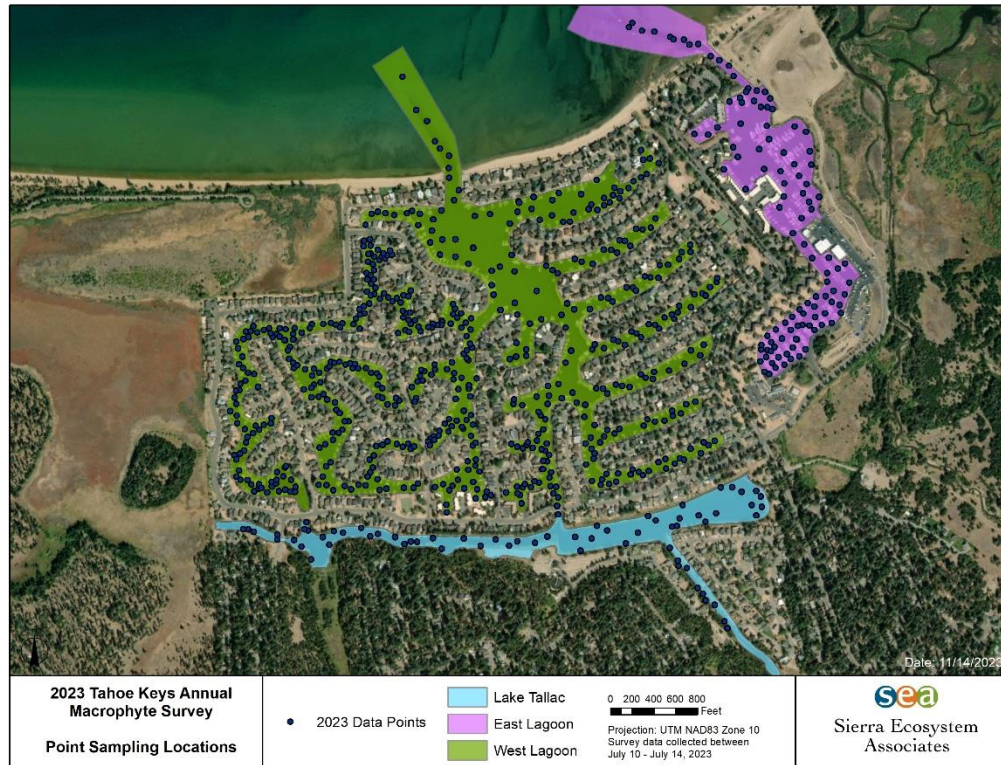
Figure 8. Points Sampling Locations for the SEA 2023 Macrophyte survey

The Annual Macrophyte Survey was conducted once during the 2023 season. This survey sampled 735 points throughout the Tahoe Keys Lagoons and Lake Tallac. At each point, a sample is taken by raking the bottom of the water column with a sampling rake. The sample is then analyzed, and the percentage of each species is estimated. The percentage and species are recorded on a data sheet, input into GIS software, and checked against archived data to determine what plants are growing where. These results were published in the 2023 Macrophyte Report created by Sierra Ecosystem Associates (SEA). This report helps identify and quantify changes to the aquatic vegetation within the Tahoe Keys Lagoons. The Annual Macrophyte Survey was not completed within CMT sites. However, additional macrophyte surveys were conducted in treatment sites (bi-weekly) by an outside contractor to fulfill permitting requirements.

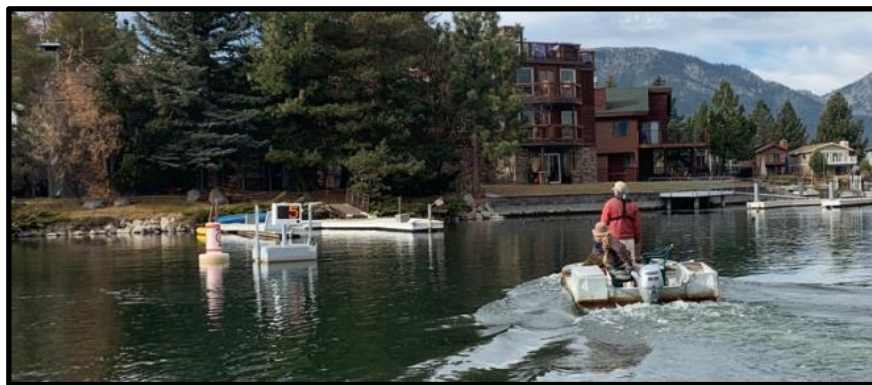
Figure 10. Mobile Radar System in West Lagoon

Two radar systems were in place and fully functional throughout the 2023 season. They are located at the West Channel entrance and at a key intersection where it was visible to most boaters in the Tahoe Keys. The goal of these systems is to encourage boaters to reduce their wakes and speeds while in the TKPOA waterways.

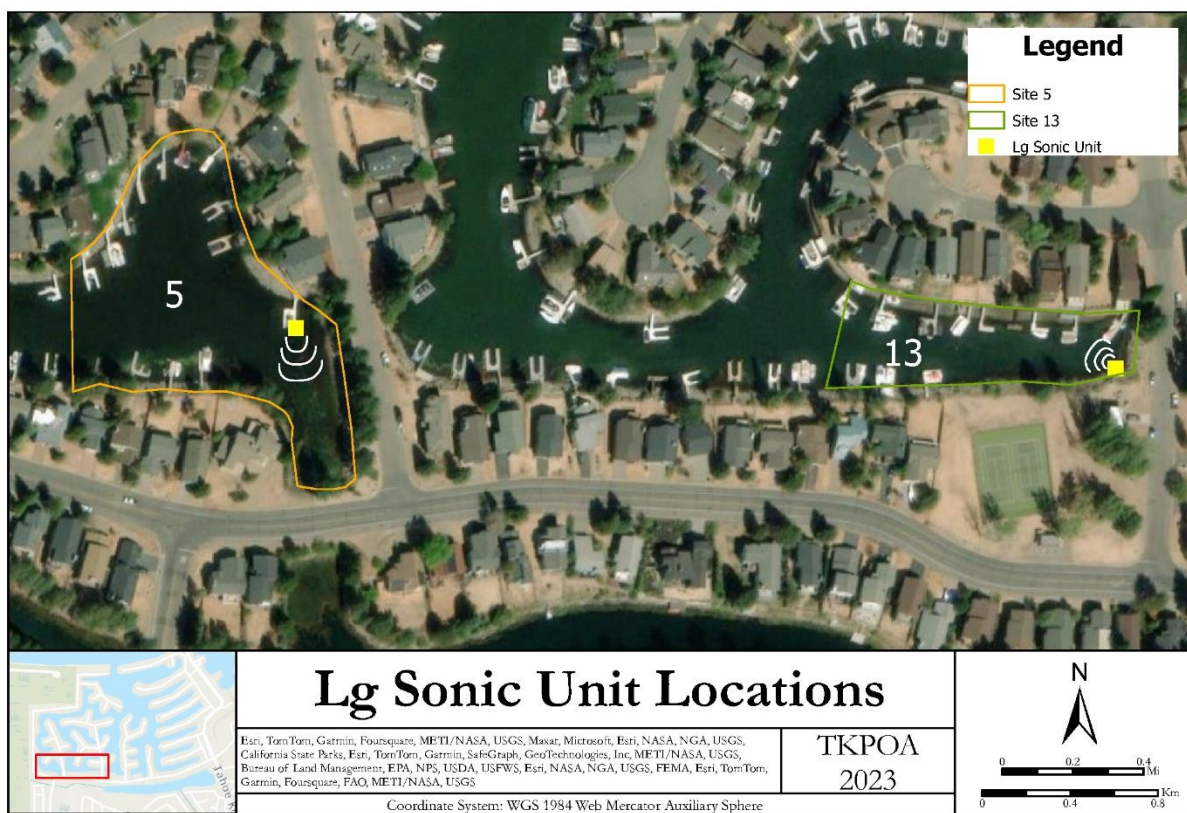
Figure 12. Lg Sonic Unit Locations in Site 5 and Site 13

CMT Sites 5 and 13 were determined optimal test sites due to their dead-end locations as well as previous years' HABs occurrences. Site locations are shown in Figure 12.

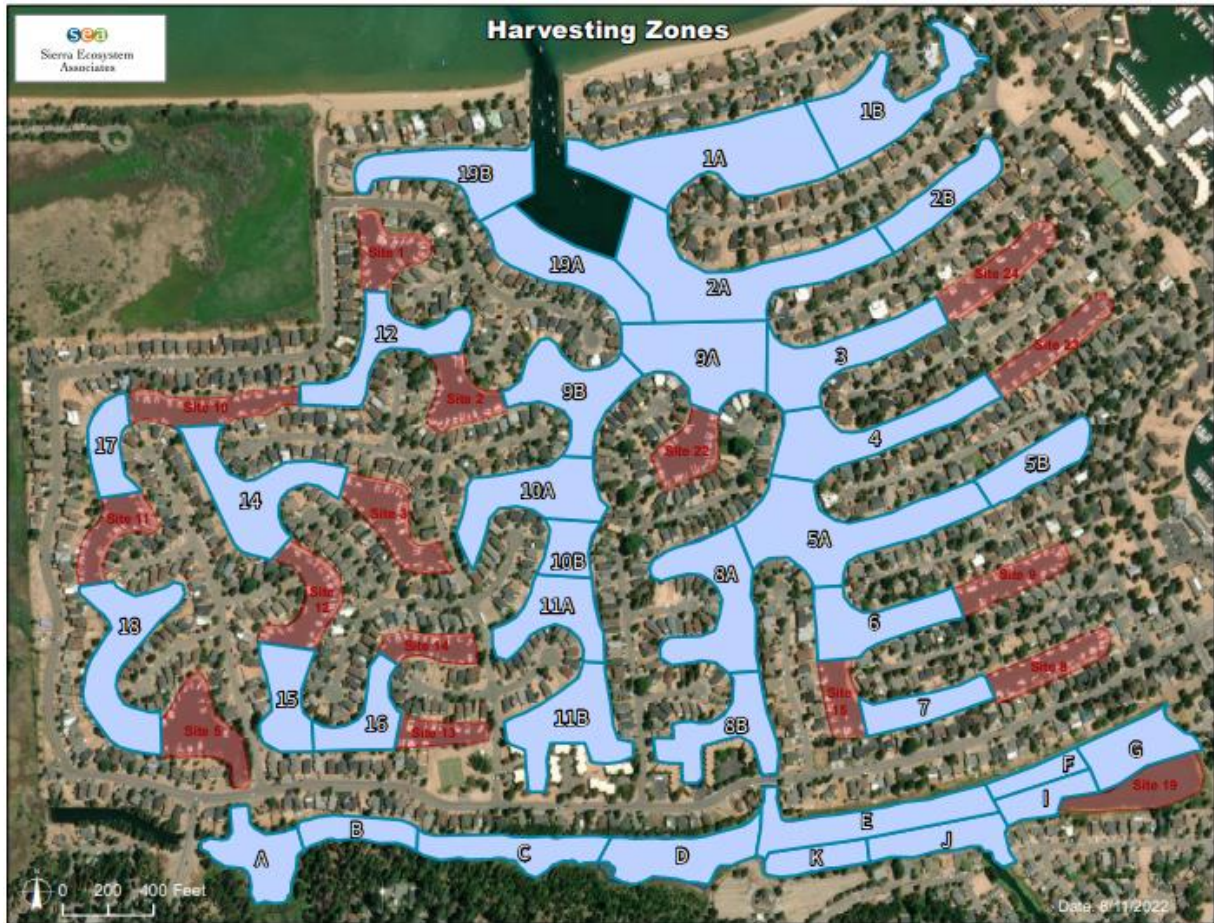
Figure 14. 2023 West Lagoon and Lake Tallac Harvesting Zones

In 2023, harvesting operations were altered to comply with the CMT. Several changes were implemented to accomplish this, however unlike 2022, harvesting operations were able to begin mid-June like previous years. Modified harvesting zones were implemented in the West Lagoon to avoid interference with CMT treatment sites. The East Lagoon’s harvesting zones were not changed. See harvesting zones in Figures 11 and 12 below.
