# 2023 TKPOA Laminar Flow Aeration End of Season Report

**Prepared Pursuant to  
California Water Boards General 401 Water Quality Certification Order  
(SB14007IN) Requirements and Basin Plan Prohibition Exemption for the  
Tahoe Keys Property Owners Association Laminar Flow Aeration Trial  
Project, El Dorado County**

## 2023 Laminar Flow Aeration Report

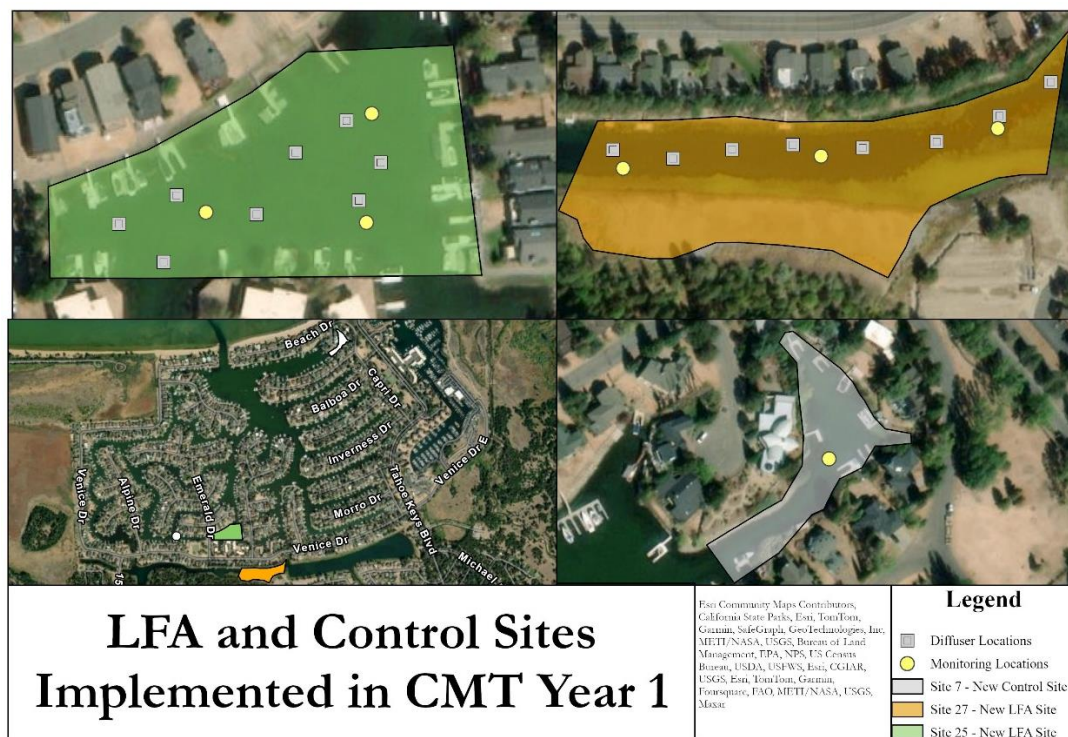
Figure 2. LFA and Control Sites Implemented in CMT Year 1

Site 25 was designed with eight diffusers placed in the middle of the lagoon area (shown in Figure 3) and has been operating since November 16, 2022. One of the criticisms with Site 26 is the spacing between the diffusers. Site 25 is designed to address this concern and condense the diffuser

Site 27 is in Lake Tallac with eight diffusers lined down the lagoon (shown in Figure 4). Since Lake Tallac does not have any docks or coves, this location best reflects the optimal location for an LFA system according to Clean-Flo International. The diffusers and air flow will not be inhibited by anything in the water, giving the most efficient treatment possible with this type of set up. This site has been running continuously since November 17, 2022. The compressor for Site 27 is in a shed behind the TKPOA groundwater Well #2 building. The airlines run a short distance down the bank into the water. Due to homeowner request, the Site 27 laminar flow aeration system was turned off for the winter of 2023-2024 on December 5, 2023, to allow Lake Tallac to ice over for recreational sports. It will be turned on again in Spring of 2024.

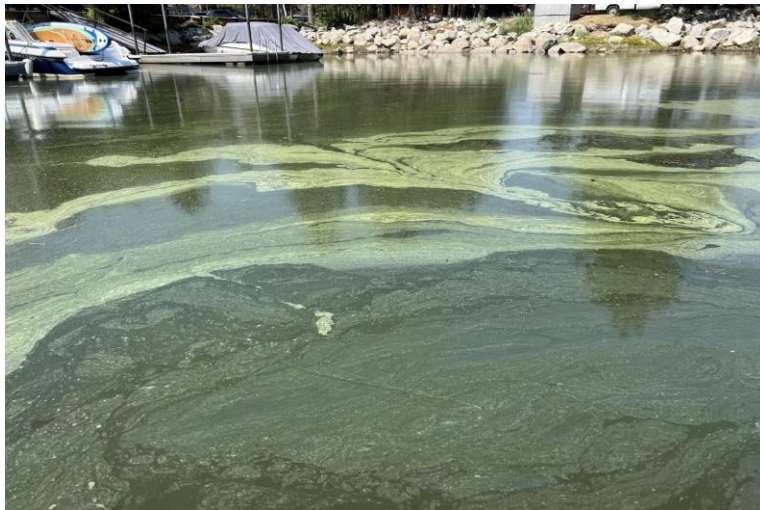
Based on the California Cyanobacteria and HAB Network trigger levels for posting HAB advisory signs, Site 26 triggered a “caution” level on July 25, 2023. Lahontan Water Boards was immediately notified of the lab results and AIS technicians posted the appropriate signage around Site 26. Once staff received two consecutive non-detects and visual indicators dissipated, the caution signs were removed (October 25, 2023). See Appendix B for Caution Sign and Appendix C trigger levels for posting HAB signage.

Figure 12. *Cyanobacteria 'paint' near site LFA-I*
