TKPOA Aquatic Invasive Species Program

2019 End of Season Report

Tahoe Keys Property Owners Association
South Lake Tahoe, California

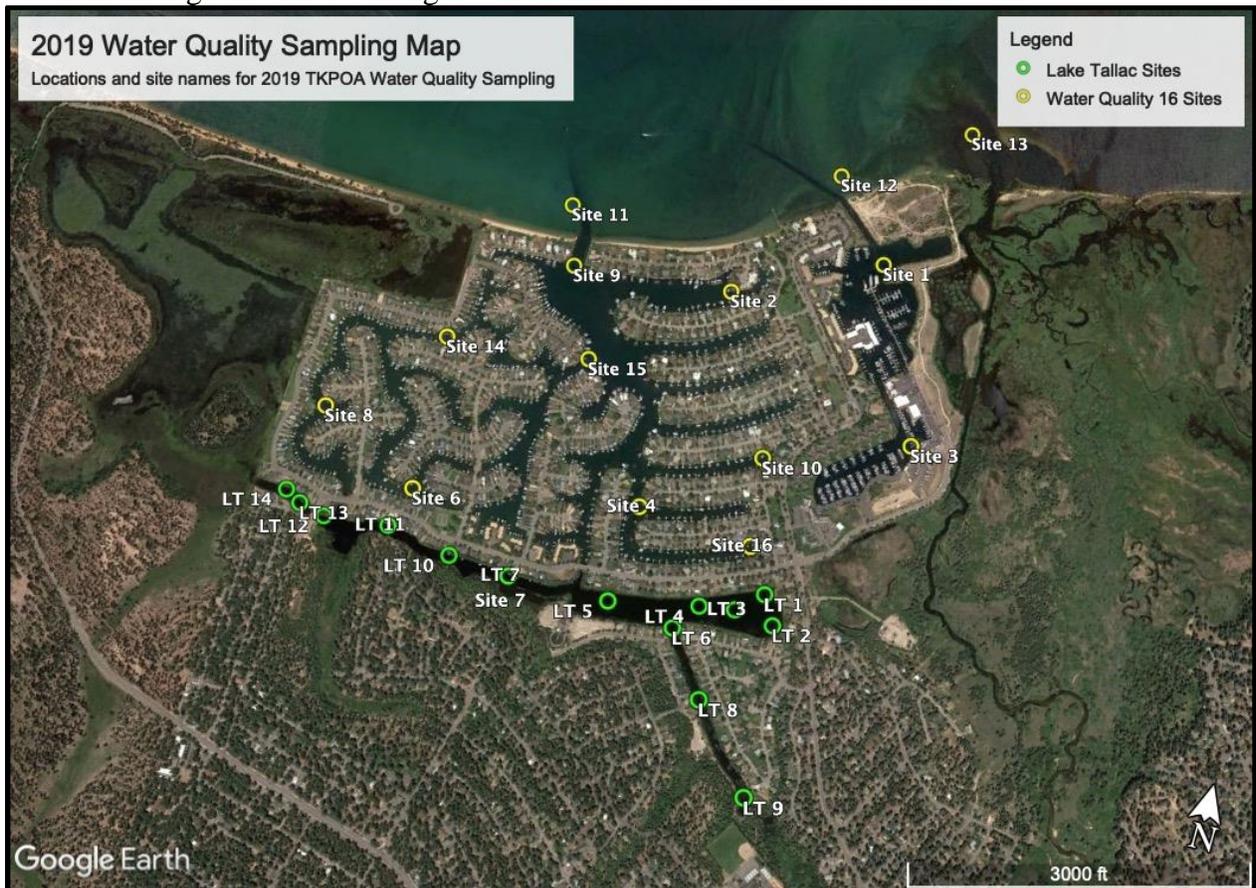
Figure 2: 2019 Water Quality Sampling Map

Figure 2 displays the locations of the 30 sites where water quality measurements were taken during 2019. Lake Tallac sites 5 and 7 are the same location as Water Quality sites 5 and 7.

In 2019, the AIS staff sampled the sites shown in figure 2 every other week. 10 water quality parameters were measured during 26 sampling events at 30 sites over the course of the aquatic plant growing season from early May to mid-October (Table 1). Due to budget constraints the TKPOA did not sample for nutrient contents at the water quality sites but did at the Laminar Flow Aeration Sites which will be discussed in Section 3.2.

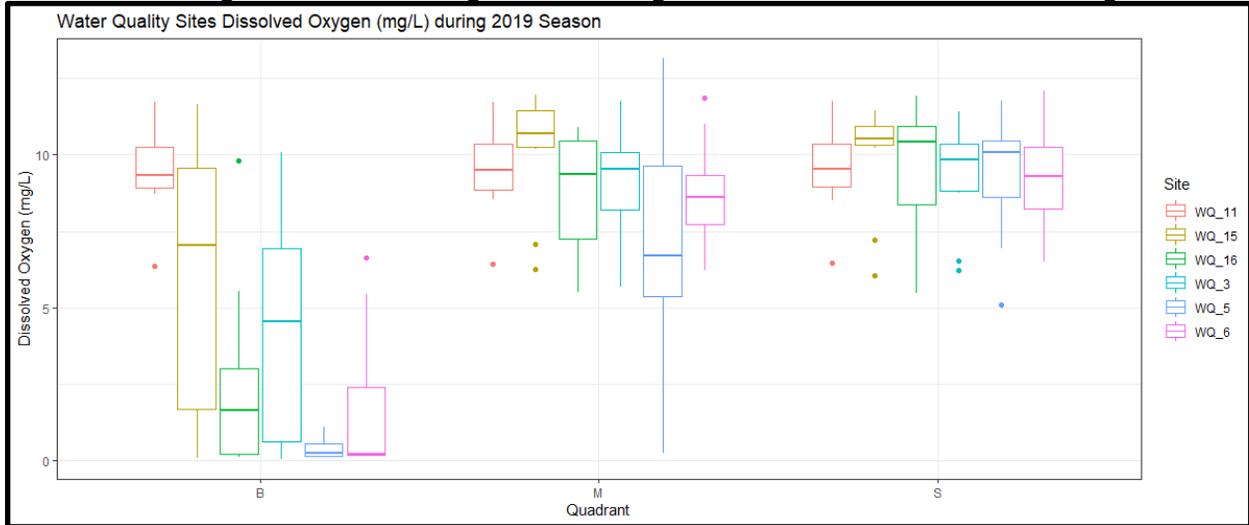
Figure 5: Dissolved oxygen for Water Quality Sites

Figure 5 displays dissolved oxygen content from 6 of the water quality sampling sites. At WQ 11 the average D.O. Level was 9.51 mg/L, the lowest level was at the bottom which was 6.31 mg/L and the highest is 11.75 mg/L. At WQ 15 the average D.O. for WQ 15 was 10.5 mg/L while the

minimum D.O. was found at the bottom and was 0.05 and the highest was in the middle and was 11.95 mg/L. The results from WQ 8 and 16 are relatively similar because they represent similar conditions, the lowest D.O. was 0.09 mg/L, the average was 8.05 mg/L and the highest was WQ 8 at 13.0 mg/L. WQ 5 in Lake Tallac had the lowest average D.O. levels the lowest recorded level was 0.11 mg/L while the average was 6.49 mg/L and the maximum was 13.15 mg/L.

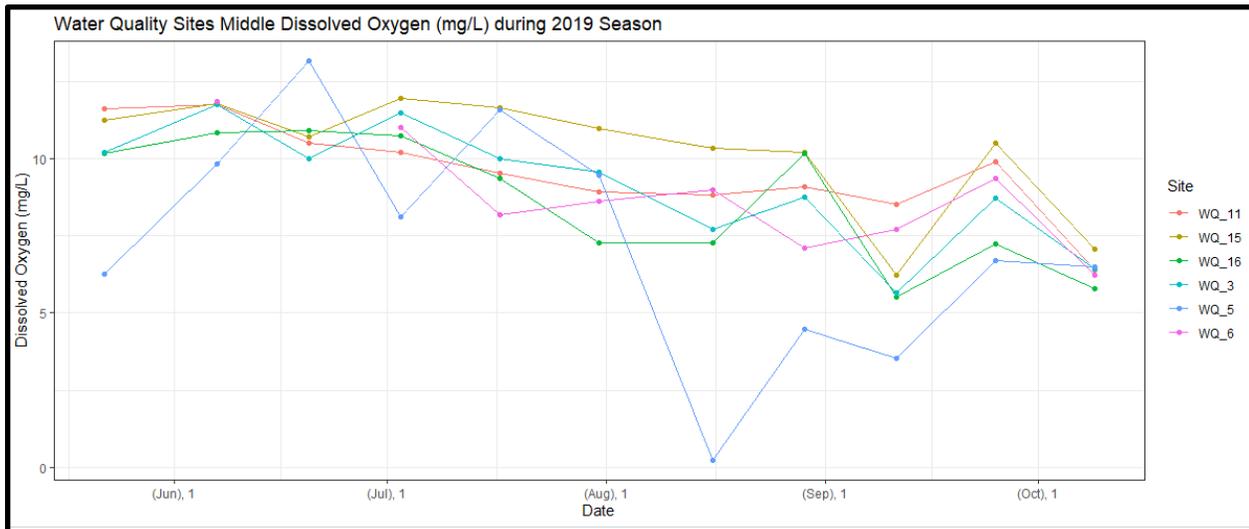
Figure 6: Mid point dissolved oxygen levels May - October

The dissolved oxygen content varied by what depth and where the measurement was taken. The bottom often had low dissolved oxygen while the mid point and surface had higher content.

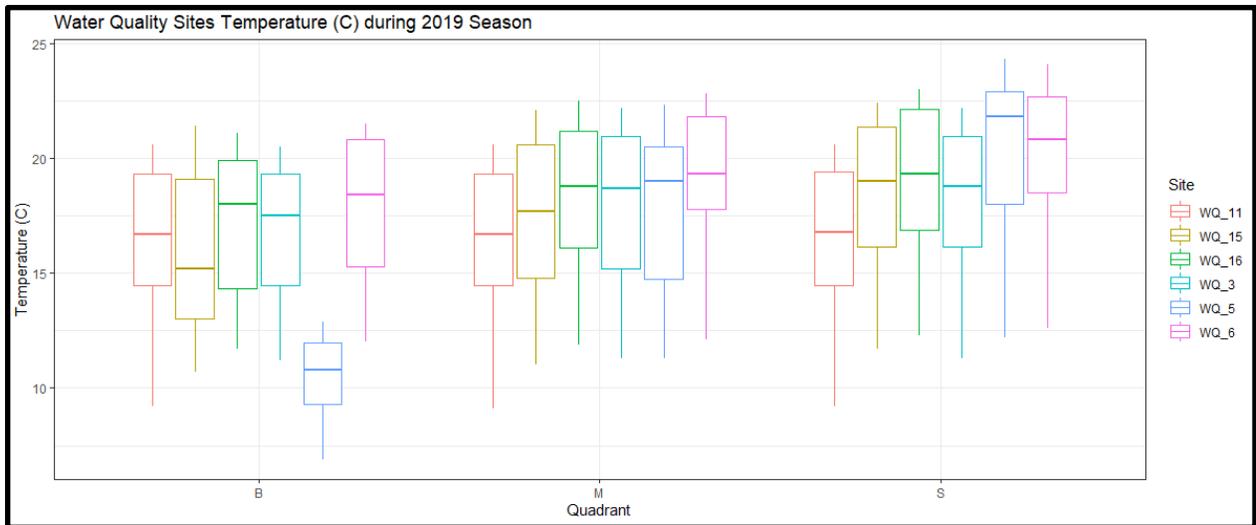
Figure 7: Bottom, middle and surface temperature for water quality sites.

Figure 8 shows that temperature is dependent on the time of year. Warmest temperatures were observed mid July through early September. Lowest temperatures were observed at the bottom of the water column while highest were at the surface.

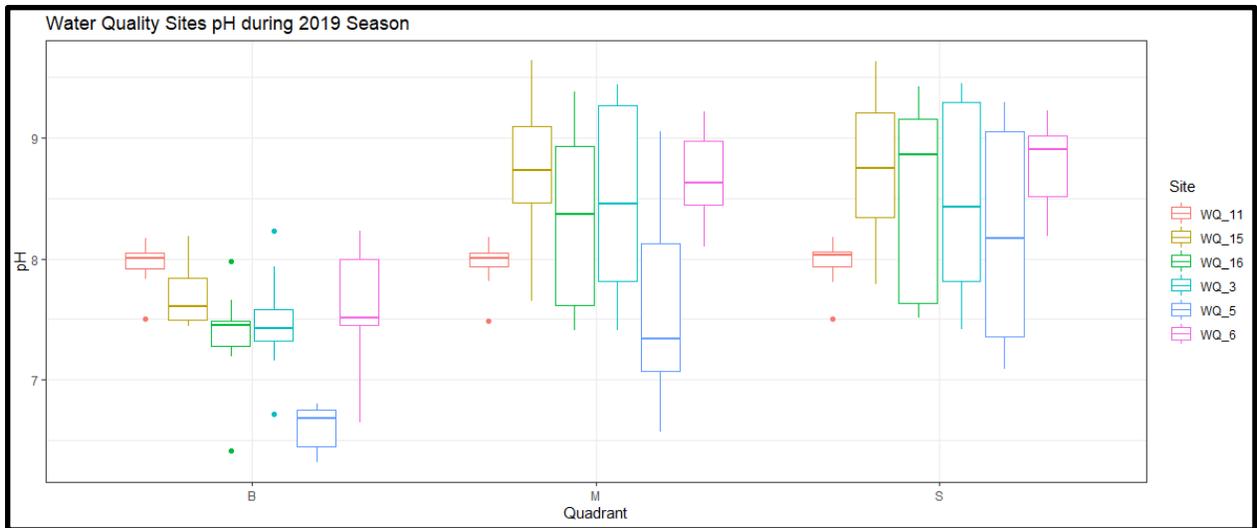
Figure 9: Bottom, middle and surface pH

The pH levels in the lagoons become highest mid June and stay high until the beginning of September. This increase is due to photosynthesis of the plants causing the water to become more basic. pH levels are lower at the bottom of the water column compared to the surface but are on average higher in the middle due to photosynthesis of the plants. Figure 10 shows WQ 11 having lower pH than other sites throughout the season. Table 1 contains averaged data from WQ 8, 15 and 16 to gain an average pH for the Tahoe Keys lagoons.

For the middle quadrant WQ 11 had an average pH of 8.01, a minimum of 7.49 and maximum of 8.18. WQ 15 had an average of 8.73, a minimum of 7.65 and a maximum of 9.64. WQ 16 had an average of 8.37 a minimum of 7.41 and a maximum of 9.38. WQ 3 had an average of 8.46 a maximum of 9.44 and minimum of 7.41. WQ 5 had an average of 7.34 a minimum of 6.57 and a maximum of 9.05. WQ 8 had an average of 8.96, minimum of 7.72 and maximum of 9.270. The average for site 8, 15 and 16 is 8.68. However, this data is only from mid May through mid October. The year round averages are lower because this data was taken during the growing season when pH is higher.

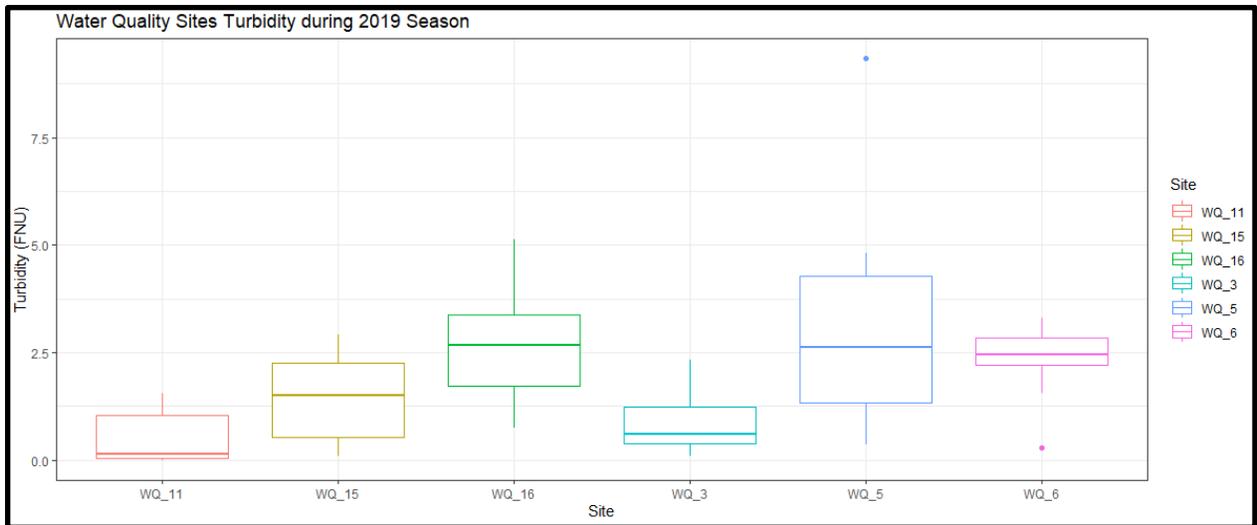
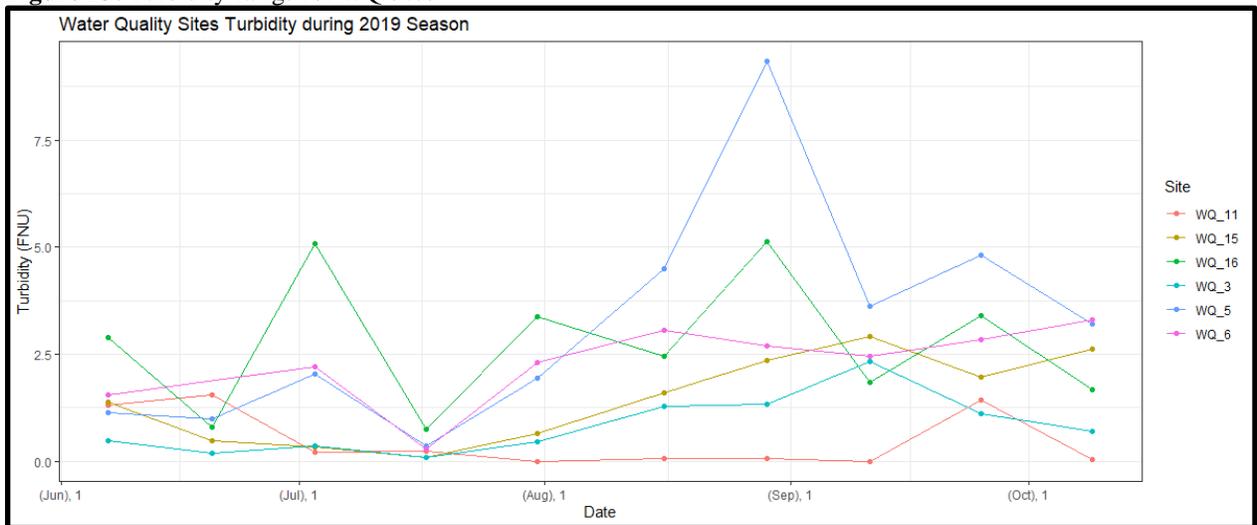
Figures 13 and 14 show turbidity results from WQ sampling. It can be observed that the first sampling had negative readings, this was due to a calibration error, these results can be considered invalid. Turbidity appeared to be highest in September when the cyanobacteria bloom was occurring. Turbidity readings were recorded in the middle of the water column.

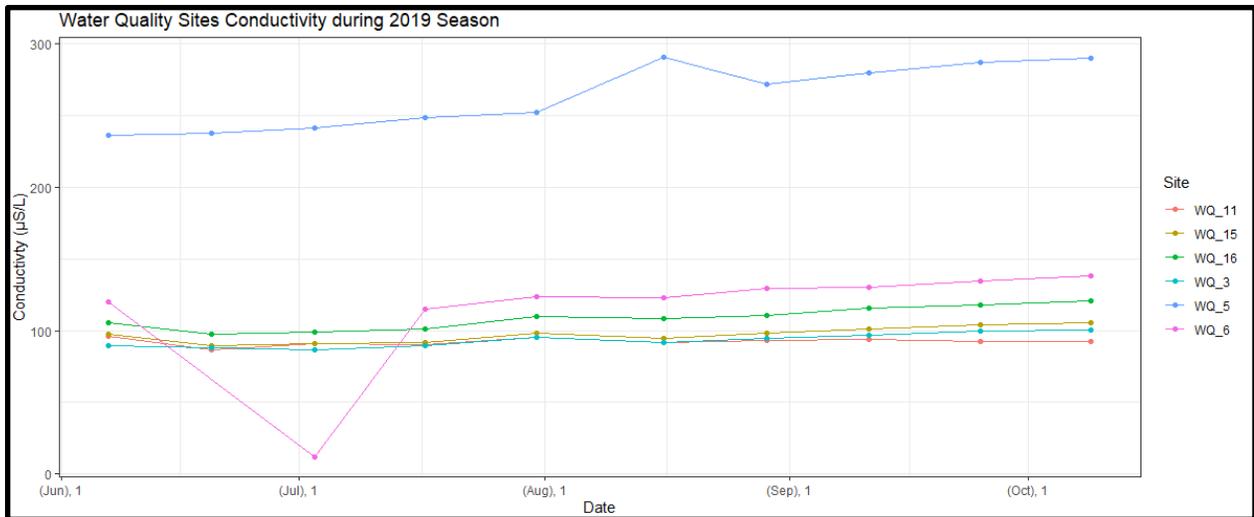
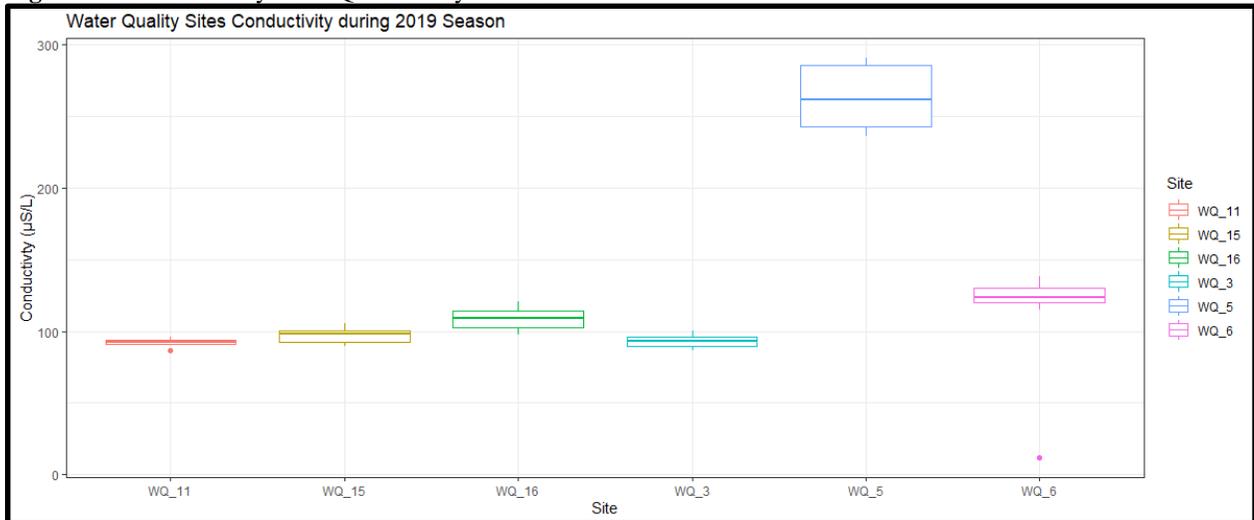
The conductivity of the lagoons is a good indicator of the overall health of the water column. Figures 15 and 16 show the conductivity measurements taken during the 2019 season. It can be observed that WQ 5, located in Lake Tallac has much higher conductivity than the rest of the sites.

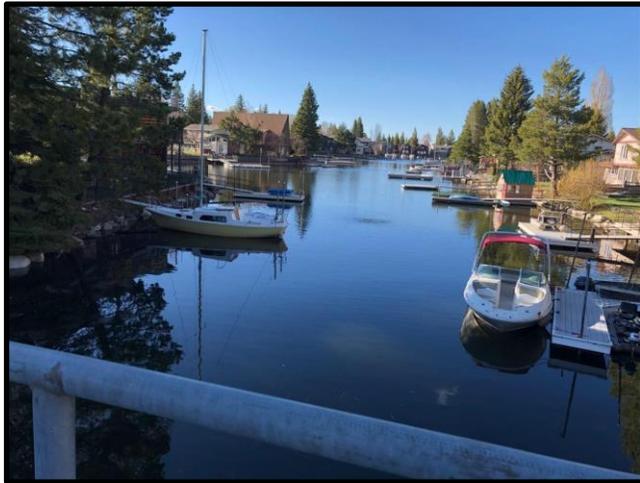
Figure 17: LFA project area view from Venice drive bridge looking North

LFA technology uses microporous ceramic disks that are placed throughout the area to be aerated. These disks are connected by self-sinking hoses connected to an air compressor. Air is pumped through the system creating a dual density fluid that rises and creates circulation. This both oxygenates the water through the introduction of air and circulates oxygen from the surface to the bottom of the water column, where dissolved oxygen is typically the lowest.

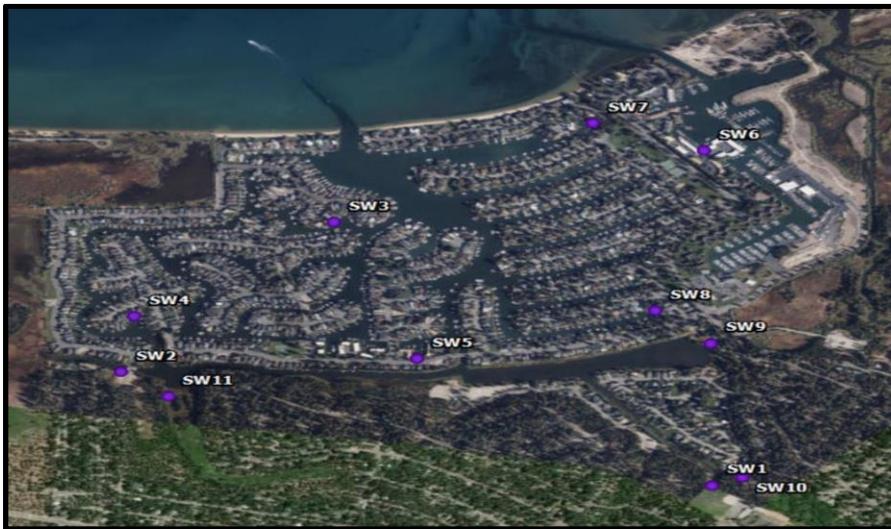
Figure 18: 2019 First Flush Site Map

Water samples were collected from surface water drainages, within storm drain inlets, or from the outlet of storm drains where accessible and above the lake level. Figure 1 shows the eleven sampling locations. SW 1 is in the surface drainage at the south end of the Lake Tallac canal, just north of Tahoe Valley Elementary School. SW 2 is a storm drain outlet that enters the west part of Lake Tallac and drains areas along 15th Street south of the Tahoe Keys. SW 3 and 4 drain relatively small areas within the western part of the West Lagoon area of the Tahoe Keys. SW 5

drains an area along Venice Drive just west of Christy Drive. SW 6 is a TKPOA-CSLT shared stormwater drain system that collects stormwater from TKPOA-owned common areas and townhomes along Ala Wai Boulevard. SW 5 and 6 are located in or receive drainage from potentially sensitive drainage areas that are identified in the January 2018 NPS Plan. SW 7 receives the runoff from single family residences and the TKPOA common areas, including the Pavilion, between Ala Wai Boulevard and Capri Drive. SW 8 receives runoff from single family residences, several townhomes, the TKPOA common area, and the Tahoe Keys Village commercial area along Lake Tahoe Boulevard and Danube Drive. SW 9 primarily drains runoff from outside of the Tahoe Keys along Tahoe Keys Boulevard. SW 10 and 11 are surface runoff drainages from South Lake Tahoe. These 2 locations drain from the intersection of Highway 89 and Highway 50 and nearby South Lake Tahoe neighborhoods. Other than the surface runoff at SW 1 and the shared drain system at SW 6, other locations are all CSLT-only stormwater drains.

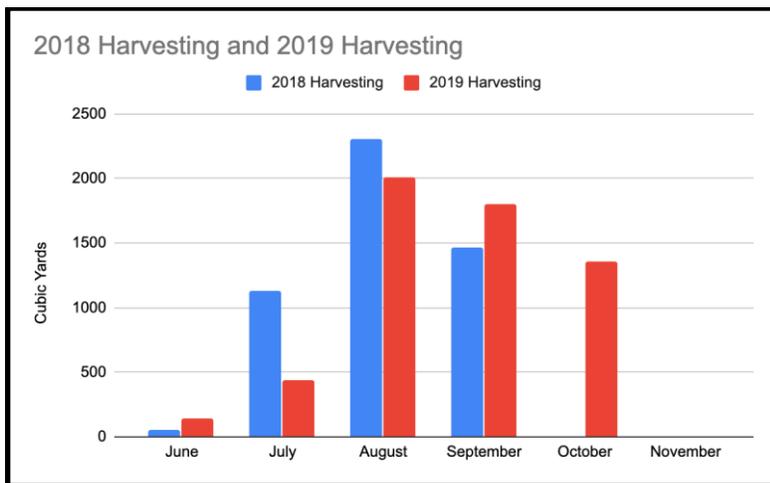
Figure 20: 2018 and 2019 harvesting totals throughout the season

The TKPOA Board of Directors approved the Water Quality Committee recommendation to a one year pilot project that altered the standard harvesting schedule set by the 2016 TKPOA BOD Scope and Direction on Harvesting Operations. In previous years, harvesting operations began in June and ended at the completion of the boating season which was in early October. The 2019 Pilot Project, harvesting operations began in June but at a limited level, then went full operational after the July 4th holiday and ended in November. Due to the fewer harvesters, the main objective during the boating season was to keep the navigation lanes clear and if time permitted focus on docks and shorelines. Starting in October, the objective shifted from the navigation lanes to focus on homeowners docks and shorelines (if the harvester could fit into the area). The reason for this was to harvest around the plants growing cycle and try to reduce the amount of plant biomass that would turn into nutrient loaded organic material in the sediment. The schedule change resulted in substantially greater late-season weed harvest, as shown in Figure 20. The later harvest is intended to minimize nutrient levels in the water due to weed decay over the winter.

During the 2019 harvesting season, the Water Quality Department removed 6,274 cubic yards of plants and plant fragments from the water. This was broken down into 5,747 cubic yards that were removed by the harvesters and 526 cubic yards that were removed by the skimmer boats. The table below is the 2019 End of Season Harvesting and Fragment Control (Table 3.)(Refer to Appendix D for the 2019 End of Season Harvesting Report)

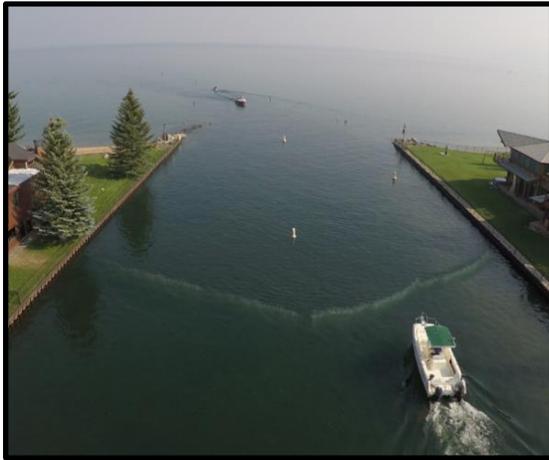
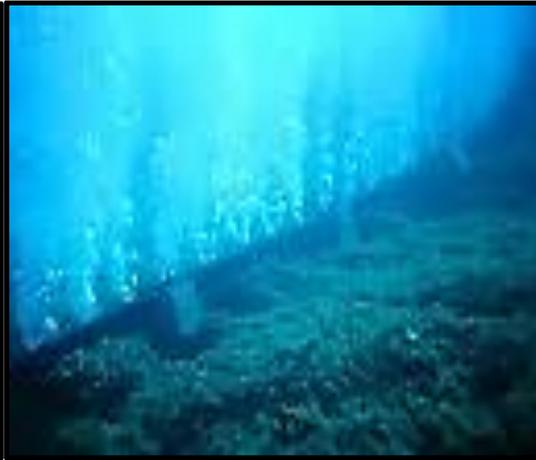
Several improvements were implemented in the 2019 season based on 2018 observations. In 2018 the bubble curtain airline encountered buildup of vegetation around the air line reducing the flow of bubbles. To fix this, in 2019 the bubble curtain was underlined with bottom barriers to reduce buildup of vegetation. This solution proved moderately effective, some vegetation built up around the line due to sediment settling on the barriers.

The bubble curtain performed adequately throughout the 2019 season. This is due to the compressors being replaced at the beginning of the season with new compressors. However, the new units are beginning to deteriorate. The units were recalled due to abnormal wear during extended use. It is recommended for the 2020 season that the WQ department purchase a compressor that has more output and is rated for continuous use.

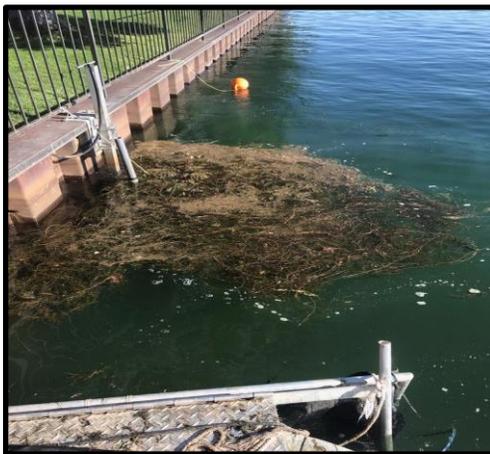
Figure 24: Seabin and bubblecurtain with accumulation of weeds

The Sea Bin that was in place during the 2019 season was effective at collecting weeds; it did have a few problems. Boat wakes and waves from the lake often knocked the collection net out of the bin. It is recommended that for the 2020 season that the WQ Department implement a way to shield the Sea Bin from waves and boat wakes. Another improvement that would benefit the collection team would be to implement an easier way to empty the sea bin basket or designing a new basket. The bin also had problems with water levels dropping, preventing it from working properly. It is recommended that the Sea Bins are placed on a floating platform with a wave attenuator facing towards the lake. This solution should help alleviate some of the problems that occurred during the 2019 season.

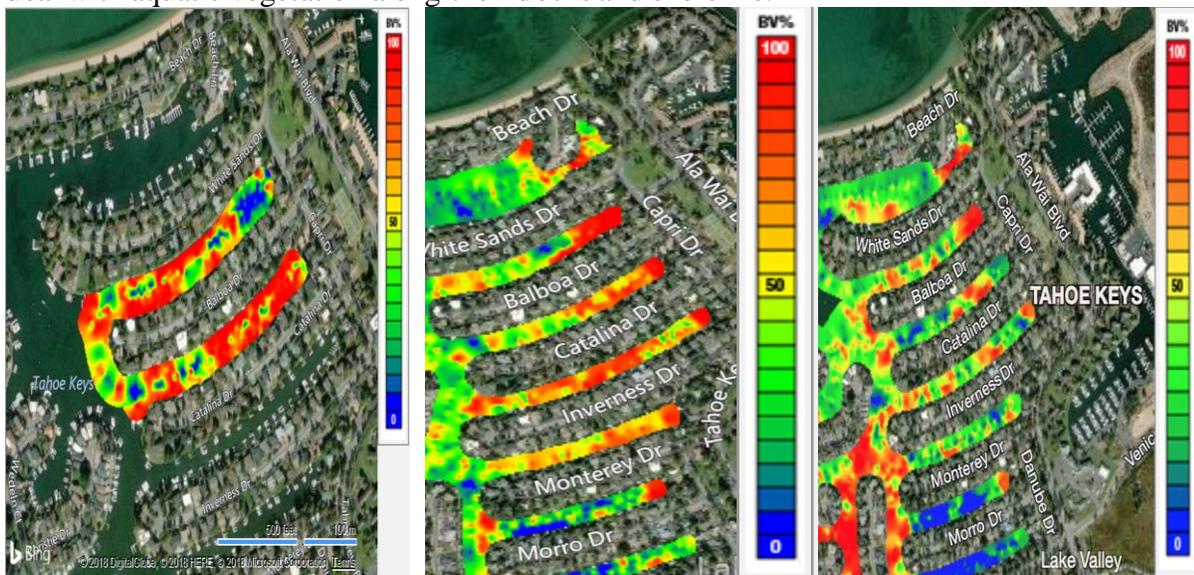
Figure 27: Skipper Cove Large Scale Bottom Barrier Project. Left Hydro-Acoustic Scan was taken October 12, 2017, the middle is from September 20, 2018 and the right was taken September 16, 2019.

It can be seen in figure 27 that the weeds have around 100% return rate once the barriers are removed. Figure 27 shows that the return was also seen 2 years after removal. Due to these downsides the department decided to not implement a large scale bottom barrier test in 2019. Instead the WQ Department continued to use a more small scale program to help homeowners deal with aquatic vegetation along their docks and shoreline.

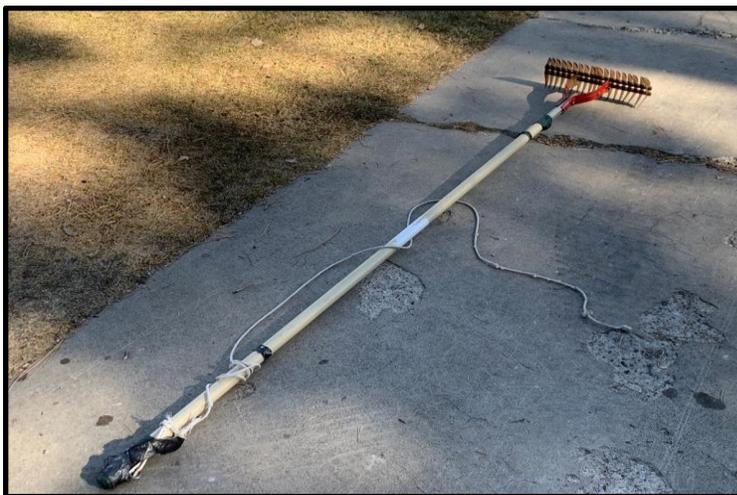
Figure 28: Sampling thatch rake used for macrophyte survey

The Annual Macrophyte Survey was conducted once during the 2019 season. The survey sampled 588 points throughout the Tahoe Keys Lagoons and Lake Tallac. At each point a sample is taken by raking the bottom with a sampling rake (Figure 28). The sample is then analysed and the percentage of each species is estimated. The percentage and species is recorded on a data sheet, input to GIS software and checked against archived data to determine what plants are growing where. These results were published and are incorporated into the 2019 Macrophyte Report created by Sierra Ecosystem Associates.

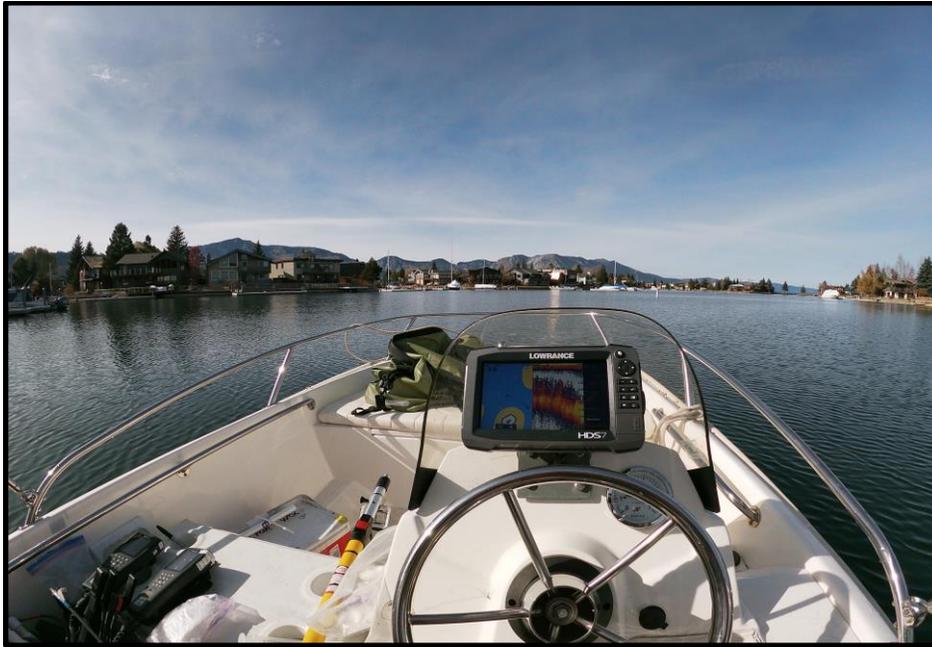
Figure 29: LowRance for Hydroacoustic Scans Survey

Throughout the 2019 season the AIS staff mapped plant density in the Tahoe Keys Lagoons. This was done using an HDS 7 Lowrance system with a HDI 83/200 Transducer mounted on the AIS boat and Biobase software that determines plant density based on the structure scan produced by the Lowrance system. The AIS Staff added a scanner to the TKPOA Architecture Control Committee (ACC) boat later in 2019 as well. The hydroacoustic scans map where plant density is greatest and if needed the WQ Department Manager can direct harvesters to the high density areas to clear up the areas.

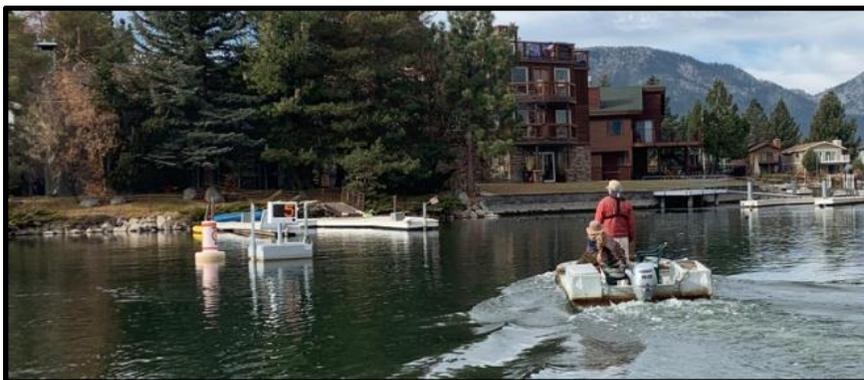
Figure 31: Mobile Radar System in West Lagoon

The radar system in the West Channel has been functioning properly for the entire 2019 season. The TKPOA would like to use the West Channel system to monitor boat traffic coming into the Keys. This would help track the amount of boats in The Keys over time. The system for the East Channel was removed shortly after installation due to complaints from homeowners. The WQ Department then decided that this system could be mounted on a mobile platform to display the speeds of boaters as they pass by it in the lagoons. The Department consulted with a local dock company to construct such a platform. This system was installed midway through the 2019 season, at a key intersection where it would be visible to the most boaters in the Tahoe Keys.

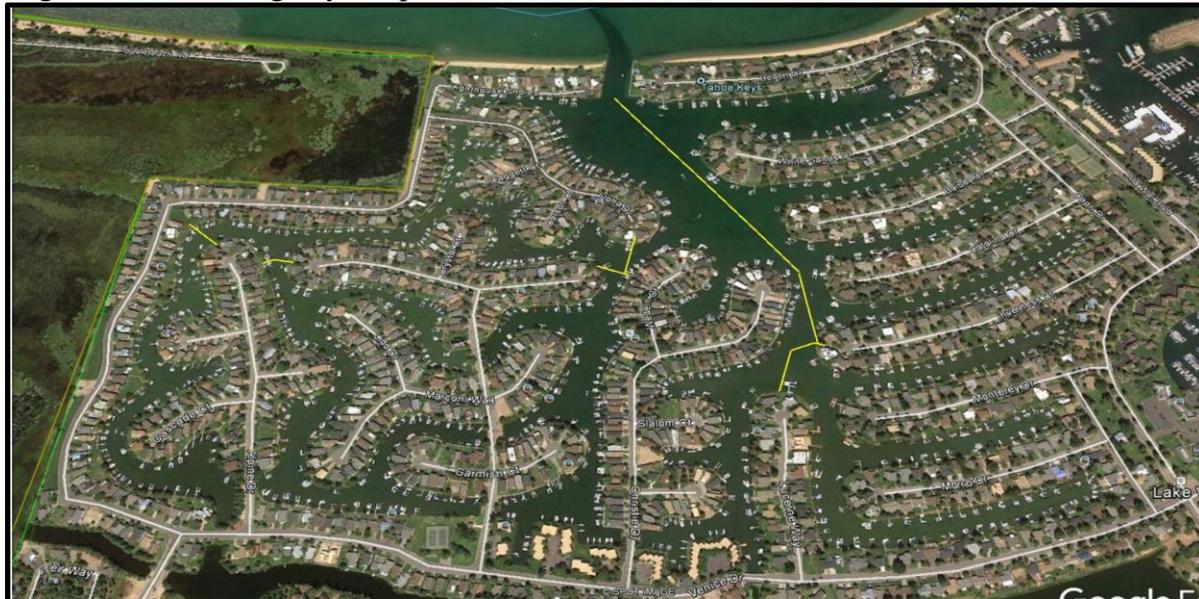
Figure 32: Map of 2018 Boat Count Sections.

Due to the commonness of rental properties in the Tahoe Keys and resulting flux of boat numbers it is important to track the amount of boats that are inside the West Lagoon. In 2019, the WQ Department and security split into 7 groups for 8 sections of the lagoon. The number of

boats in each section was recorded. This gave the TKPOA a total number of boats in the West Lagoon, not including kayaks, pedal boats or other non motorized vessels.
