2020 TKPOA Lake Tallac Control Projects

End of Season Report

Tahoe Keys Property Owners Association

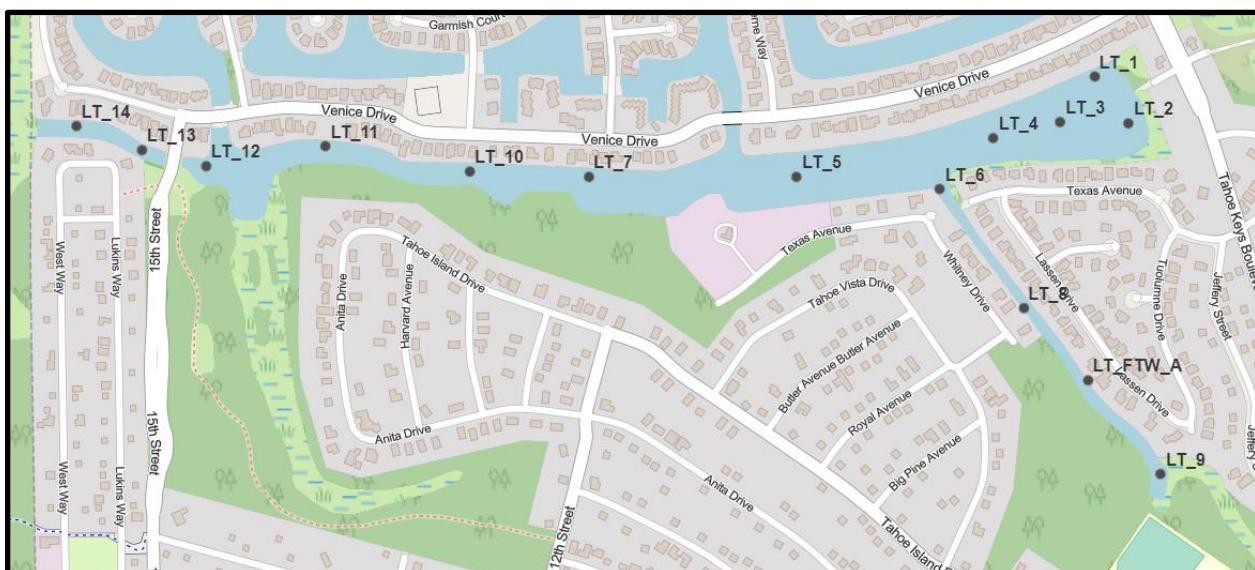
Figure 1: 2020 Lake Tallac Sampling Sites Map for Lake Tallac

Figure 1 displays the locations of the 14 sites where water quality measurements were taken during 2020.

In 2020, the AIS staff sampled the sites shown in figure 1 every other week. Nine water quality parameters were measured during seven sampling events at 14 sites over the course of the aquatic plant growing season from late May through November. Due to budget constraints the TKPOA did not sample for nutrient contents at the Lake Tallac sites.

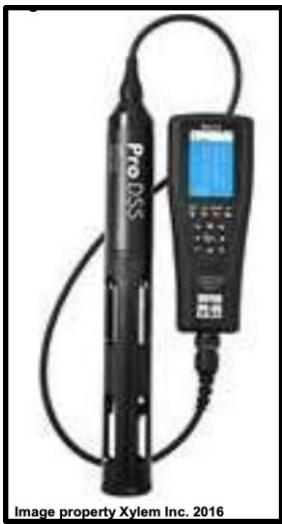
Figure 2: YSI ProDSS

Data was collected at each site using the YSI ProDSS and a YSI Pro 1020. Depth of each site was determined using measured markings on the YSI ProDSS cable. The cable has measured marks every 0.1 meters so depth was only accurate to the nearest tenth of a meter. The depth was used to determine the sampling depth for the 5 different points in the water column. These points included bottom (B), quadrant 1 (1), middle (M), quadrant 3 (3), and surface (S).

Once depth was determined the instruments were raised 6 inches off the bottom and left to run for roughly a minute, to ensure the reading had stabilised. The temperature, DO, turbidity, electrical conductivity, pH, oxidation reduction potential (ORP), ammonium, were then recorded onto the data sheet along with the site number and time. These measurements were repeated at each quadrant. Additional data for turbidity and conductivity was collected at the mid point. Data from the data sheet was entered into the database workbook and the original hardcopy was scanned to be saved as an electronic copy.

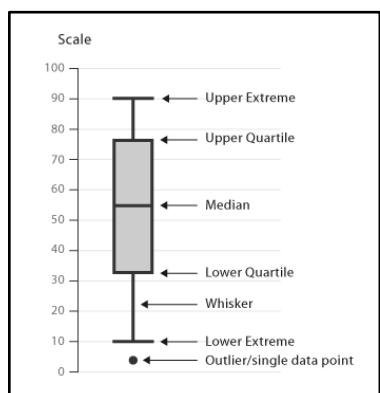
Figure 3. Box and whisker plot description

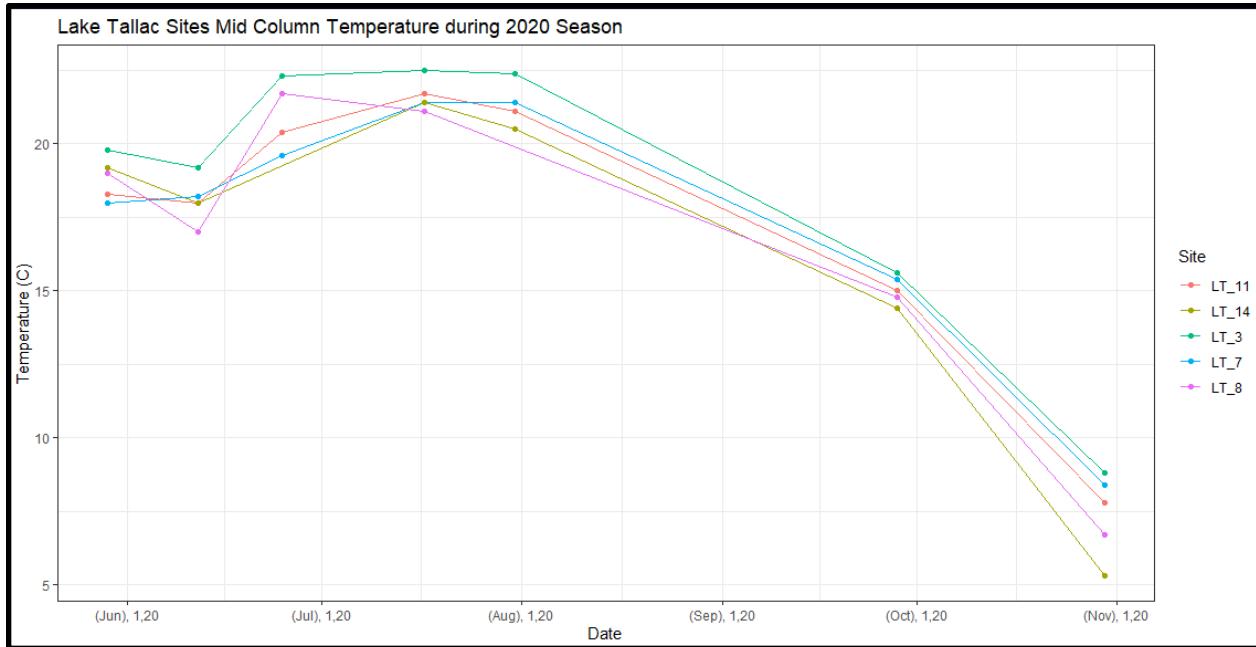
As expected, the warmest temperatures were observed mid July through early September. Lowest temperatures were observed at the bottom of the water column while highest were at the surface.

Figure 4. Mid Column Temperature Levels for Lake Tallac Sites during 2020 Season

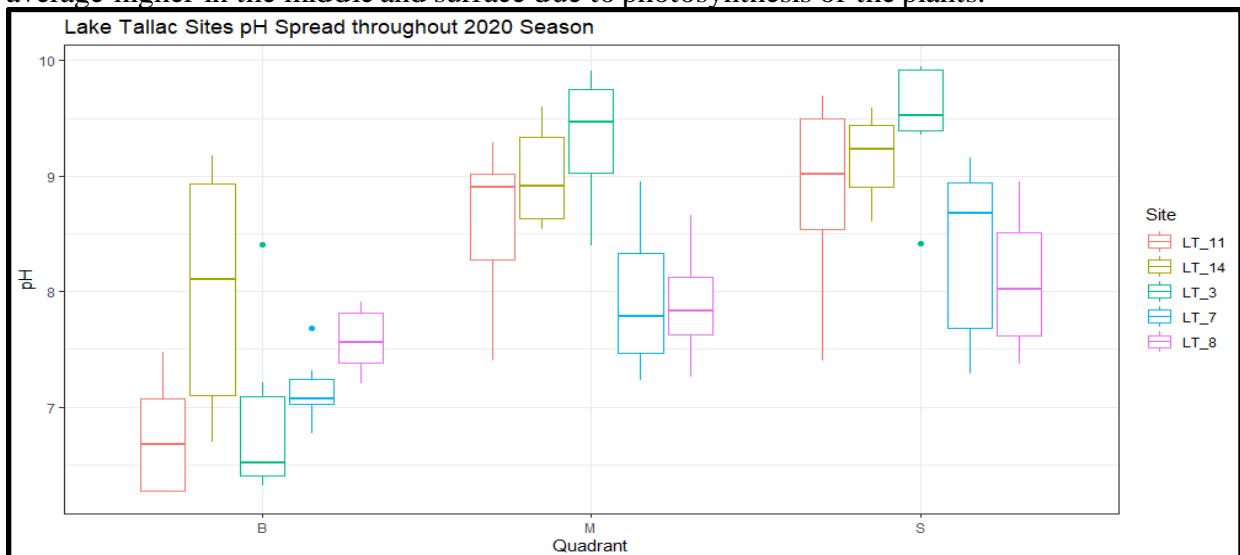
pH levels are lower at the bottom of the water column compared to the surface but are on average higher in the middle and surface due to photosynthesis of the plants.

Figure 5. pH Spread for Lake Tallac Sites during 2020 Season

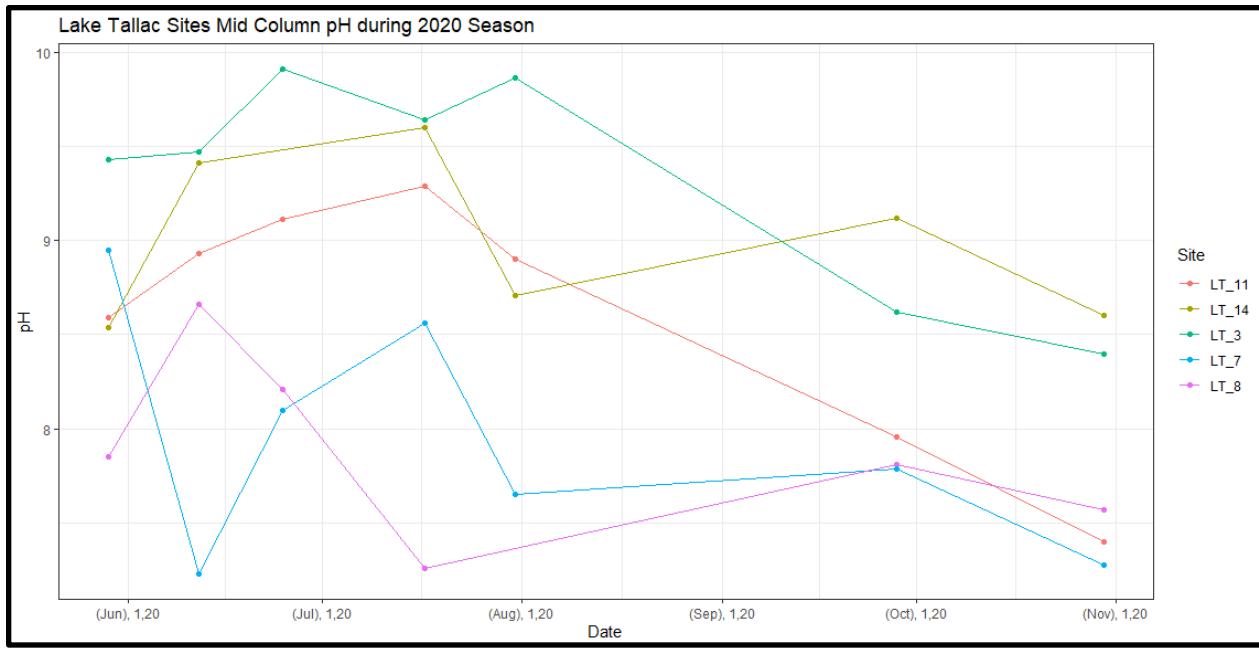
Figure 6. Mid Column pH Levels for Lake Tallac Sites during 2020 Season

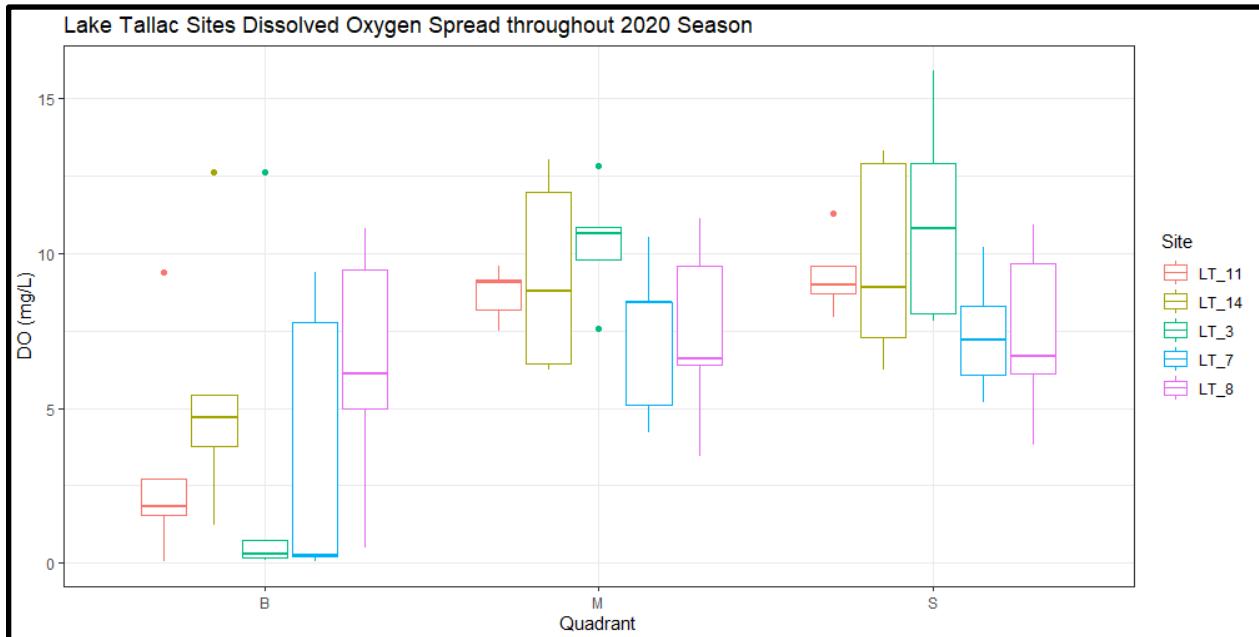
The dissolved oxygen content varied by what depth and where the measurement was taken. The bottom often had low dissolved oxygen while the mid point and surface had higher content.

Figure 7. Dissolved Oxygen Spread for Lake Tallac Sites during 2020 Season

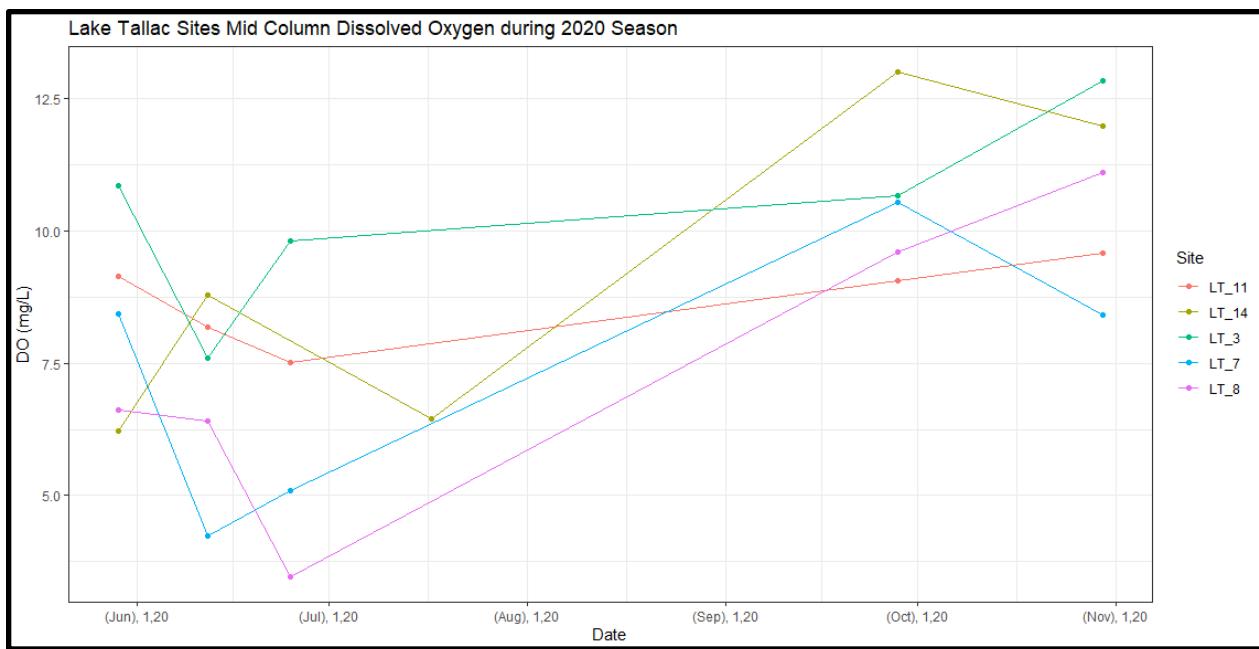
Figure 8. Mid Column DO throughout 2020 Season

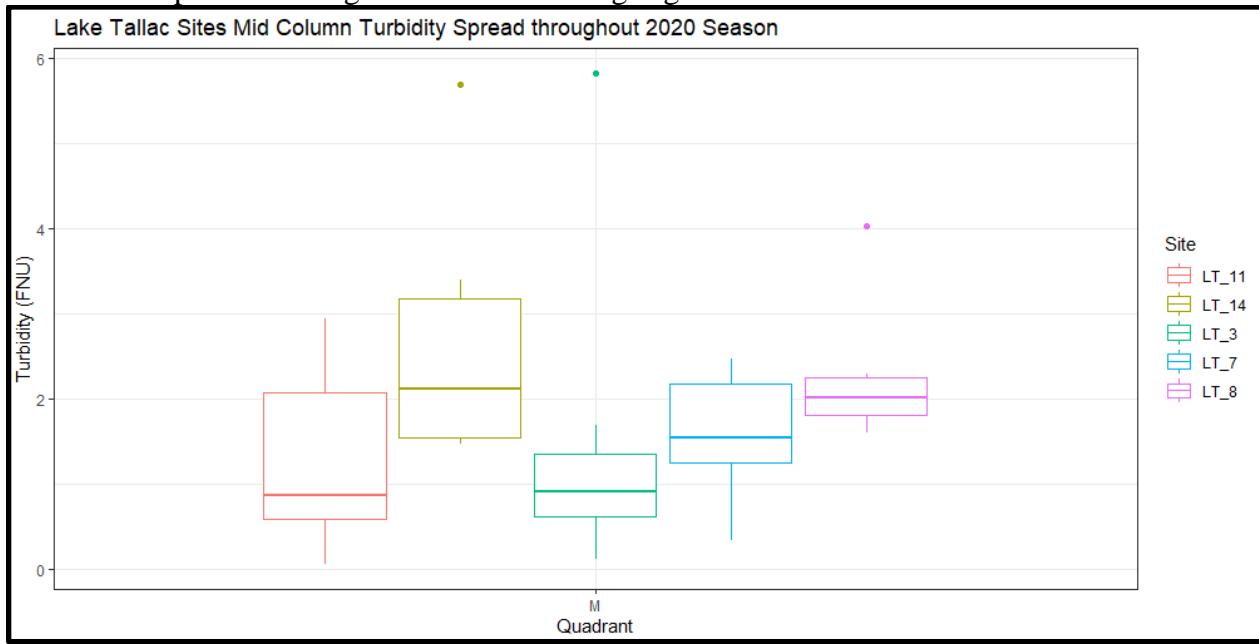
Figures 9 and 10 show turbidity results from WQ sampling. Turbidity readings were recorded in the middle of the water column. Turbidity was higher during the summer months, likely due to increased suspension of organic material and algae growth.

Figure 9. Turbidity spread for Lake Tallac Sites during 2020 Season

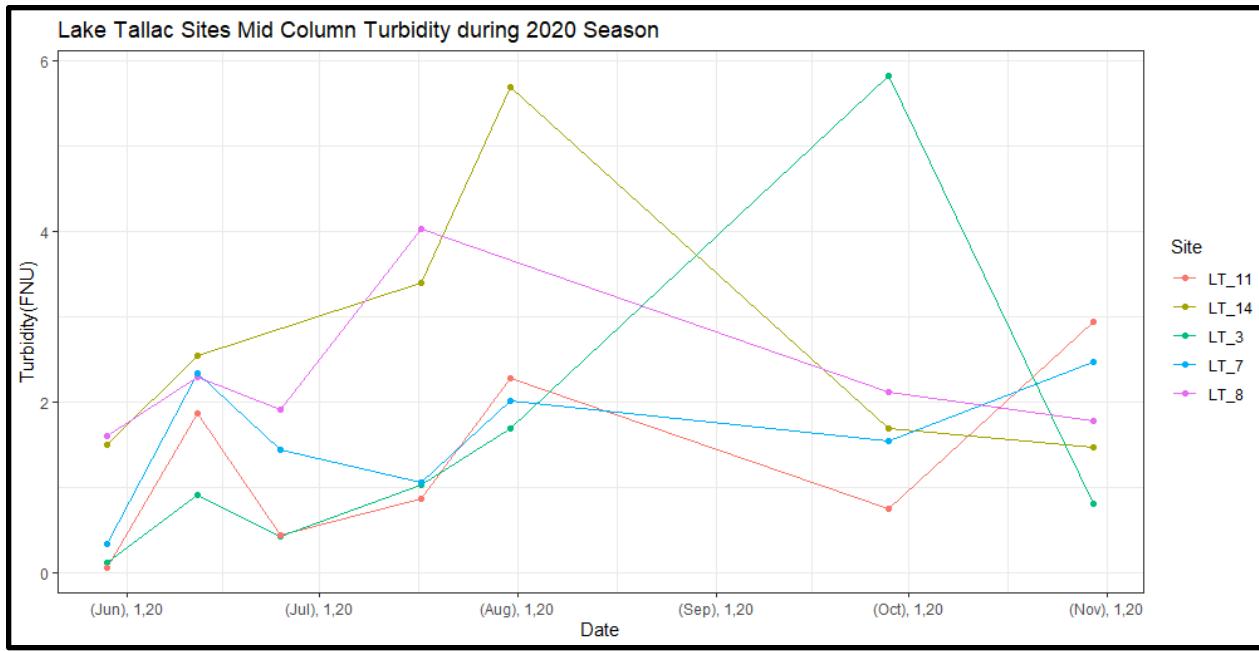
Figure 10. Turbidity levels for Lake Tallac Sites during 2020 Season

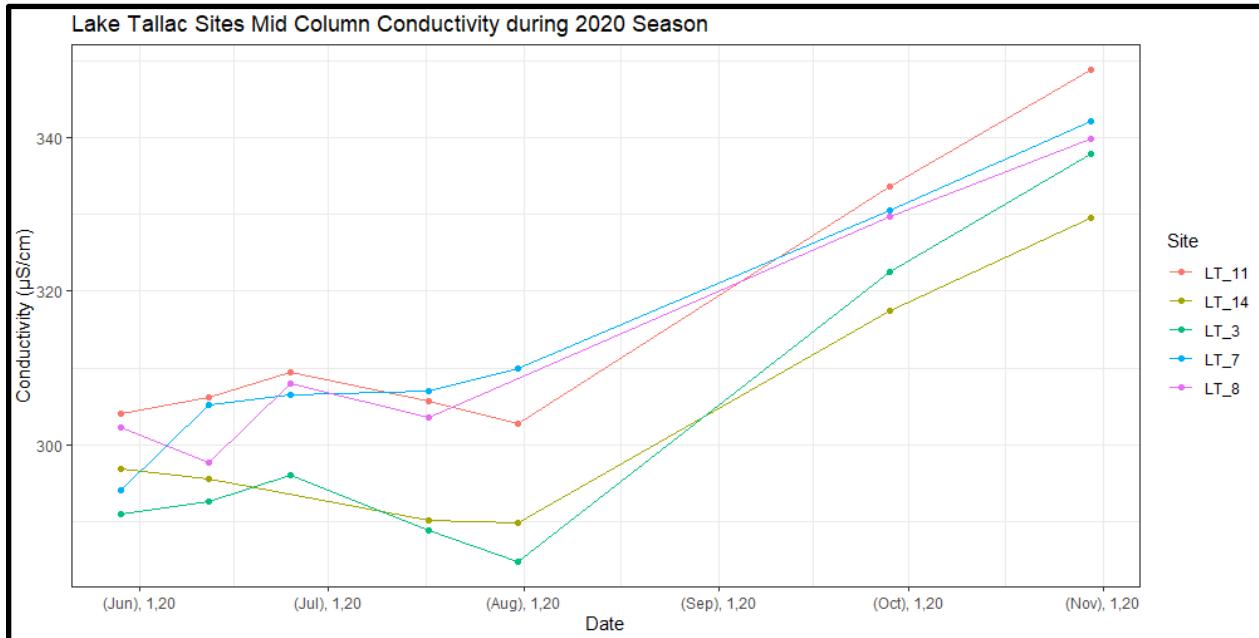
The conductivity of the lagoons is a good indicator of the overall health of the water column. Figure 11 depicts observed conductivity throughout the lake and shows higher conductivity later in the season.

Figure 11. Conductivity Levels for Lake Tallac Sites during 2020 Season

There are some trends in pH and conductivity worth noting. Conductivity increased later in the season likely due to increased water temperature causing faster evaporation rates, which in turn increased total dissolved solids within the water column. When harvesting occurs it mixes the water column causing the average pH to drop on the surface and middle and increase on the bottom. Figure 6 shows a decrease in pH at site 8 around the middle of July when the Yellow Pond Lily project was ongoing and site 8 saw a decrease near the beginning of August when West of 15th St. was being harvested. Turbidity values occasionally rose above the objectives set by the WDR but mostly stayed within the defined range. pH values stayed consistently above the maximum WQO stated in the WDR, likely due to excessive biomass within the lagoon.

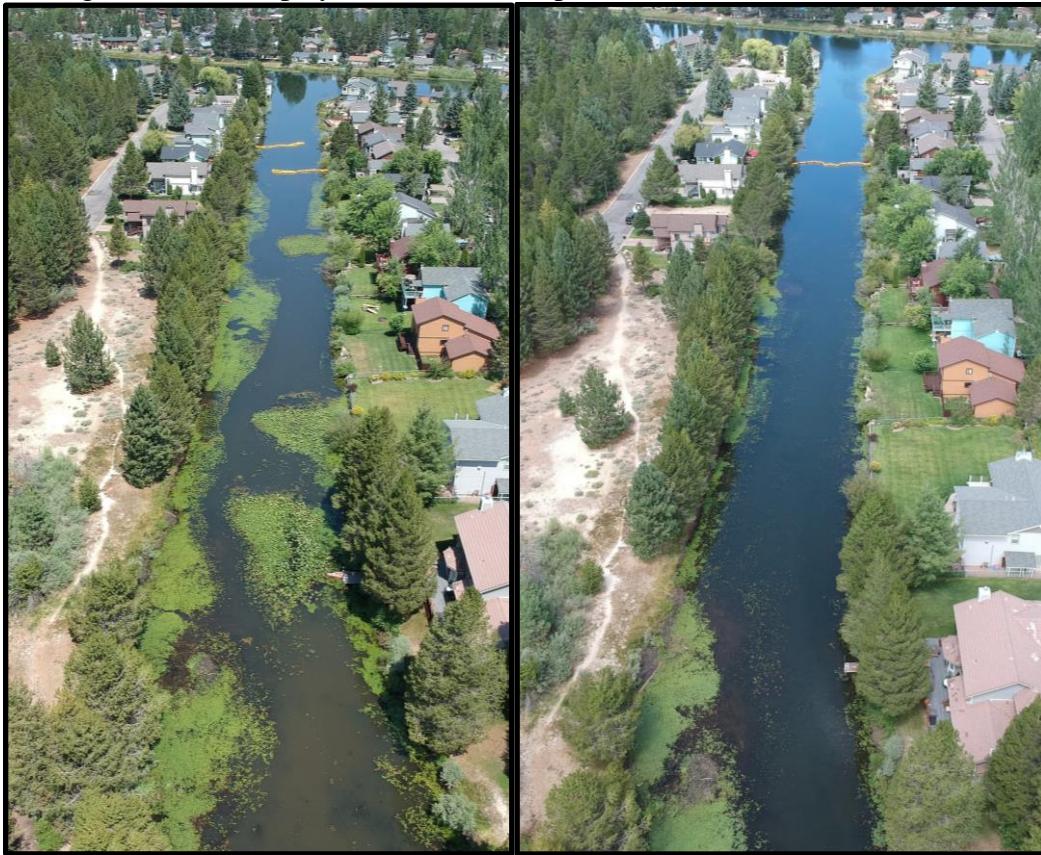
The figures below display before and after photos of the Lake Tallac Canal taken from a drone.

Figure 12. Pre-Treatment taken July 20, 2020 (left), and Post-Treatment taken August 14th, 2020 (right)

Initially, after the removal of the rhizomes, there appeared to be no more YPL within the Lake Tallac Canal. However, a few weeks following the removal, YPL could be seen reemerging within the canal. WQ Staff removed around ~3500 lbs of rhizomes and ~210 cubic yards of plant material from the area but the infestation still remains. Figure 13 below shows the pile of rhizomes that the divers and skimmers removed. Figure 14 shows the reinestation post project.

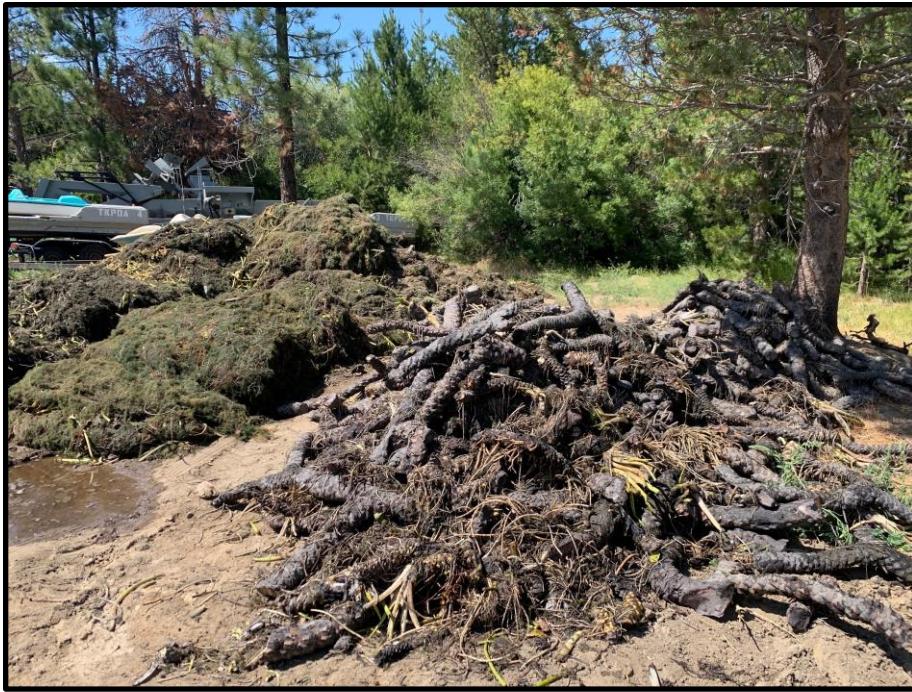
Figure 13. Rhizomes and other vegetation removed from Lake Tallac Canal.

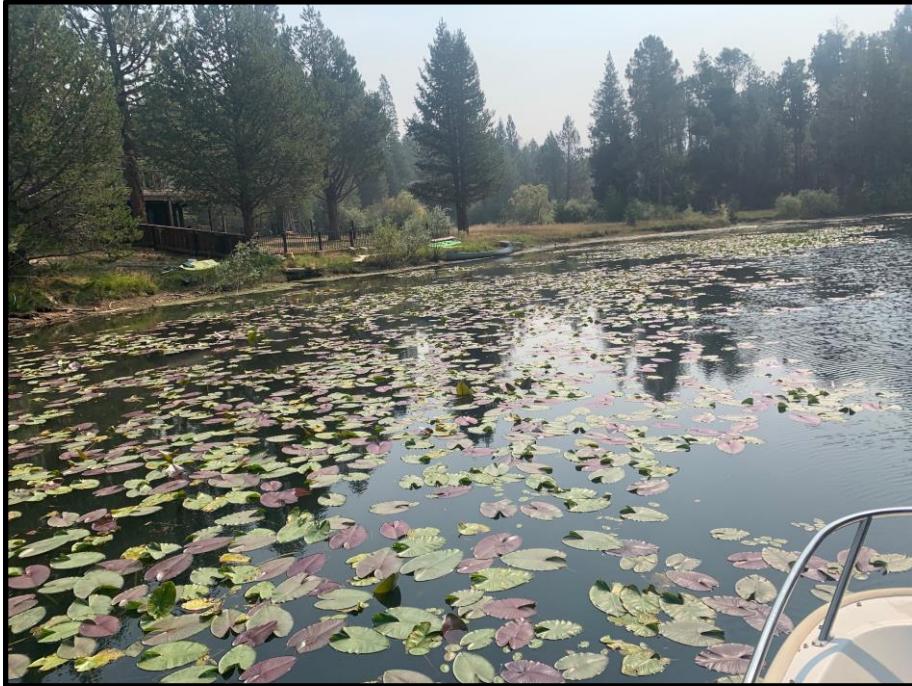
Figure 14. September 15th 2020, Yellow Pond Lily presence post project.

Due to the remaining presence of the YPL it is apparent that the project was not successful at removing all of the plant rhizomes. This is likely due to problems such as locating the rhizomes and poor visibility. When the divers pulled up the rhizomes from the bottom of the channel the turbidity increased due to stirred up sediment to the point where they could not see inches in

front of them. This made locating more rhizomes nearly impossible. It is also possible that the rhizomes were rooted deeper in the sediment than anticipated. Clearly the divers had missed some rhizomes due to the presence of YPL post project. If this project is to be conducted again it is recommended that rotovating be utilized. Rotovating would possibly reach deeper into the sediment allowing for a greater number of rhizomes to be unearthed and removed.

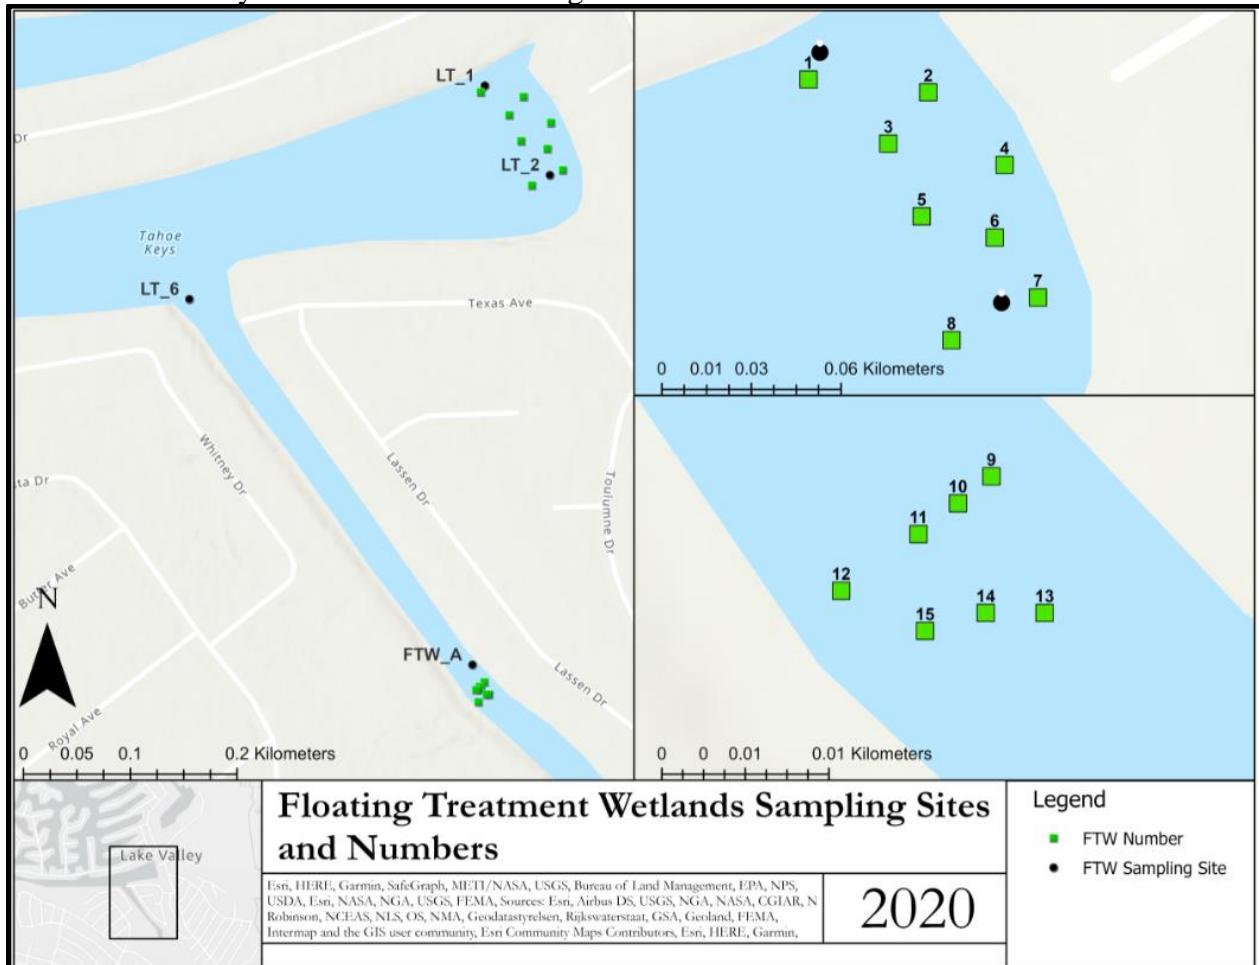
Figure 15. Floating Treatment Wetlands Project Map

Figure 16 shows the mortality rate observed at each FTW. At FTWs 9-15 there was observable wildlife activity where wildlife dug up and consumed a few of the plants. See figure 15 for where each FTW is located.

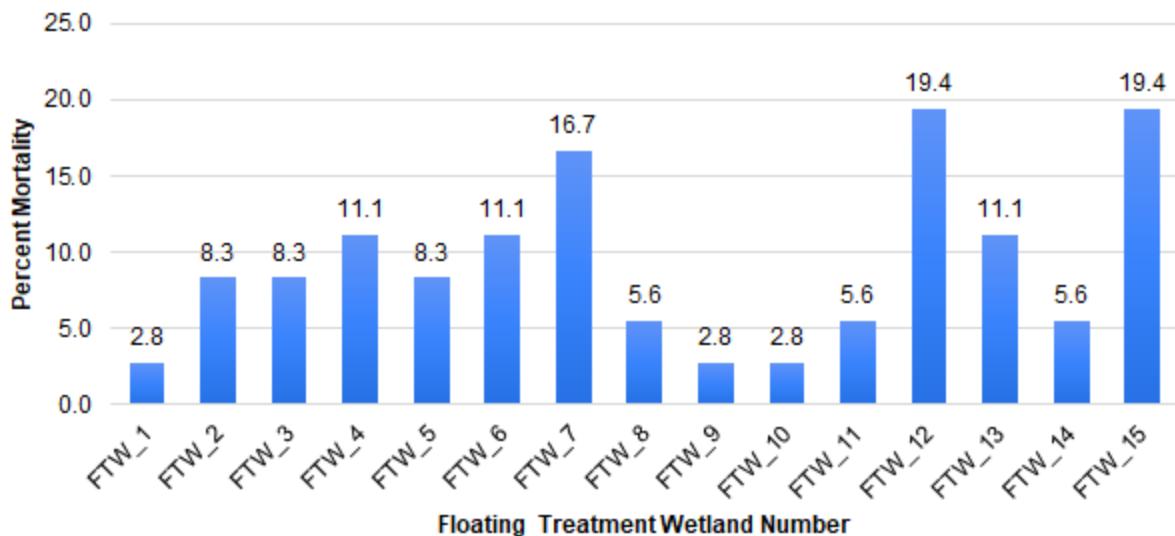
Figure 16. Percent Mortality for Plants on Each FTW

The vegetation on each FTW appears to be taking root as of the last monitoring event on 10/30/2020. Roots can be observed on the bottom of each FTW and biofilm appears to be forming on each FTW as well. There have been relatively low mortality rates on the FTW (figure 17), some mortality was to be expected as stated by Floating Islands West LLC. Wildlife had chewed through the fencing of FTWs 9-15 and consumed a couple of the plants. This fencing has been patched with metal mesh to prohibit wildlife from consuming more of the plants.

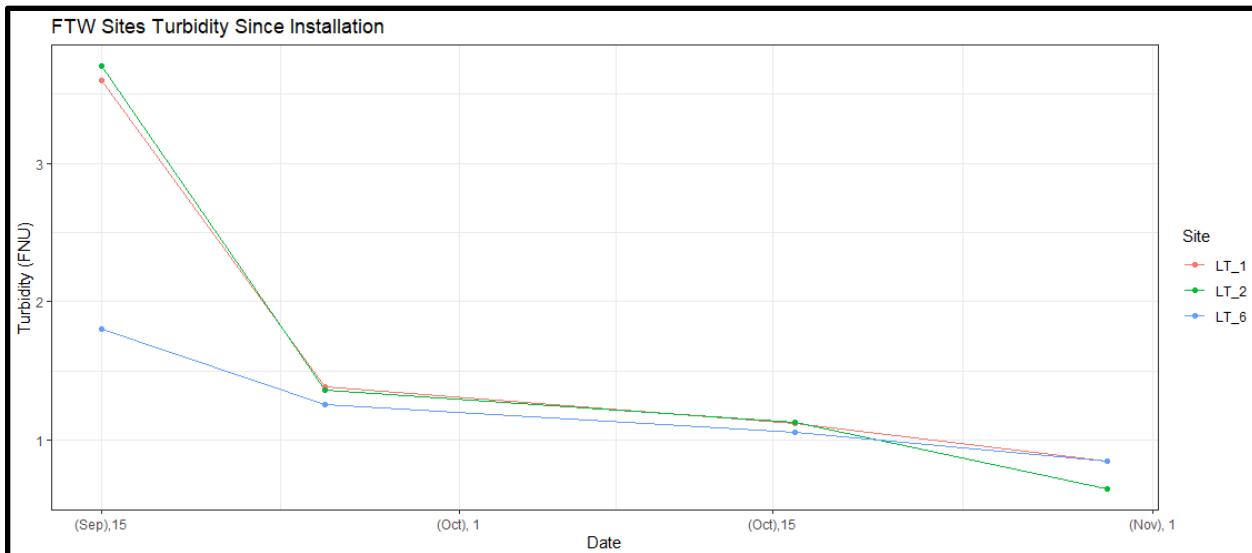
Figure 17. Turbidity at Floating Treatment Wetland Monitoring Sites

Figure 17 shows the turbidity at the 3 sites sampled during floating treatment wetland monitoring. Turbidity readings were taken from the surface at all sites.

The water turbidity reduction at the 3 sampling sites may be due to the FTW. However, it is also likely that this reduction is due to water quality improvement later in the year as the aquatic vegetation dies off. Monitoring during the 2021 season will determine if this reduction of turbidity is due to the FTWs.
