2020 TKPOA West Channel Control Projects

End of Season Report

Tahoe Keys Property Owners Association

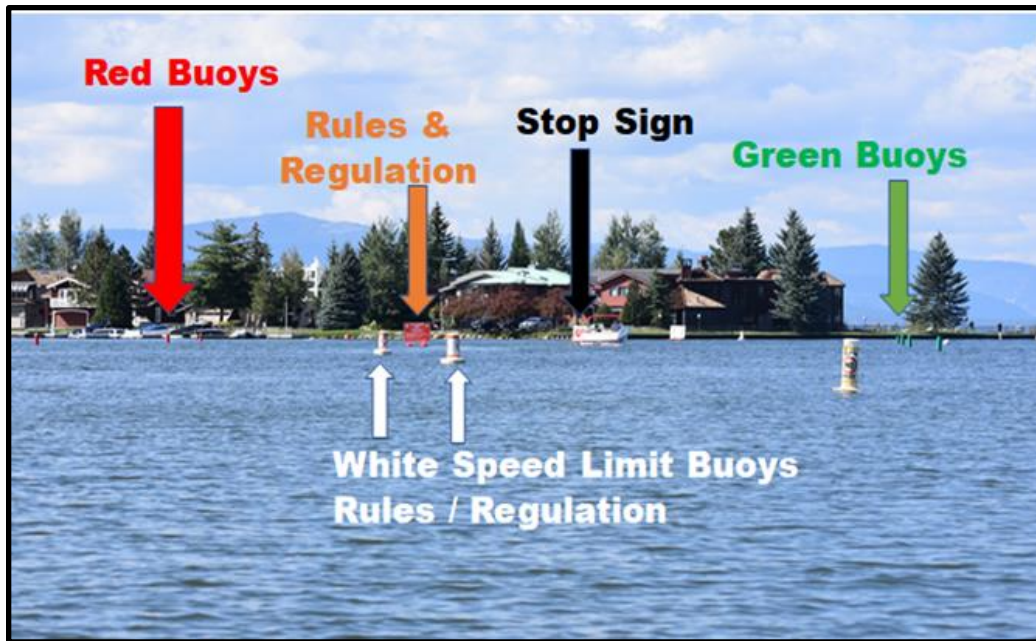
Figure 2: Overview of the Boat Back-Up Station oriented south facing north.

- b. Design: When viewing the Back-Up Station from within the Tahoe Keys West Channel, it offers a resemblance to a roadway system for boaters to follow. The entire area has the same positioning as the buoys that are out on Lake Tahoe with the addition of the informational sign, the Boat Back-Up station Stop sign, the waterway rules, and a mooring buoy. The lanes are designated with green buoys on the east, red buoys on the west and white buoys in the middle that inform boaters of the 5-mph speed limit (refer to Figure 2). Beginning the Back-Up Station is a sign informing boaters to prepare to stop (Figure 3), this sign was installed in 2020 hoping to inform boaters why the BUS helps stop invasive weeds from entering Lake Tahoe. The new sign reads "TKPOA Boat Back-Up Station, Stop the Spread of Invasive Weeds, Prepare to Stop". Next, about halfway through the

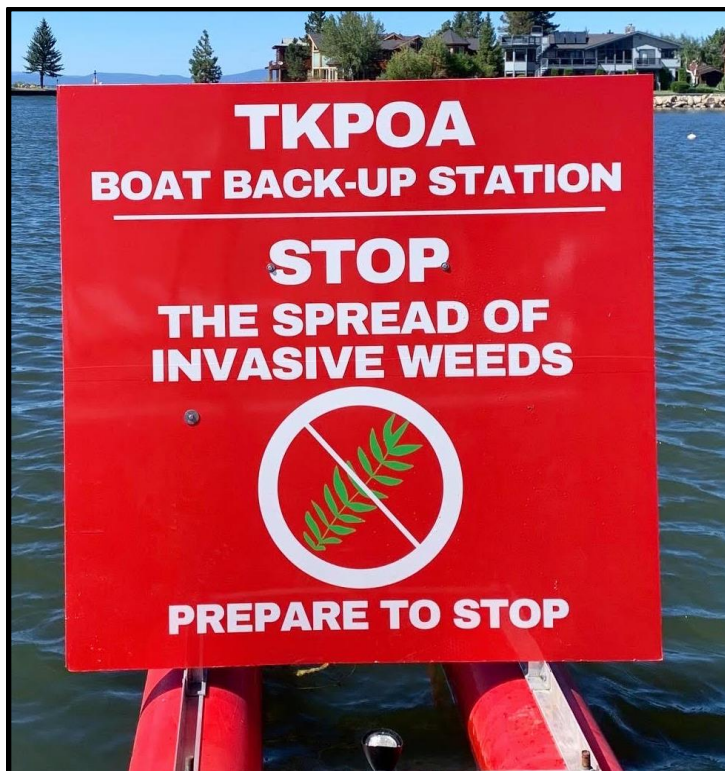
Figure 3: New "Prepare to Stop" pontoon buoy; no back text

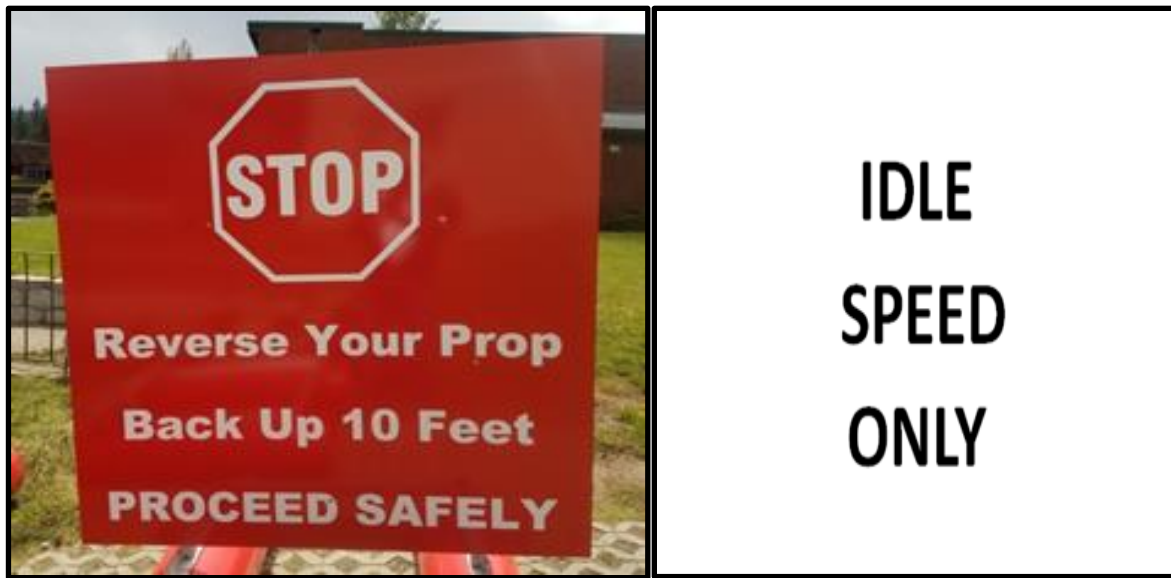
Figure 4: “Reverse Prop” buoy and “Idle Speed Only” Back Text

channel, there is a red stop sign with the Back-Up Station Procedures visible (Figure 4). In addition, a sign was placed on the back for incoming boaters to read “Idle Speed Only”. After the Boat Back-Up stop sign, there is a double-sided TKPOA Waterway Rules sign (Figure 5) which covers all of the TKPOA Waterway Rules that are intended to keep everyone safe. These signs in the center of the lane create the division between the incoming and outgoing boat traffic. This provides adequate space for boaters to safely follow all requirements that the Boat Back-Up Station has in place.

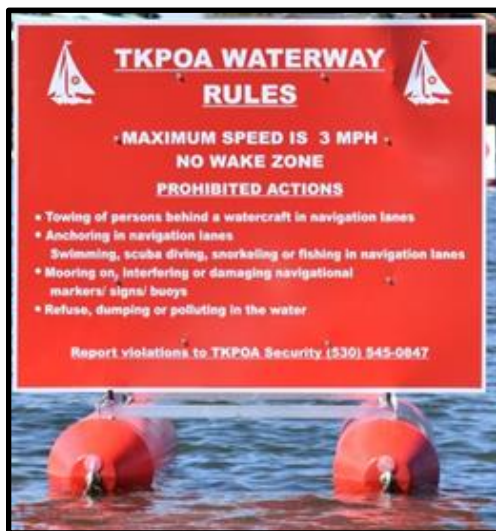
Figure 5: TKPOA Waterway Rules sign, center lane of the Back-Up Station.

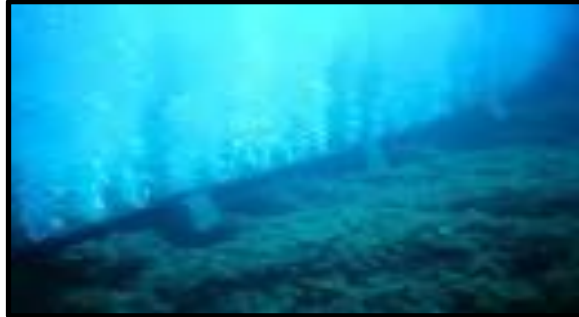
Figure 6: An underwater view of the Bubble Curtain.

and the LFA diffusers. TKPOA purchased a 12.7 horsepower, 3 phase compressor with an output of 79 cubic feet per minute (cfm). This compressor pushes air through 170 feet of self-sinking airline tubes. As the bubbles push through the water, it creates a “curtain” that extends from the sediment layer to the surface (Canadian Pond) (refer to Figure 6 and 7)

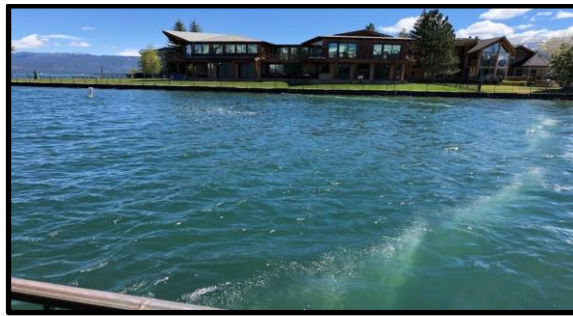
Figure 7: A surface view of the Bubble Curtain.

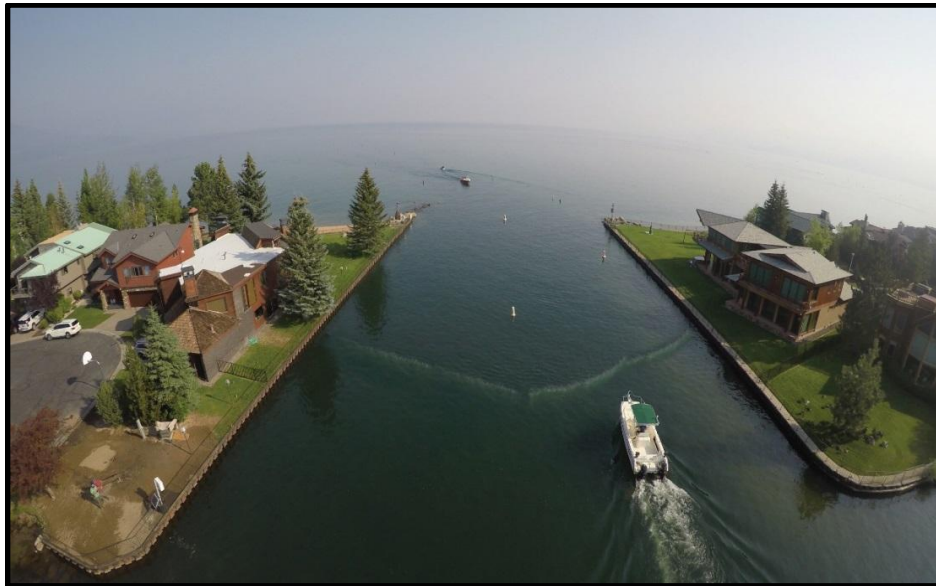
Figure 9: An aerial view of the Bubble Curtain.

- c. Design: The Bubble Curtain is set up in a “V”-shape formation that acts as a wall to stop fragments of aquatic invasive species from entering Lake Tahoe (refer to figure 9). The purpose for this design was to create three collection points for plant fragments and garbage to collect. The positioning of these collection points were based on the hydrology of Lake Tahoe and the Tahoe Keys along the prevailing winds on the Lake Tahoe Watershed. These collection points are at either side of the channel next to the bulkhead and in the direct center of the “V”. As snowmelt run-off increases the level of Lake Tahoe, water levels rise inside of the Tahoe Keys as well. As the water flows into the Tahoe Keys, the collection point is in the center of the “V” on the lake proper side. When the water level is moving out of the Tahoe Keys or when the prevailing wind is from the south, the collection points are on either side of the channel. All three of these collection points were created to avoid hindering the flow of recreational boating. In 2020 three bottom barriers were placed beneath the Bubble Curtain to help disrupt the growth of aquatic plants around the tubing (refer to figure 8).

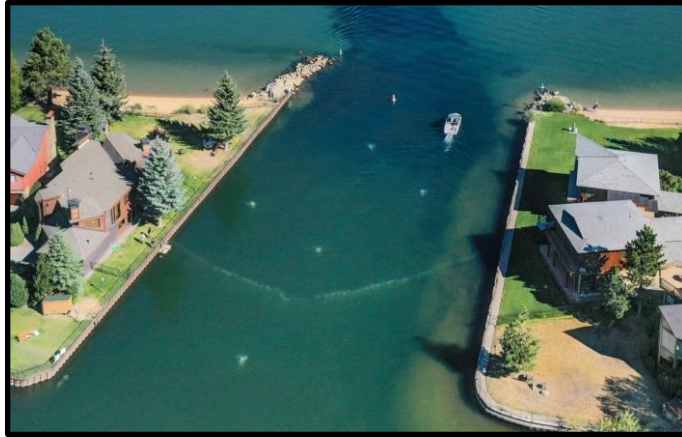
Figure 12: West Channel LFA layout with Bubble Curtain

- b. System Overview: The Laminar Flow Aeration system placed in the West Channel has 8 diffusers (4 of these are placed North of the bubble curtain towards Lake Tahoe and 4 are South of the bubble curtain in the main lagoon) (See Figure 12). Refer compressor specs to section 4.2 b.

- c. Design: On August 12, 2020 the WC LFA was installed in the channel connecting the Tahoe Keys to Lake Tahoe in accordance with Clean- Flo International. This was conducted using a GPS of the LFA locations and then lowering the ceramic disks into the water with a rope. It was decided to place the LFA in a diamond formation, this allowed it to cover a larger surface area within the confines of the West Channel. (Refer to Figures 1, 12 and 14)

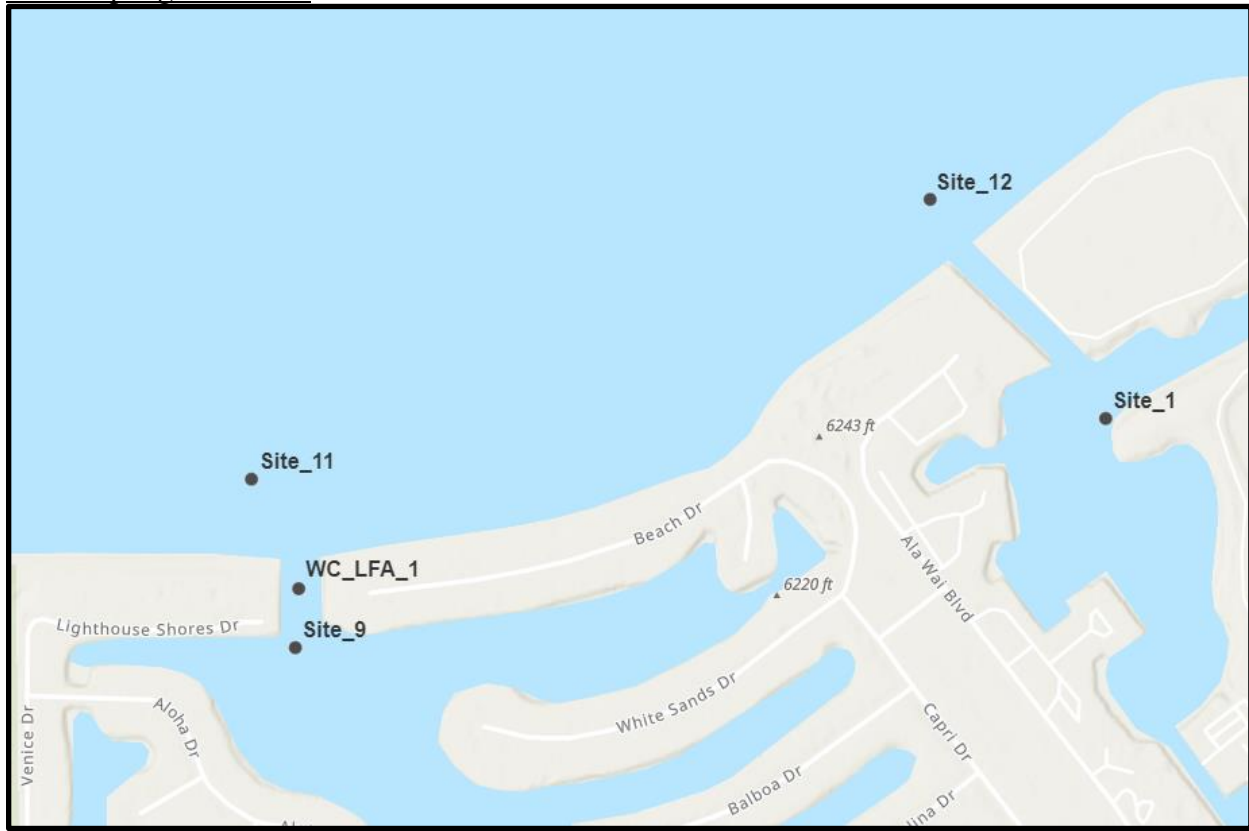
Figure 13: West Channel LFA Sampling Sites

The TKPOA selected these sites based on their proximity to the project area. Sites 1 and 12 were selected as control sites. Site 12 has similar conditions to site 11, as they are both in Lake Tahoe and site 1 has similar conditions to site 9 since they are both just inside the East and West Channels. The site WC_LFA_1 was created because it is in the middle of the project area.

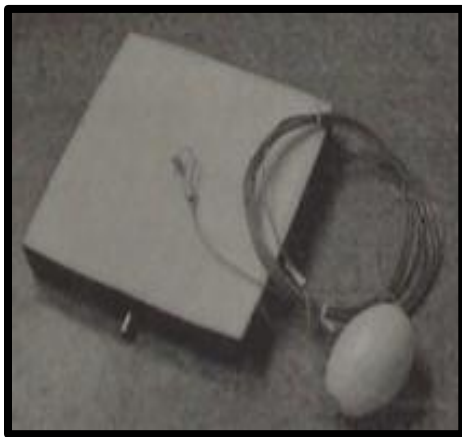
Figure 15: Diffuser.

This system was specifically designed for the project area's size and water depth. It consists of a 12.7 horsepower compressor, variable frequency drive, eight microporous ceramic diffusers (refer to Figure 14), stainless manifold with equal number of ports and control valves, and approximately 170 feet of self-sinking airline.

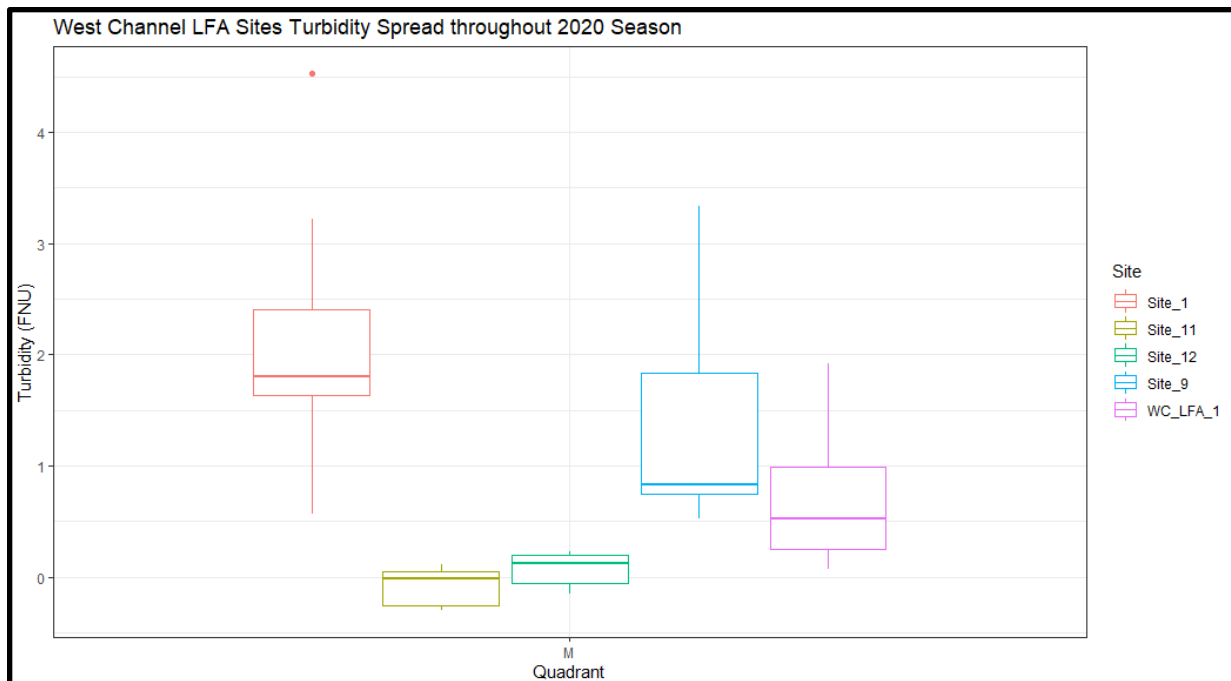
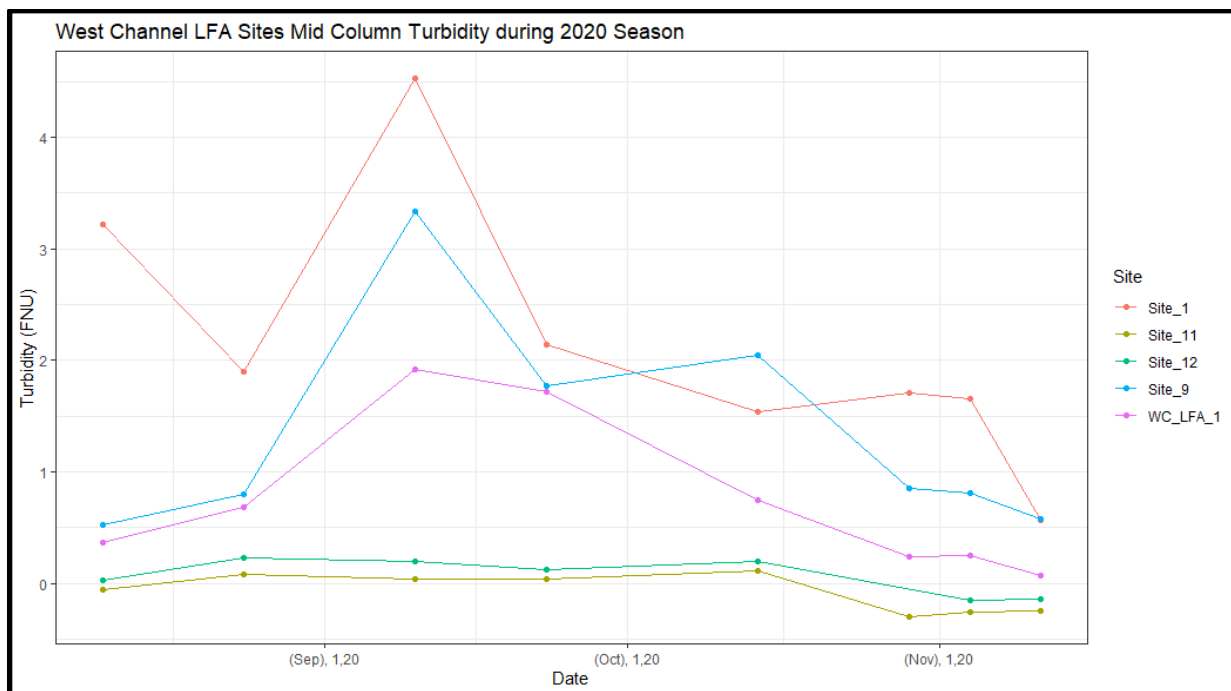
Figure 16: Turbidity Boxplot for West Channel LFA Sites

Figure 17: Turbidity readings from 8/10/2020 to 11/11/2020

Figures 16 and 17 show Turbidity readings in FNU from the YSI ProDSS Turbidity sensor. Turbidity at the Lake Tahoe sites (sites 11 and 12) was lower than the sites within the east and west channels. Figure 17 shows a spike in PC during the beginning of September at the control Site 1, WC_LFA_1 and Site 9.

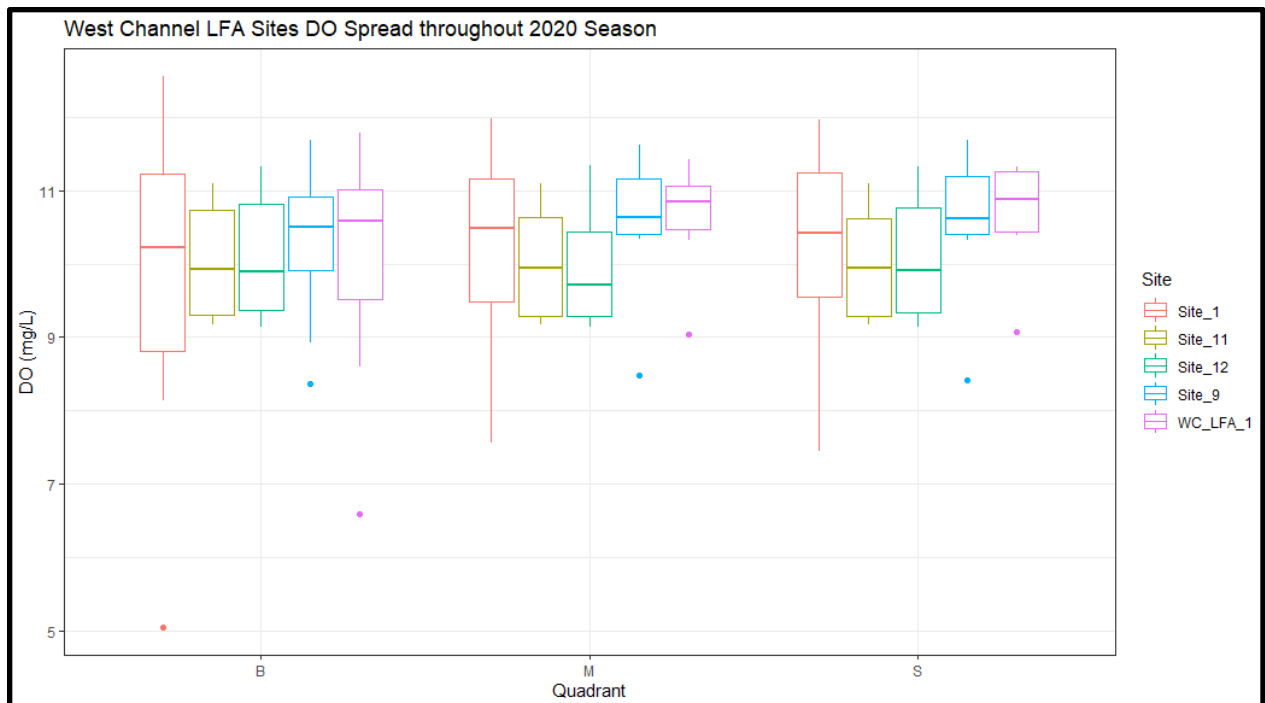
Figure 18: West Channel Sites DO Boxplot for data 8/10/2020-11/11/2020

Figure 19: Mid Column Dissolved Oxygen 8/10/2020-11/11/2020

Figures 18 and 19 show the DO readings from the YSI ProDSS Dissolved Oxygen Sensor. Figure 19 shows how DO was constant in Lake Tahoe. DO rose at all sites as the water temperature decreased later in the season.

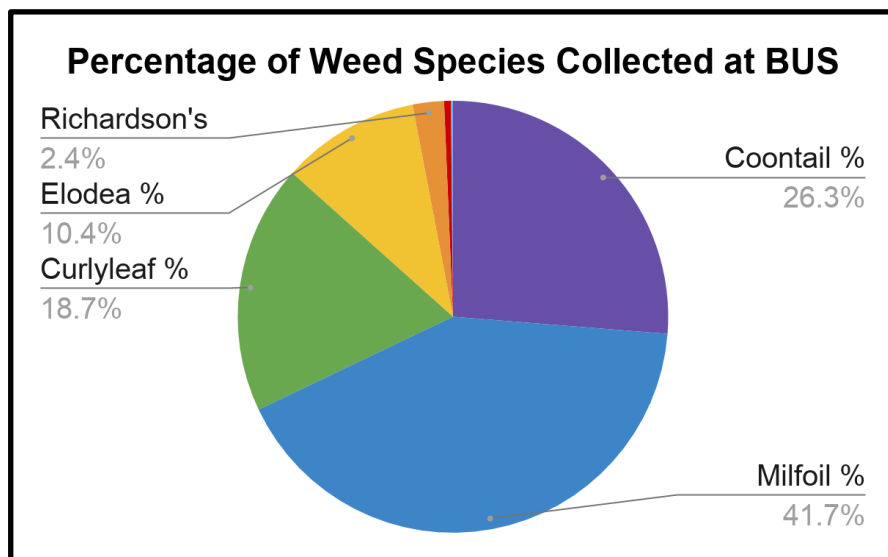
- a. Over the 131 days of monitoring, approximately 95 ft³ of weed fragments were collected, sorted and identified.
- b. These plants and their approximate percentages were: Eurasian Water Milfoil (*Myriophyllum spicatum*) 41%, Coontail (*Ceratophyllum demersum*) 25%, Curly Leaf Pondweed (*Potamogeton crispus*) 18%, Elodea (*Elodea canadensis*) 10%, Richardson Pondweed (*Potamogeton richardsonii*) 2%. Leafy Pondweed (*Potamogeton foliosus*), Common Bladderwort (*Utricularia macrorhiza*) and common grass clippings were all under 1% (Refer to Figure 25).

Figure 25: Graph of Estimated Plant Fragment Percentages.

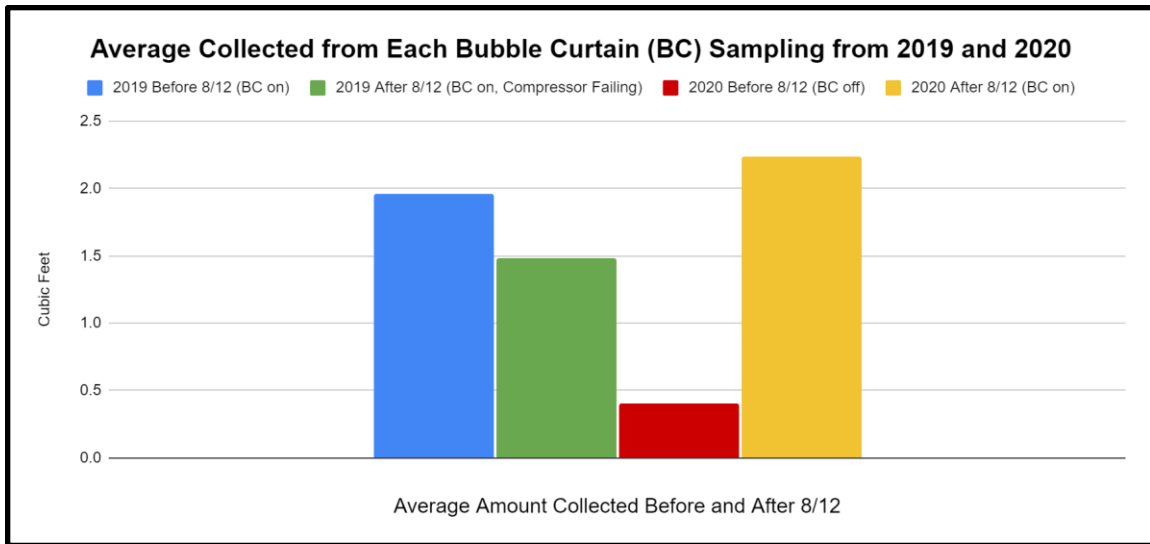
Figure 26: Comparison of the Amount of Weeds Collected at Boat Back-Up Station Before and After System was Turned On for 2019 and 2020

- c. Due to the Bubble Curtain being turned on half way through the monitoring season (8/12/2020), WQ Staff analyzed the amount of weeds collected before and after to see the efficiency of the system. As shown in figure 26 above, it can be seen that when the Bubble Curtain is on, more weed fragments are collected. In 2019 after 8/12, the compressors began failing due to faulty design (as shown in the green bar). Based on the data, it can also be determined that when the Bubble Curtain is not fully functional it is not as effective. This means that when the Bubble Curtain is on and fully functional, it is more efficient at keeping weed fragments from entering into Lake Tahoe.
