# **INTEGRATED MANAGEMENT PLAN FOR AQUATIC WEEDS FOR THE TAHOE KEYS LAGOONS**

PREPARED PURSUANT TO  
CALIFORNIA REGIONAL WATER QUALITY CONTROL BOARD  
LAHONTAN REGION BOARD ORDER NO. R6T-2014-0059

## **TAHOE KEYS INTEGRATED WEED MANAGEMENT PLAN**

**JANUARY 2024**

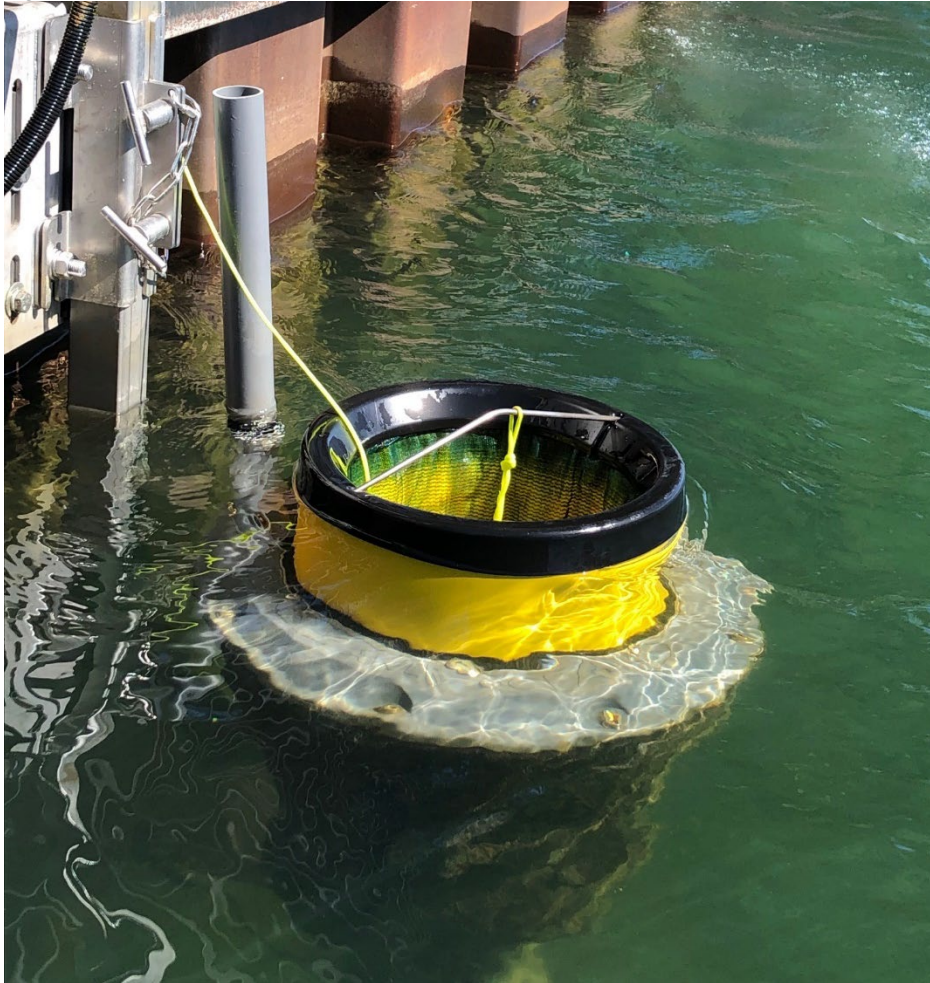
**Figure 5. Seabin**

In 2019, TKPOA deployed a single Seabin in the West Channel along the western bulkhead (shown in Figure 5) and again in 2020 using a floating dock to anchor the Seabin. The addition of the floating dock was an effort to combat wave and wind disturbance that frequently swamped (caused the Seabin to sink to the bottom of the channel) or dislodged the Seabin from its platform anchor in 2019. However, despite the new floating dock, the Seabin was plagued with operational challenges caused by the frequent wind and wave disturbance and required significant maintenance (up to four times weekly). TKPOA Water Quality staff ultimately removed the Seabin in September of 2020 with a recommendation of utilization in areas with less wind and wave disturbance, or to invest in a wave attenuator to protect the Seabin to improve its effectiveness.

The Seabin project in the Tahoe Keys was placed on hold during the 2021 and 2022 seasons and was discontinued in 2023 due to the conditions of the West Channel being inadequate for the Seabins to properly function.

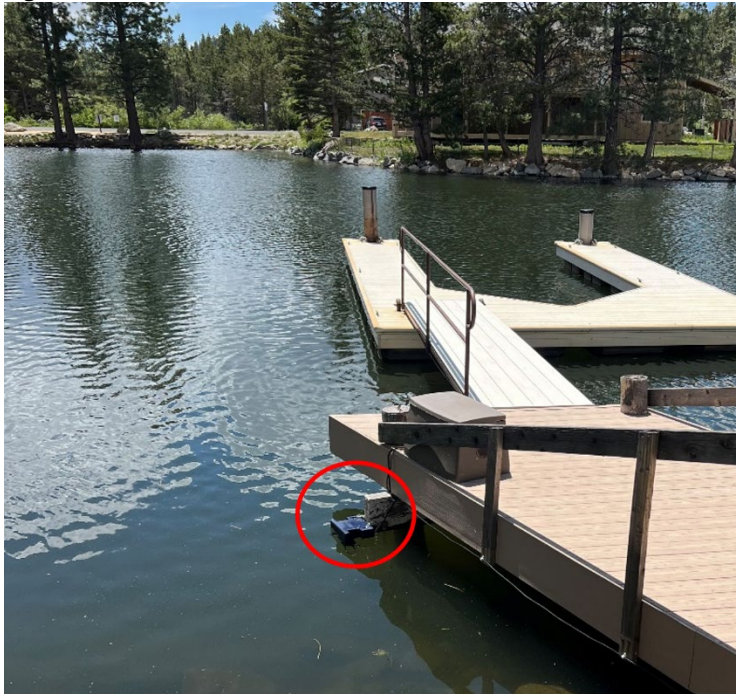
**Figure 8. Ultrasonic Unit in Site 5**

Two ultrasonic units were installed in June 2023 on a dock in CMT Site 5 and CMT Site 13, which are both dead end areas known to have large cyanobacteria blooms (See Figure 9). Both units were removed in October 2023 and will be re-installed in spring 2024. Before use, it was calibrated using factory settings as instructed by the equipment manual. The device was visually monitored throughout the season and HAB sampling occurred for analysis. The device was simple to install, unobtrusive, and will continue to be used in future seasons. The effectiveness of the unit cannot be concluded at this time but will be described in future IMP updates.

In 2020, TKPOA began researching potential use of ultrasonic waves to manage algae within the Keys lagoons. This concept was first proposed to TKPOA's WQC in 2018-2019 by TKPOA residents. According to current research, the use of ultrasound influences (i.e., reduces) the buoyancy of algae which plays a large role in algal metabolism resulting in its inability to obtain sufficient sunlight and nutrients. Most studies have been limited to laboratory data interpretation due to the complicated environmental conditions in the field (Park et al. 2017). TKPOA purchased two (2) units in 2021 (Figure 8), with the intention of installation and testing

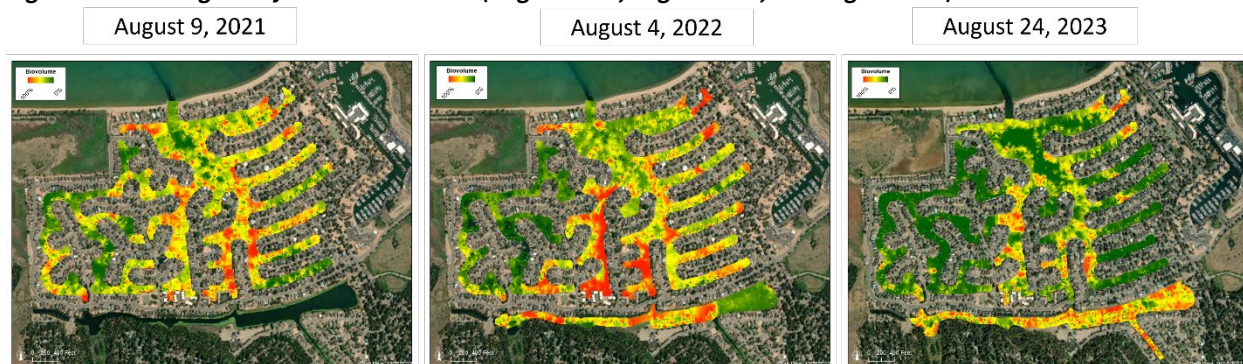
**Figure 11. West Lagoon Hydroacoustic Scans (August 2021, August 2022, and August 2023)**

The hydroacoustic scans for 2021, 2022, and 2023 used a down-scan setting for the sonar channel and a 1.3-foot minimum vegetation depth. The vegetation depth of 1.3 feet accounted for shallower depths seen in certain areas of the Keys for water year conditions experienced in 2021 and 2022.

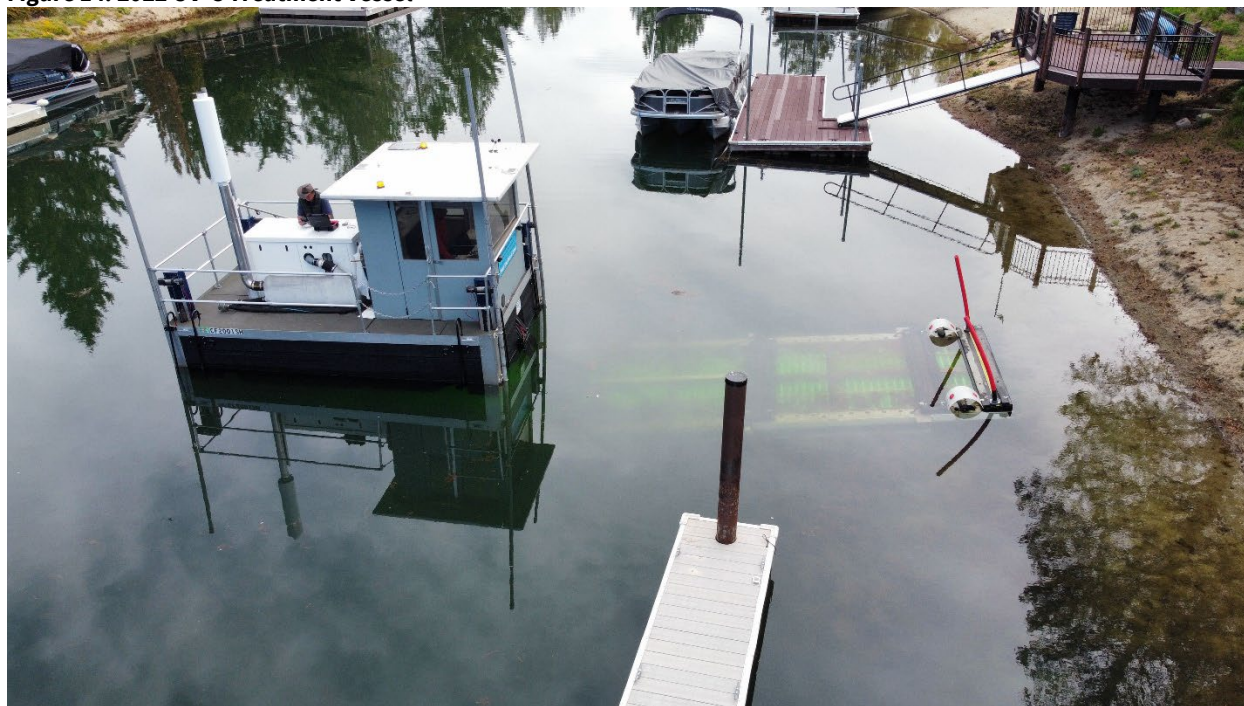
**Figure 14. 2022 UV-C Treatment Vessel**

UV-C light is a new aquatic weed control method that has been experimentally tested at nearby Lakeside Marina and within the Keys lagoons since 2020. The initial design of the UV-C treatment vessel is shown below in Figure 14. Recent research indicates the use of UV-C light (short-wave electromagnetic radiation light) can damage the cellular structure and DNA of both aquatic weeds and their fragments (TRCD 2019). Therefore, the possibility of UV light as a control method for aquatic weeds in the Tahoe Keys and greater Lake Tahoe Basin is of great interest.
