# Performance Solution Scenario

### Stair Intermediate Landing

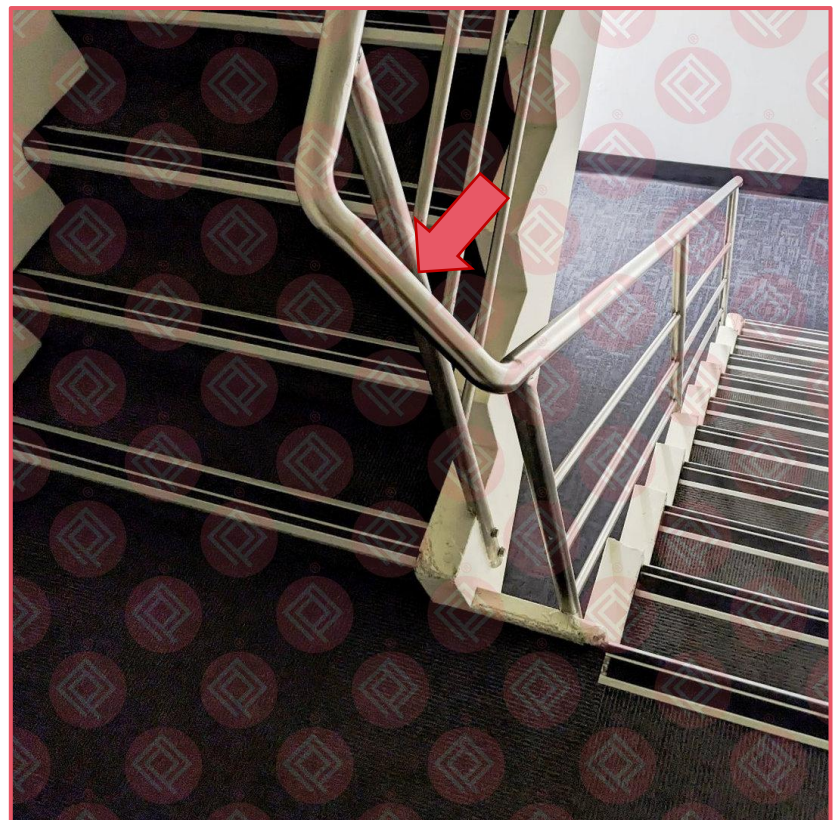
The internal handrail will likely have a vertical section or an inconsistent height.

Due to spatial constraints within the existing building, the first ascending riser from the mid-landing is not set forward at a depth of one stair tread, resulting in an angled section on the internal handrail as it turns around the intermediate landing.

While the existing stair mid-landing design will be accepted, the stairway must be upgraded to meet compliance with AS 1428.1 in all aspects, including two handrails, TGSIs, and contrasting nosing strips. Lighting will also be improved.
