Applied Research Project

Deer Mortality on Roadways

Natural Resources Environmental Technology

Date: April 8, 2017

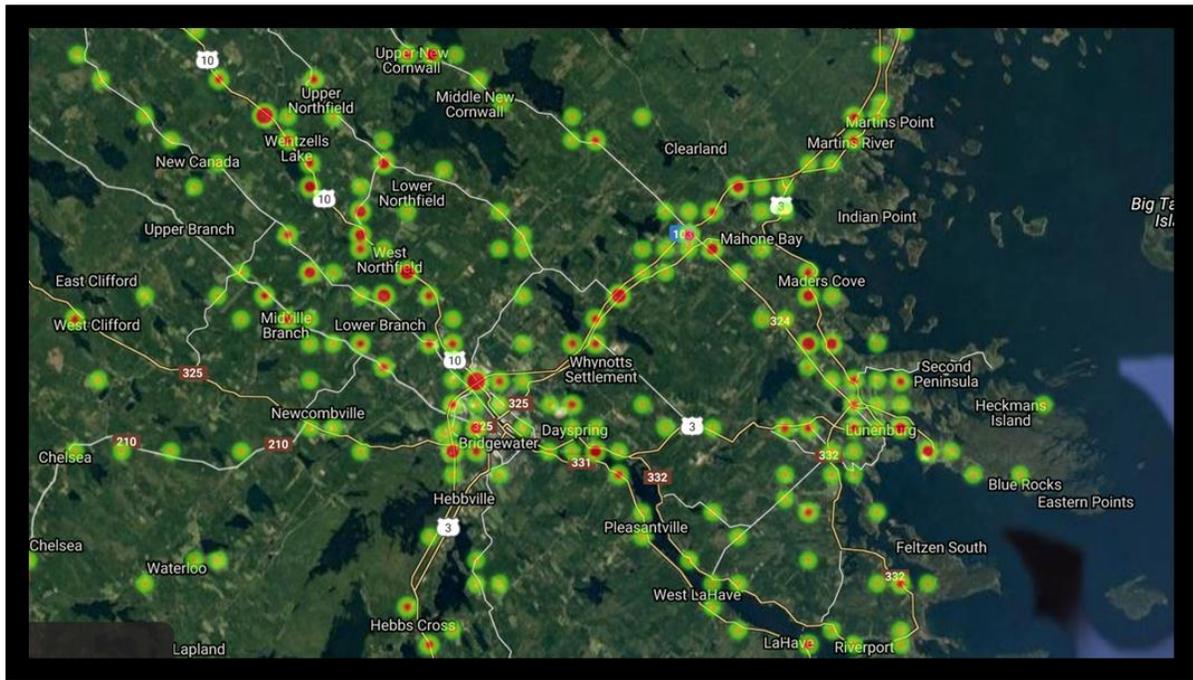
Since 2007, there has been over 1000 White tail deer vs car accidents in just Lunenburg County alone. Between the both of us, we are looking to find the 5 worst places in Lunenburg County that result in accidents that involve White Tail Deer. Our job was to generate a list of 5 locations (See figure 1) in Lunenburg County from an excel document with the accident reports inside that were the worst and write an assessment on each one. Afterwards we would come up with a list of affordable and practical recommendations based on the location for each sight. We hope that our information and research will lead to changes within these areas and the county through better signage, fences, and other precautionary items.

Figure.1 Heat Map of Lunenburg County Whitetail Deer Accidents

When we first received the data on the excel spreadsheet we had to filter and sort, until we narrowed it down, to only data that we found useful for the project. The coordinates were all in the wrong order so we had to convert them to Latitude and Longitude. To figure out the worst five places in Lunenburg County we used a heat map, the heat map highlighted the areas in the County that had the most points in colours.

After using the heat map (Refer to Figure 1), we discovered the five worst places in Lunenburg County were:

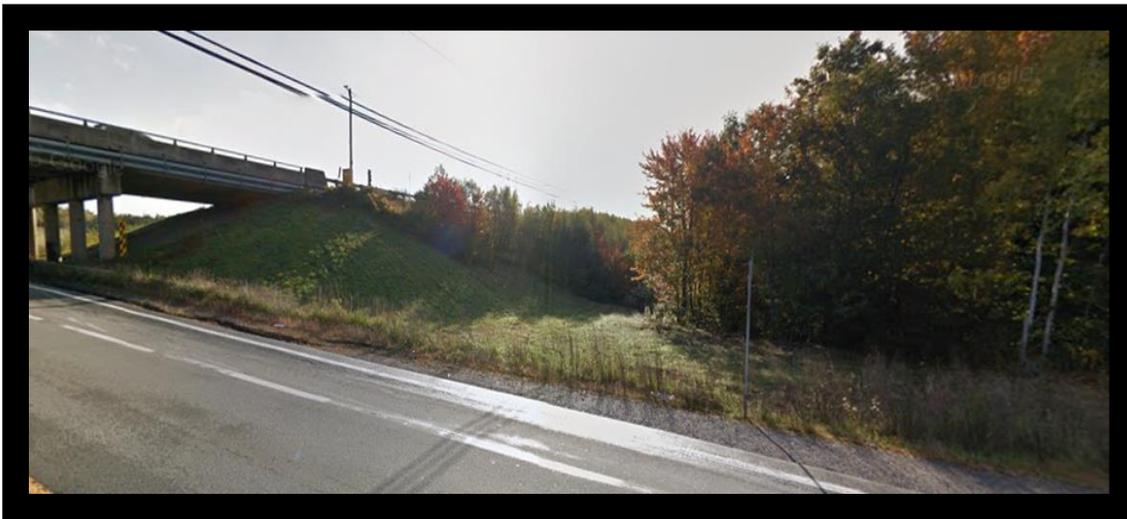
- What is unique about the exit 11 underpass is that the recently tried to fix the problem which we inferred that it was the worst because the others still have not been fixed.
- They had put up 7-8 feet tall deer fencing along the highway stretch there.
- This area had cars going at speeds of 100-110km/hour.
- The trees are closer at this location than any other part of the highway, so deer may cross because there is less fragmentation at this location. (See Figure 2)
- No immediate food source.

Figure. 2 Shows the area at sight 1 that is less fragmented. (Google maps, 2017)

- Sight 1: The fencing at the overpass is suspected to reduce the accidents within the area that was of most concern. Flashing signage has been used and could reduce the number of accidents as well. 0.00 (See Appendix C)

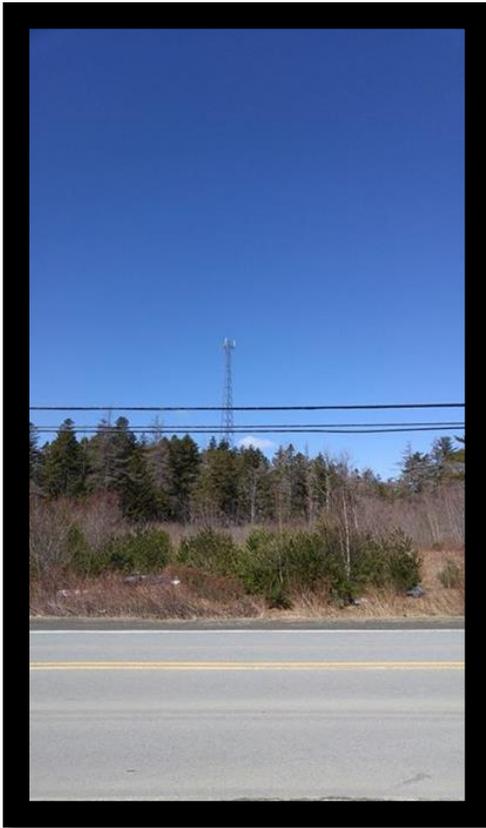
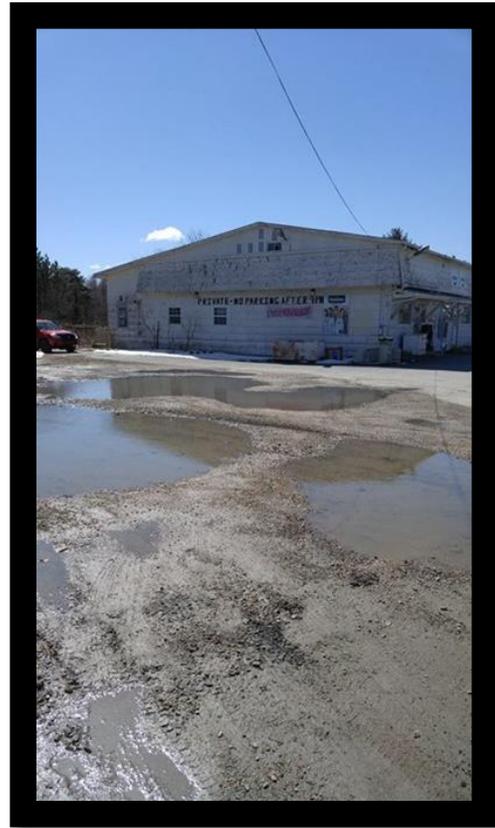
- At sight two there were young growth for about 100 meters. (See Figure 3.1)
- The speed limit was 80 but cars were driving by at faster speeds.
- It's a crossroad section where a fair amount of traffic comes through.
- Clear cuts in other areas leading up to this location, making this location less fragmented.
- The surrounding area is: couple of houses, church, and Sam's quickmart. (See Figure 3.2)
- No food source

Figure 3.1 The area where there is under growth for 100 meters.
Figure 3.2 Just one building from the surrounding area.

- Sight 2: Reduced Speed limits and more signage because there is none. Other options are not viable for this area because of prices. Deer crossing signage with a light that flashes when there have been more intense accidents. \$750.00

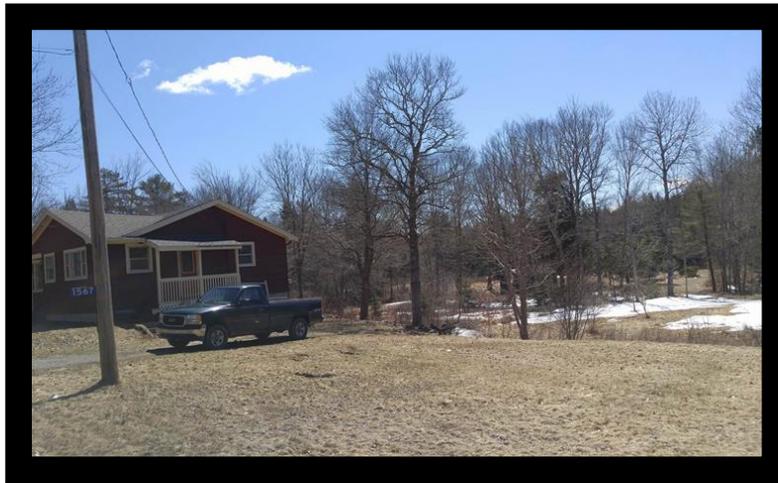
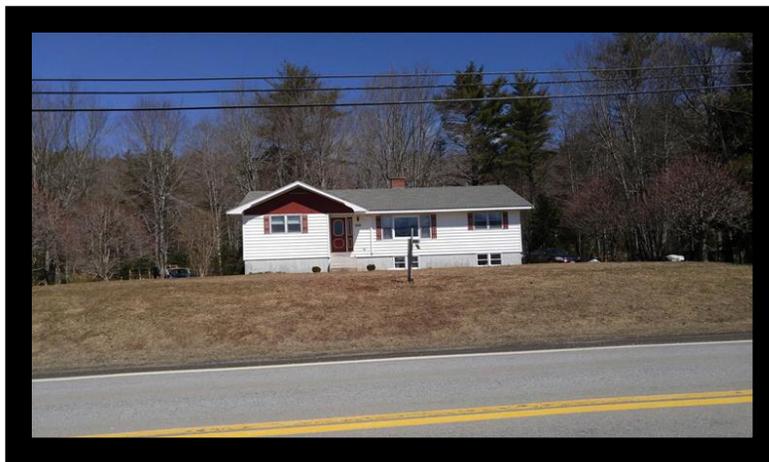
- There are two houses across from each other both with fairly sized yards.
- The speed limit is 80 but the cars were driving noticeably fast.
- Few clearings leading up to the spot that may cause fragmentation. (See Figure 4.1)
- We did find a potential food source in one of the yards, there seemed to have been some type of ornamental cherry tree that the deer could have been feeding on. (See Figure 4.2)
- The area is located on a long straight stretch where cars would tend to drive faster.

Figure 4.1 Shows the very openly fragmented landscape behind the burgundy house.
Figure 4.2 Shows the food source to the right of the white house.

- Sight 3: Potentially the removal of the food source, along with reduced signage because of the speeds along the stretch. Potentially a deer sign with a light that's on when accidents have been more frequent in a timeframe. \$850.00

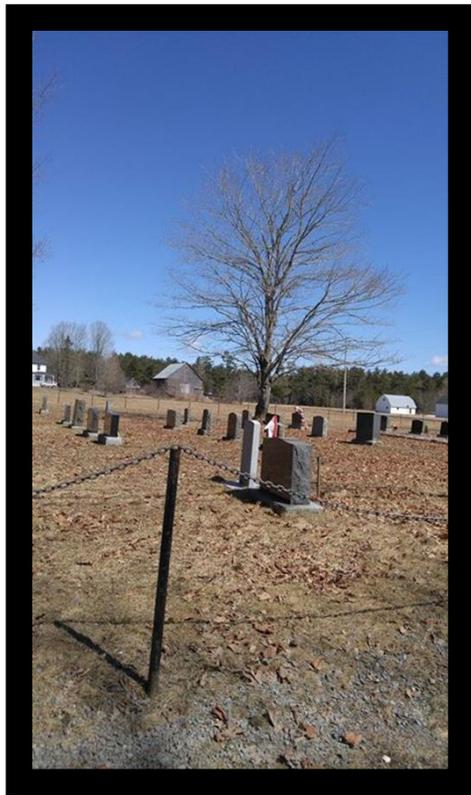
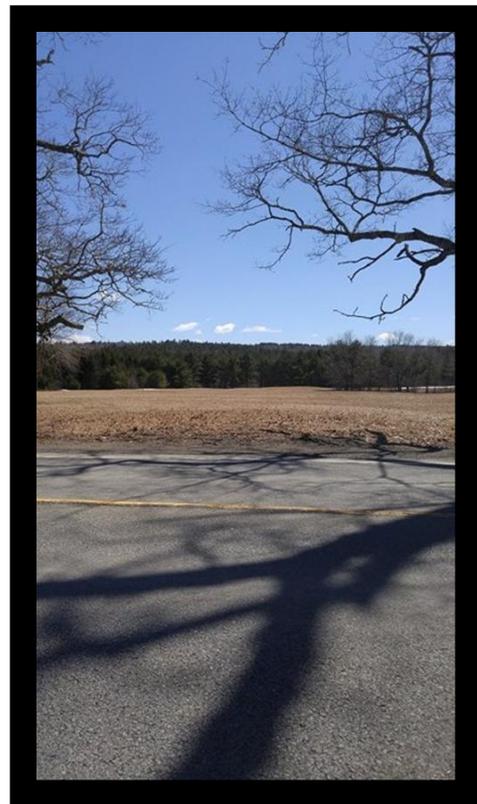
- Surrounding area includes: houses, church, and cemetery. (See Figure 5.1)
- The area is all open fields, no immediate corridors. Roughly 500 meter of open fields to cross or more. (See Figure 5.2)
- 80 zone but the cars were going noticeably faster.
- This area is all open for about 1 km before and after this area.
- No immediate food source located.
- This area is so far from the woods that it acts as a deterrent because there is so much open land to cross.

Figure 5.1 Shows the cemetery on the other side of the road and all the open space behind it. Figure 5.2 Shows the 500 meters of open fields that the deer have to cross to get to the other side.

- Sight 4: This area should have reduced speed limits and the planting of corridors which would allow the white tail more time to make their way to the road rather than straight through open land where they would be more apt to run. \$250.00

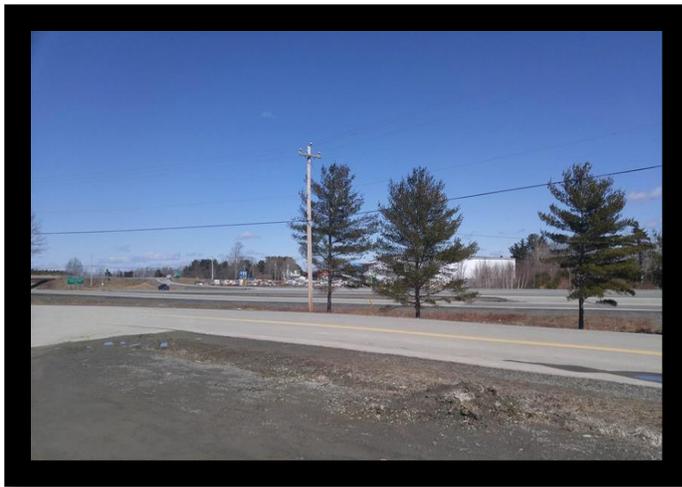
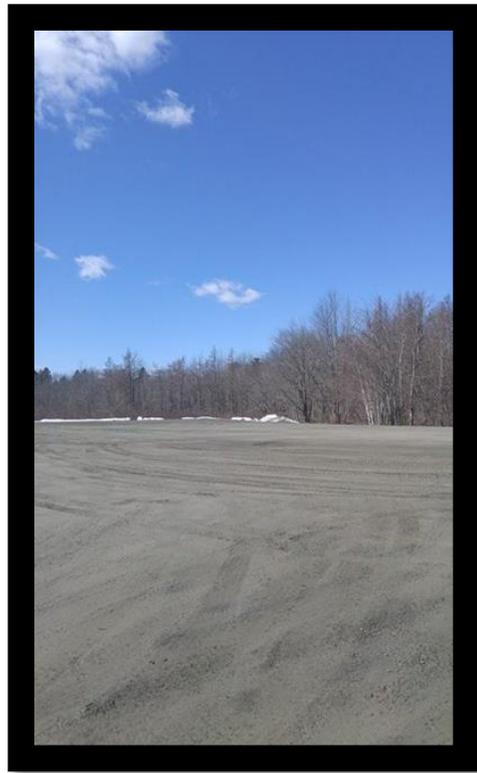
- Located right next to highway 103 at the armour transportation systems location.
- No posted speed but there was a decent amount of traffic but not at fast speeds.
- The area is mostly open and is right next to the highway on and off ramps.
- No immediate food source located.
- Near highway located approximately 1.5 km from Sight 1.
- Very fragmented, there is some green space between the ramp and the sight. (See Figure 6.1)

Figure 6.1 Shows the very small green space between the road and the ramp.
Figure 6.2 Shows the empty truck parking area that fragments the area even more.

- Sight 5: There area would need 7-8 ft fencing all along the highway ramp and about roughly go for about .2 of a km and on the other side of the highway as well. Speed signage and deer crossing signage is needed. \$2750.00 without fencing installation fee.
