December 23, 2024

Tahoe Regional Planning Agency  
Attn: Emily Justice, Aquatic Invasive Species Projects Coordinator  
128 Market Street  
Stateline, NV 89410

**UVC Light Aquatic Invasive Plant Control Pilot Project-Summary of Treatment Field Activities for the 2024 Treatment Season**

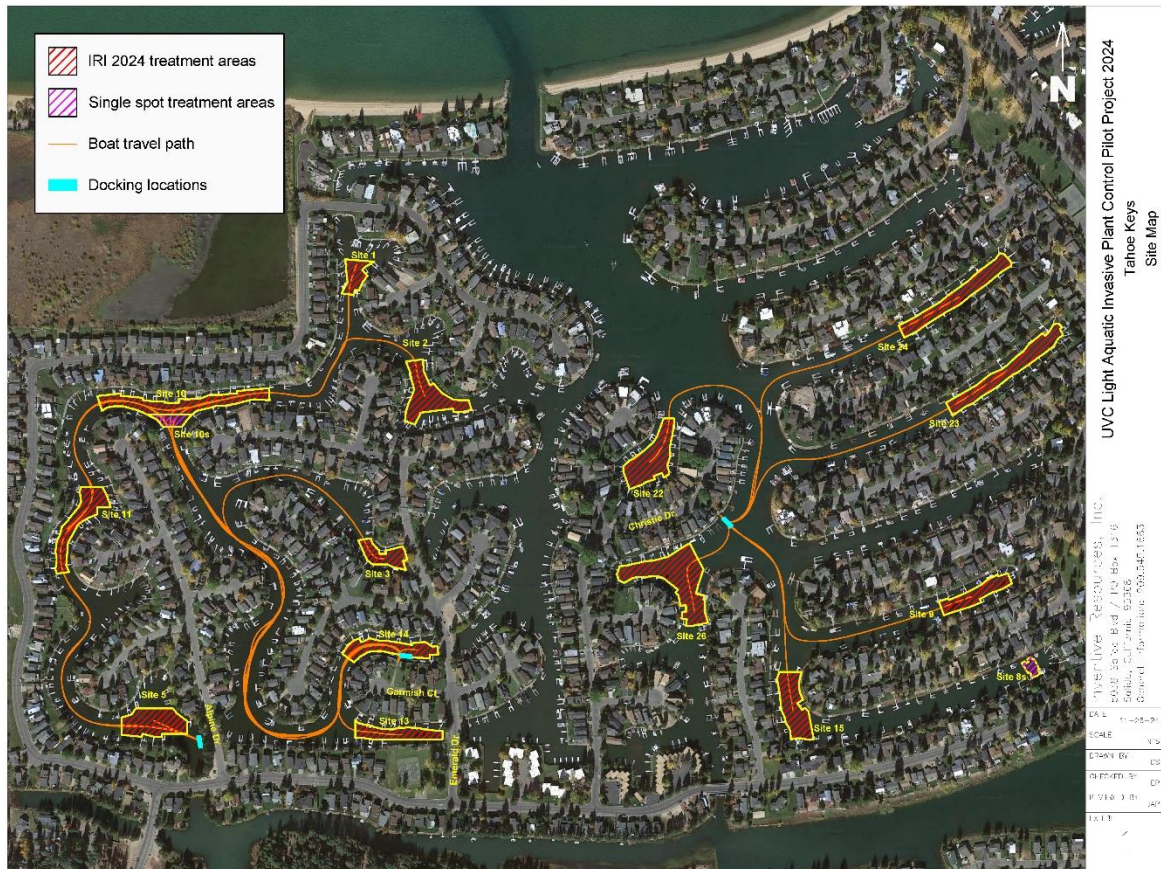
**Figure 2**  
**UVC Light Aquatic Invasive Plant Control Pilot Project 2024**  
**Treatment Site Map**

The sitemap depicted in Figure 2 highlights the locations that underwent UV treatment. There are three docking sites: one at West Garmish Court, another near Site 5 off Alpine Drive, and the third at Christie Drive. This detailed illustration aids in understanding the distribution and logistical planning of the treatment areas.

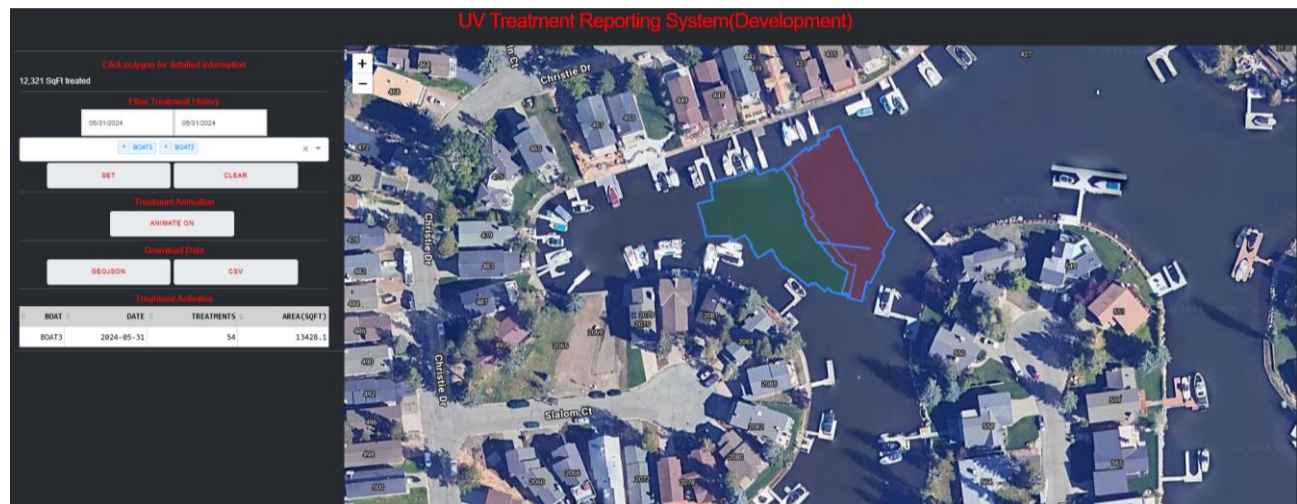
Image G illustrates Day 1, shown in red, where the operator treated approximately 12,000 square feet. The green area indicates the treatment performed on the second day, with an overlap of about 20 feet between the two areas. With improved equipment and additional training, this overlap can be minimized.

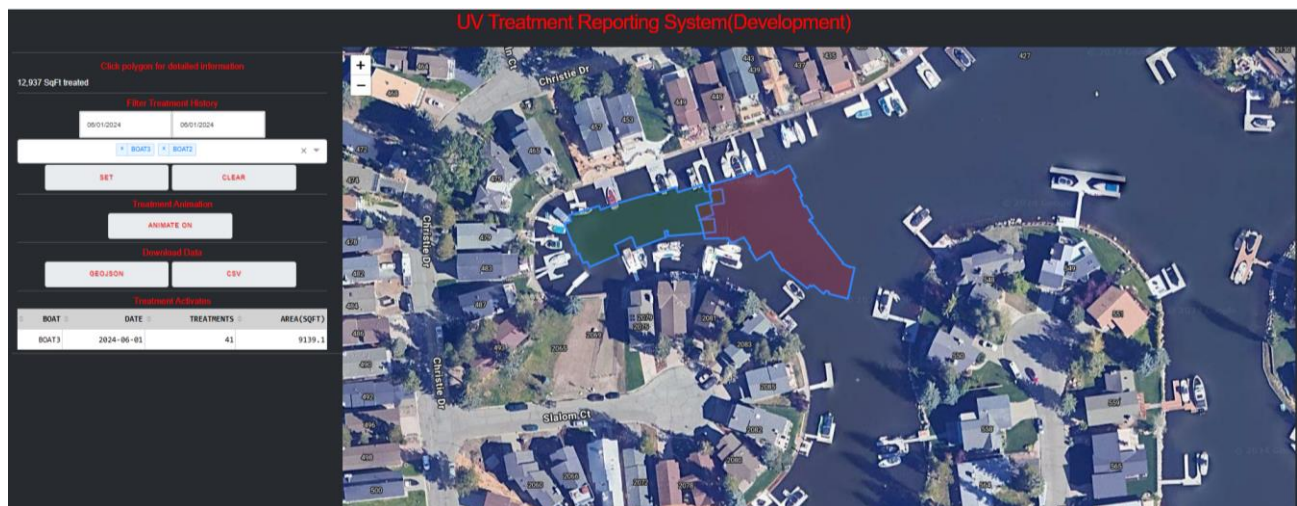
Image H illustrates Day 3 treatment, shown in green. This area was relatively small but challenging to maneuver around. Consequently, the operator treated approximately 10,000 square feet that day.

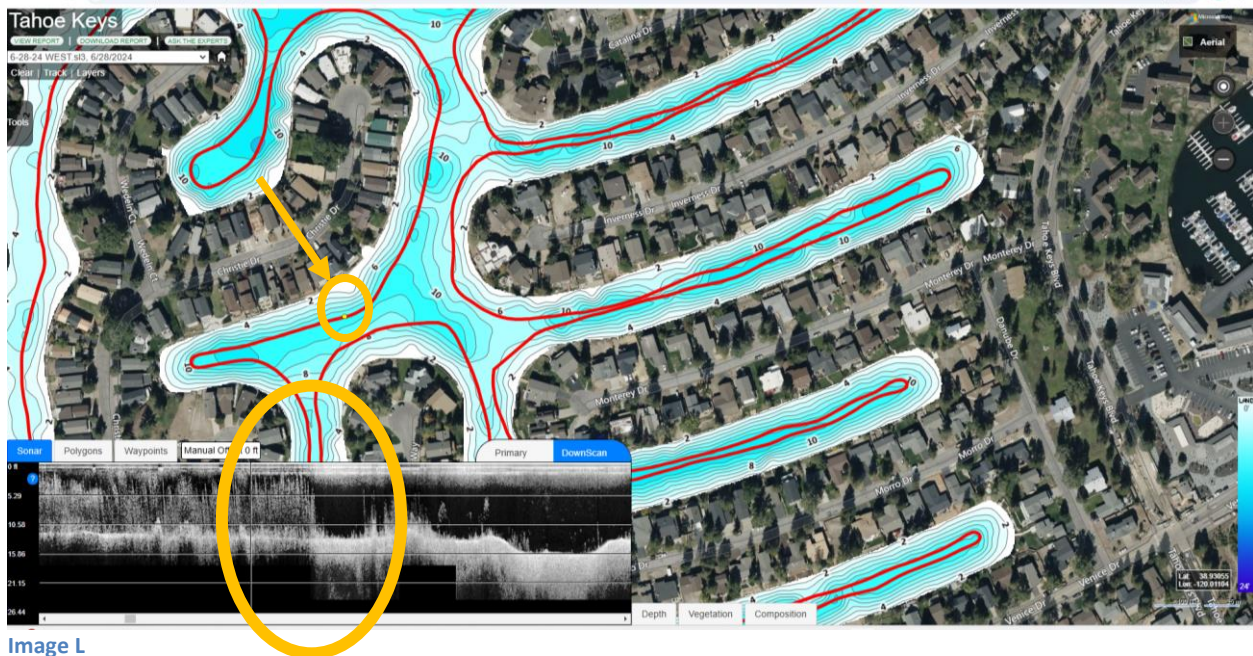
Image L illustrates the transition of a non-treated area section entering the UVC treated area 20 days after treatment. This image clearly depicts the wall of plants to the left and near bare sediment after the first treatment.

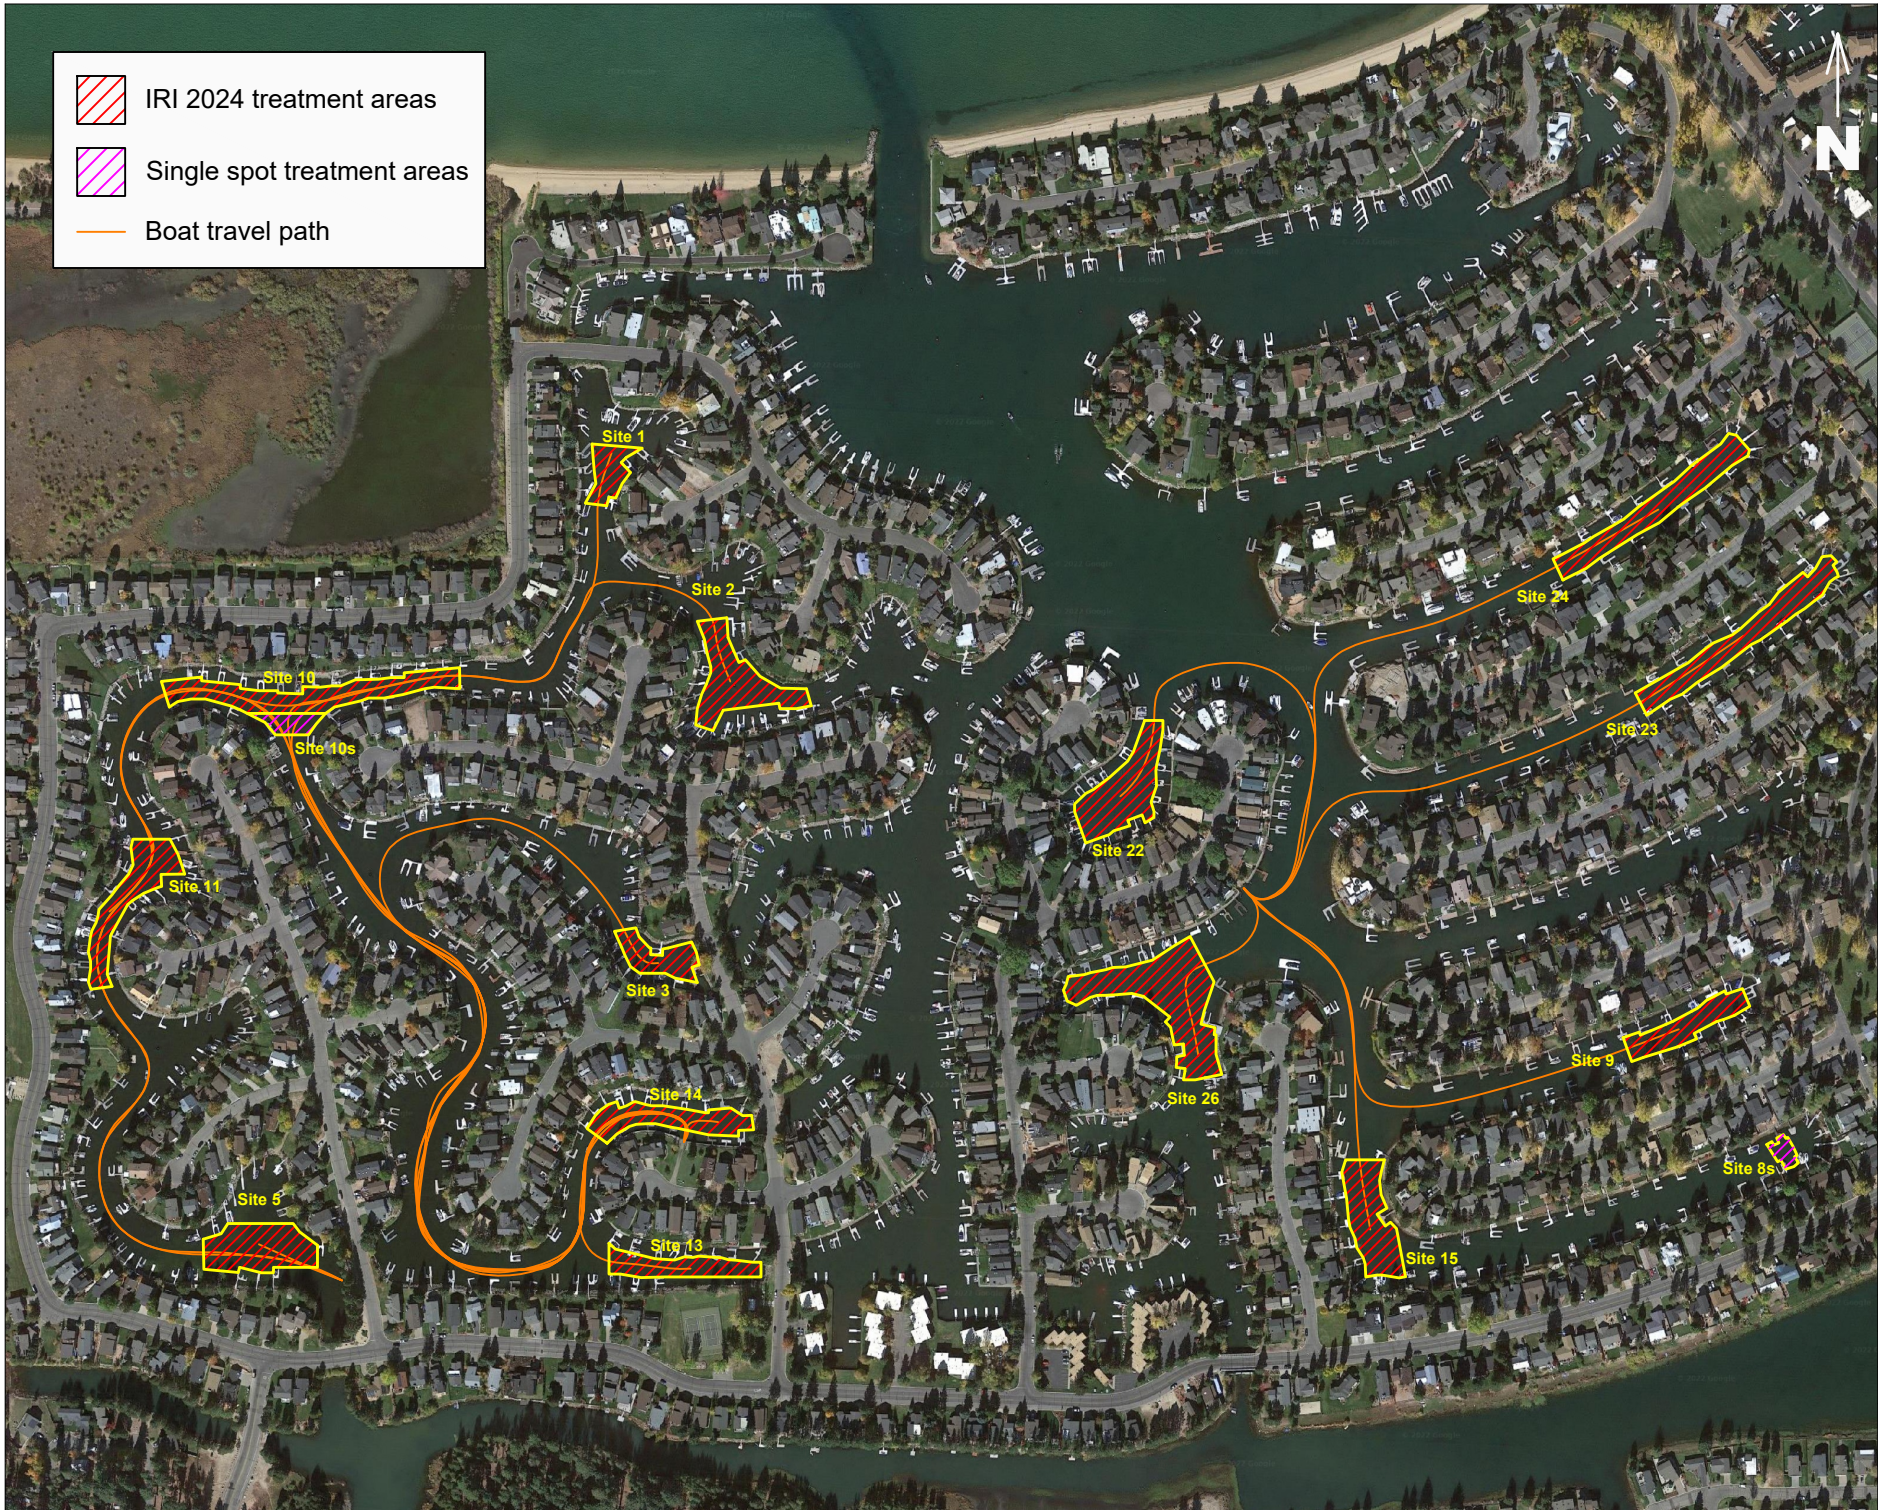
| <p>UVC Light Aquatic Invasive Plant Control Pilot Project 2024</p> <p>Tahoe Keys</p> <p>Site Map</p> | |

- IRI 2024 treatment areas
- Single spot treatment areas
- Boat travel path

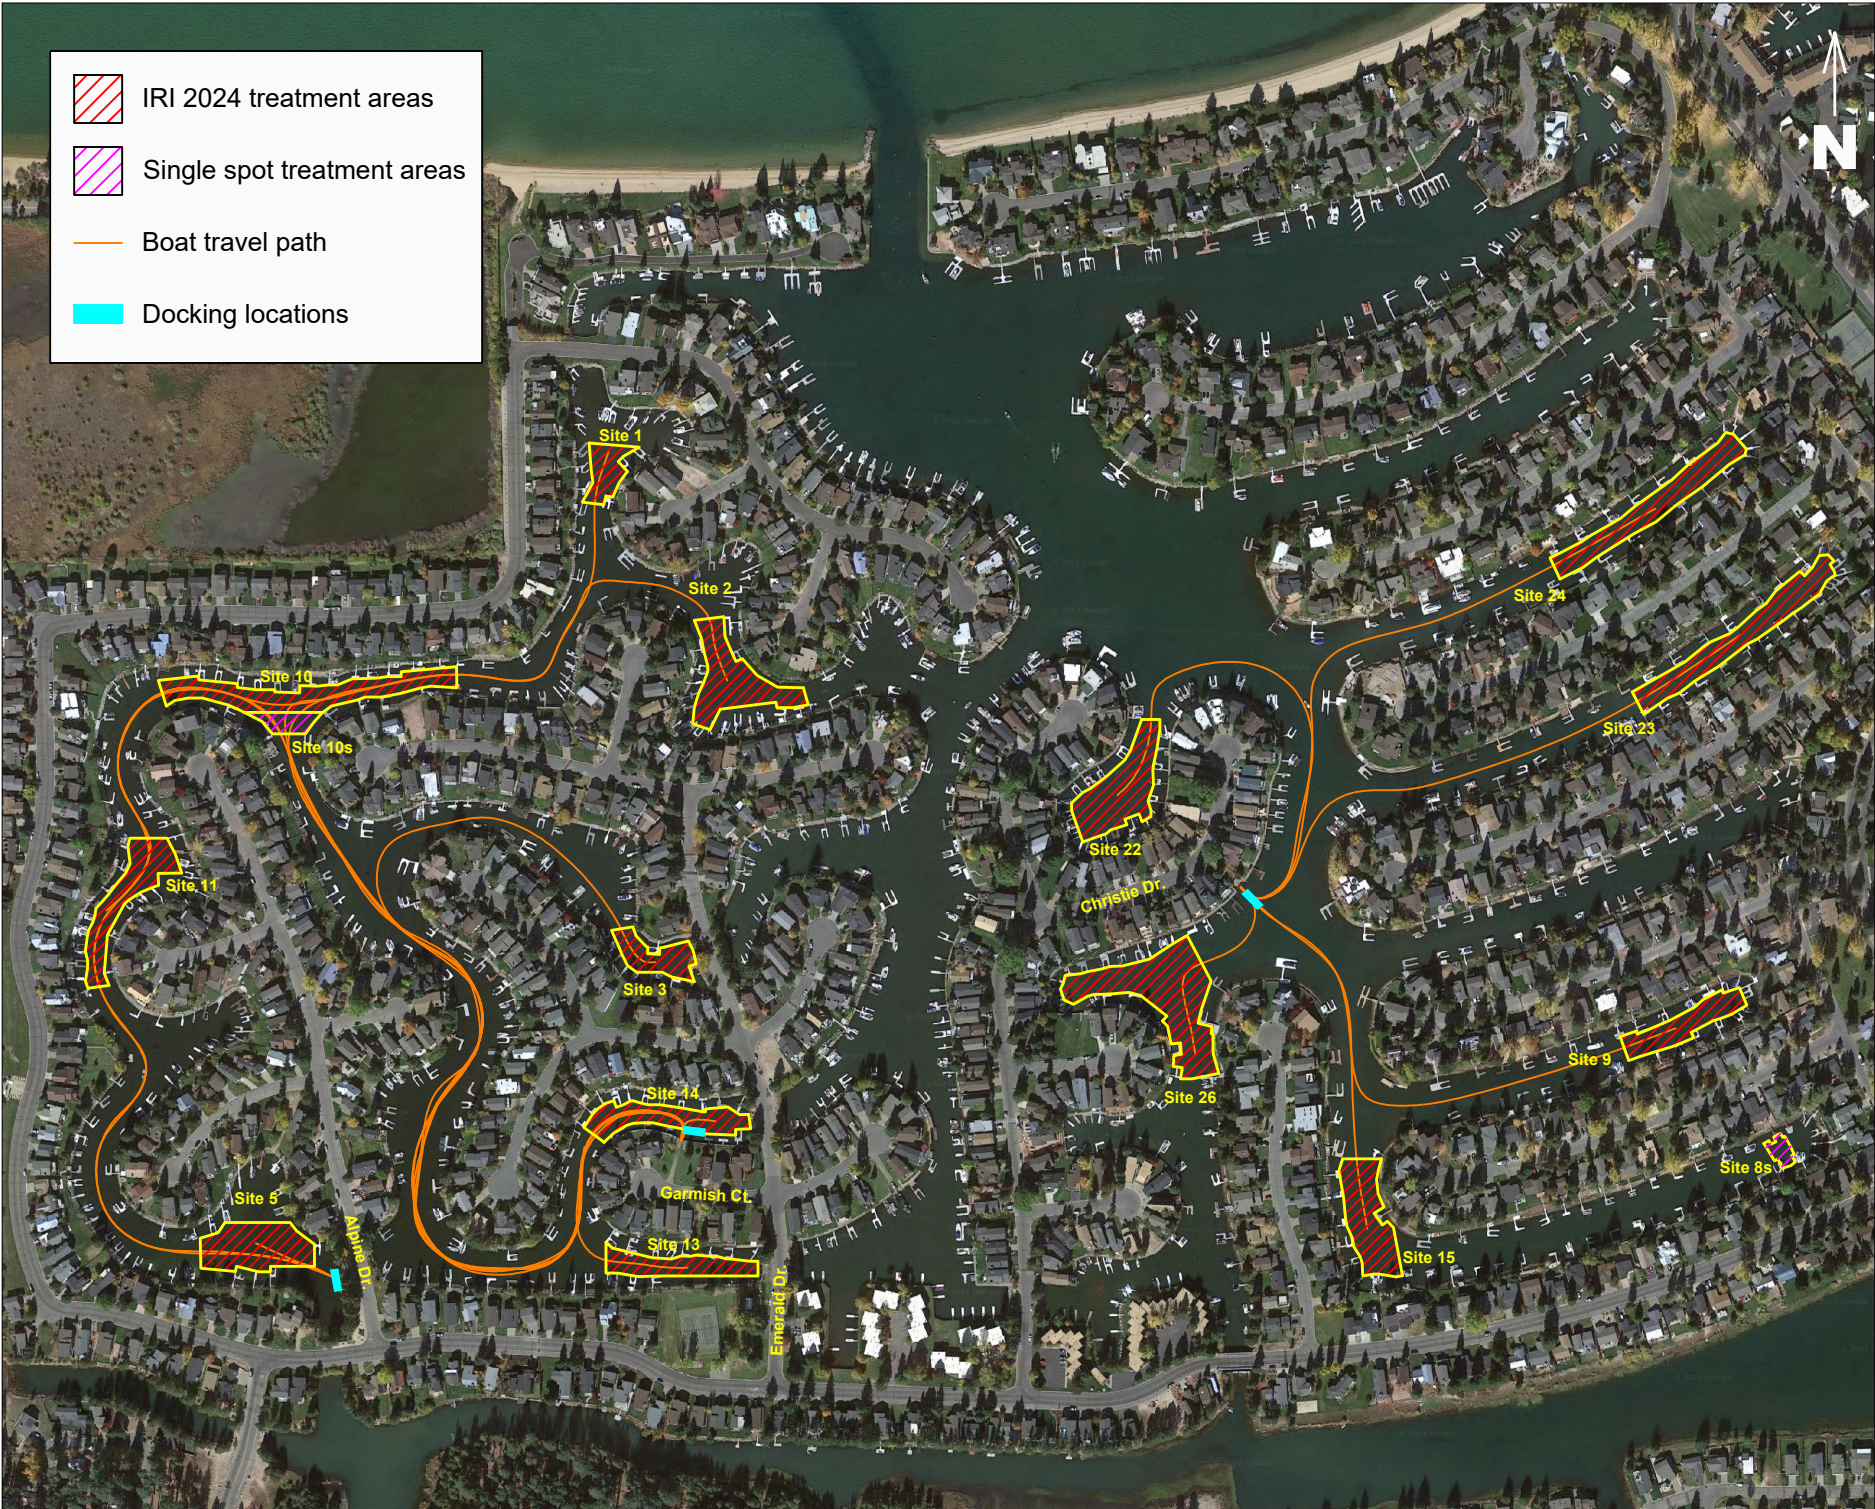
UVC Light Aquatic Invasive Plant Control Pilot Project 2024  
 Tahoe Keys  
 Site Map

Docking locations

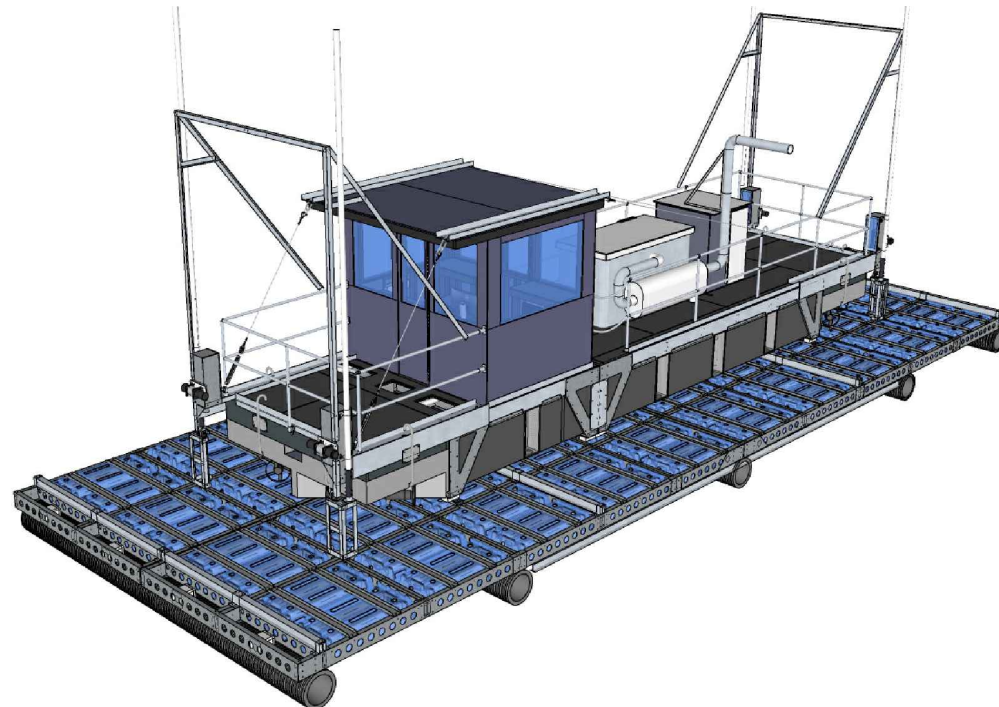
**Boat III**

8'x32' hull  
 16'x40' light array  
 99kW generator  
 (10) 36V thrusters  
 0.8mph speed
