The destruction of the Kakhovka dam and its consequences

VIEWPOINT

KEYWORDS Kakhovka dam; destruction; Kakhovske Reservoir; Russia-Ukraine War; economic and environmental impacts; Ukraine

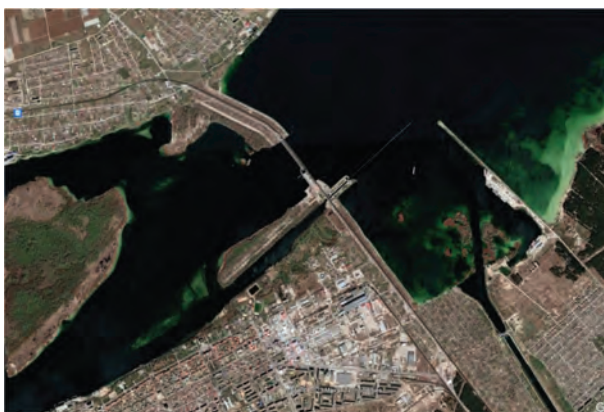
Figure 2. Satellite image of the Kakhovka hydrotechnical structure before its destruction. Source: Google Earth, 20 October 2020.

The Kakhovka dam and hydroelectric plant consisted of four parts: the left bank and the right bank ground dam with a total length of 3.8 km, a concrete spillway dam with a length of 447 m with 28 spillways, a large generator room with six turbines, and a shipping lock with a width of 18 m. The maximum height of the concrete dam was 29 m (Vyshnevskiy, 2011).

The design throughput capacity of the hydraulic structure is 21,400 m³/s; the hydroelectric plant had a throughput capacity of 2600 m³/s, capable of producing 335,000 kW of power and an annual production of electricity of 1.4 billion kWh (Figure 2).

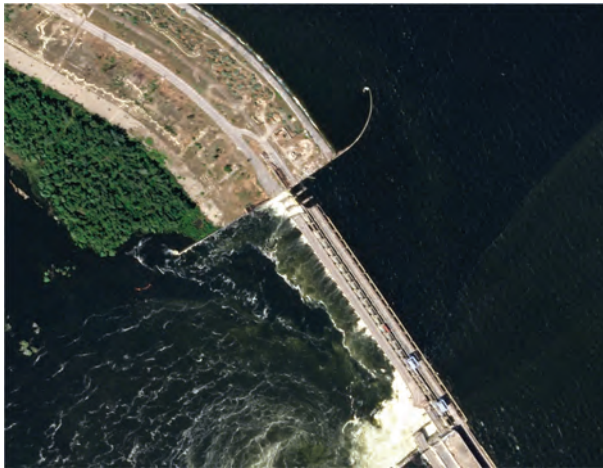
Figure 3. Satellite image of the damaged spillway of the Kakhovka dam before its destruction. Source: Skysat image from <https://twitter.com/planet/status/1666116252090388480/photo/1>

On 11 November 2022, the Ukrainian army liberated Kherson city and other settlements on the right bank of the Dnipro River. That day three sections of the spillway and part of the roadway across the Kakhovka dam near the right bank were destroyed to prevent Ukrainian forces from crossing the river (Figure 3).

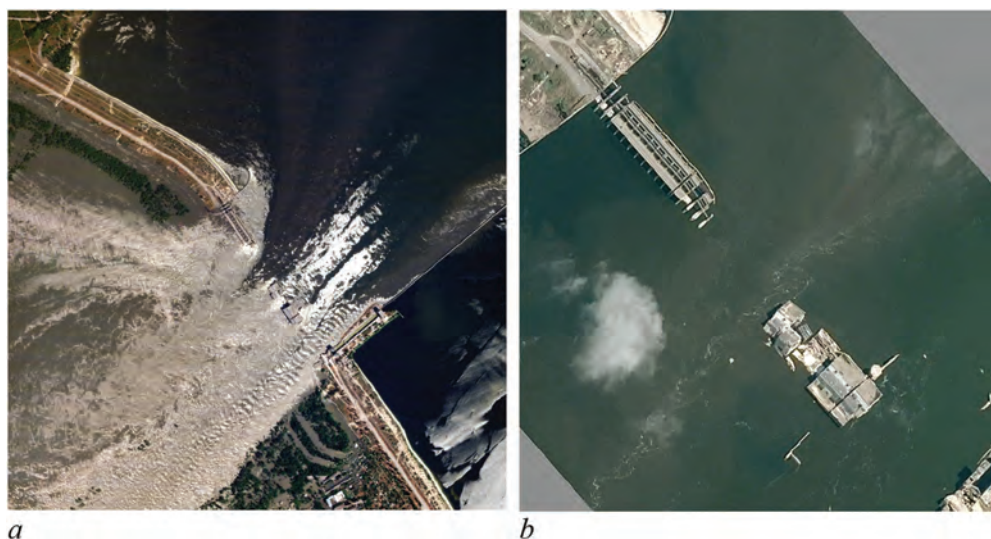
Figure 4. (a) The destroyed Kakhovka hydrotechnical structure soon after the explosion on 6 June 2023; and (b) the dam on 7 June 2023. Source: <https://apnews.com/article/ukraine-russia-dam-collapse-before-after-photos-b504eb2ce21e2c30cbcf902fbd718b71>

The explosion, which occurred between 2.30 and 3.00 a.m. on 6 June 2023, caused massive flows of water out of the reservoir and the washing away of major portions of the dam. Large volumes of sediments that had accumulated in the reservoir were flushed downstream as well (Figure 4).

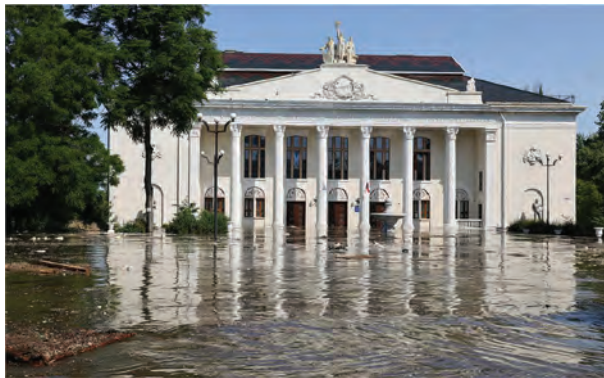
Figure 7. The flooded square before the building of the Palace of Culture in Nova Kakhovka. Source: <https://focus.ua/uk/voennye-novosti/571041-u-zatopenij-novij-kahovci-chuli-zvuki-strilyanini-rozsmi-video>

The most severe flooding occurred in Nova Kakhovka city and in the village of Kozatske both located less than 2 km downstream from the destroyed dam. At these locations, the increase in water level began a few minutes after the explosion, in the middle of the night. Most residential buildings in the central part of Nova Kakhovka city have an elevation of 11.5–12.0 masl. Photographs of this area show extensive flooding, including in the square before the Palace of Culture (elevation of 11.5 masl), with

flooding to a depth of around 1 m.⁴ From this, we estimate that the water level in Nova Kakhovka city reached 12.5 masl (Figure 7).

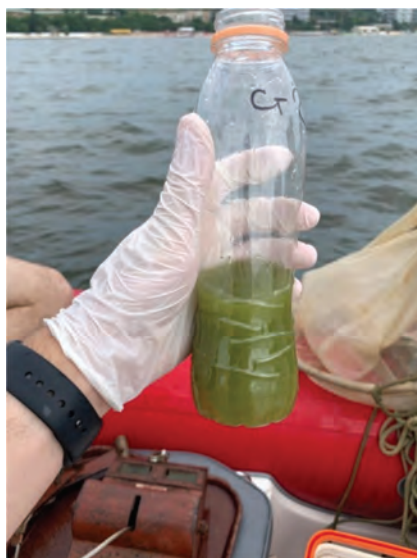
Figure 9. Seawater sample taken in the Gulf of Odessa on 20 June 2023. Photo: Oleksandr Lepyoshkin.

Water sampling in Odessa Bay by the UkrSCES revealed a significant increase of phytoplankton content, which corresponded with the emergence of green patches of microalgae in seawater near the beaches of Odesa starting from 14 June 2023 (Figure 9).
