## Full Home Inspection Report

Property address: **8047 Phone Court  
Suttons Bay Michigan 49682**

Inspection date: **Wednesday, September 20, 2017**

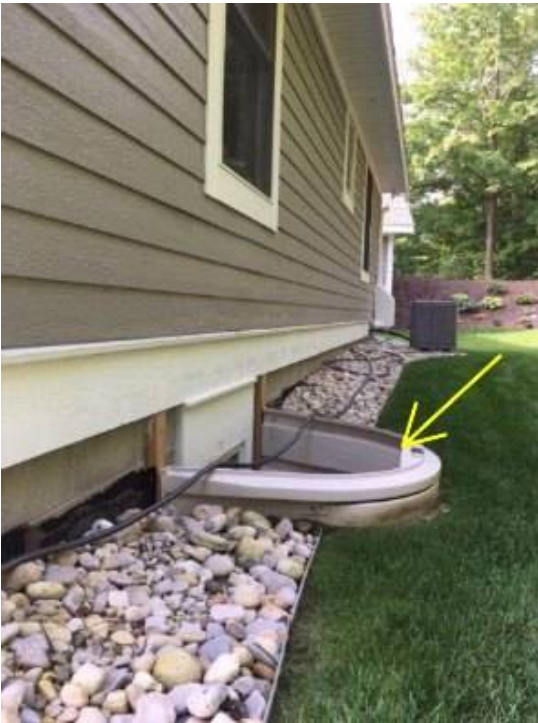
**Photo 2-1**

**2) Safety, Repair/Replace** - The egress well for the basement window was not covered. This a fall hazard. Recommend installing a cover.

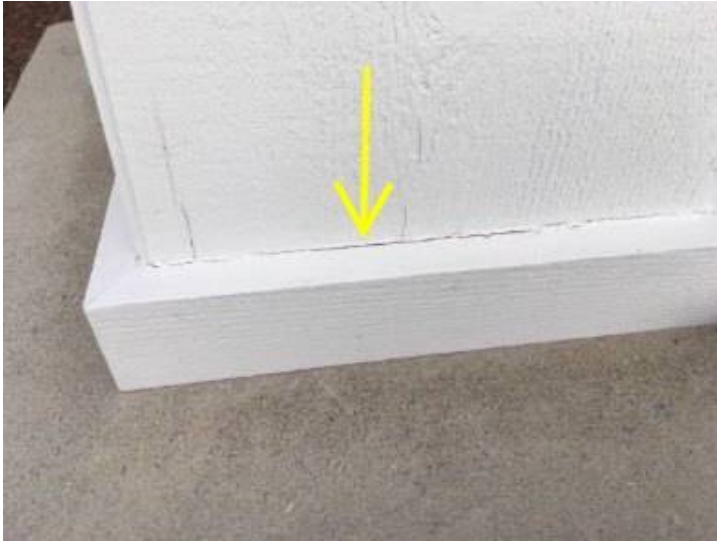
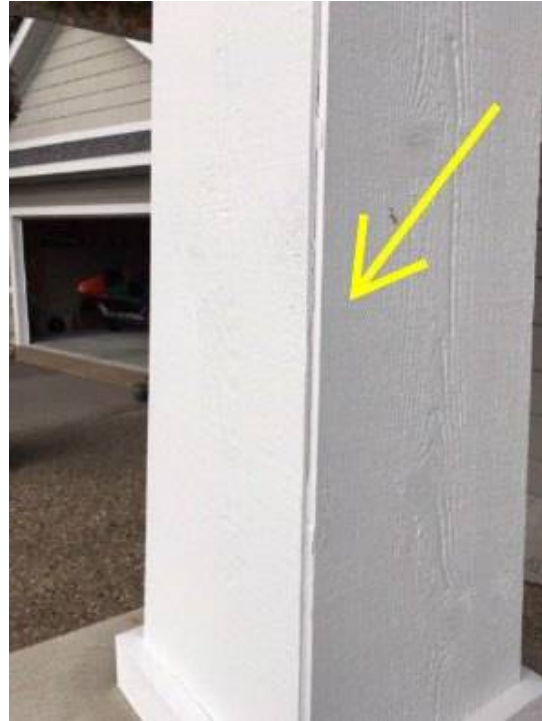
Photo 3-1

**3) Repair/Maintain** - Minor cracking was found at the southeast porch pillars. Recommend apply more caulk to prevent possible water intrusion.

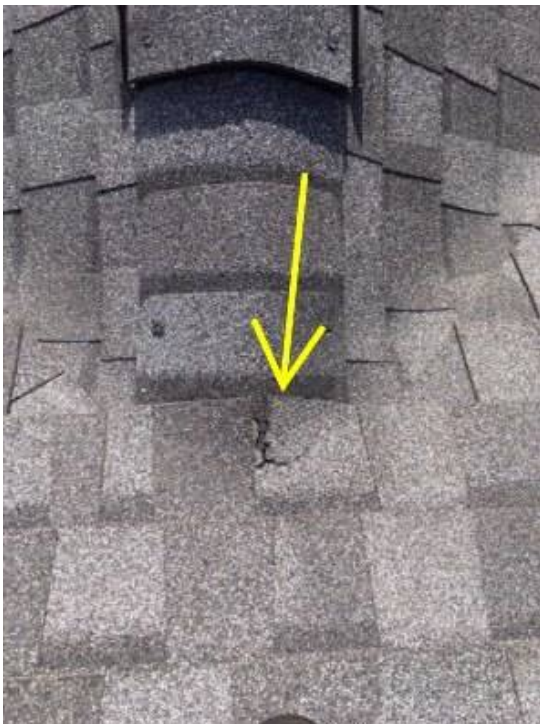
**Photo 4-1**

**4) Repair/Replace** - One composition shingle was cracked on the southeast porch peak. Leaks can occur as a result. This is a conducive condition for wood-destroying organisms. Recommend that a qualified contractor repair as necessary.

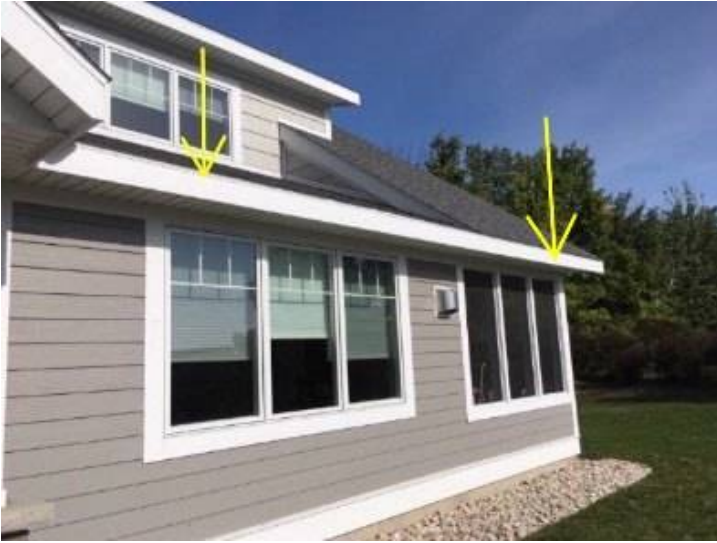
Photo 5-1

**5) Repair/Replace** - Gutters were missing on the home. Most buildings benefit from having a complete drainage system installed, but at a minimum, recommend installing gutters over entrances.

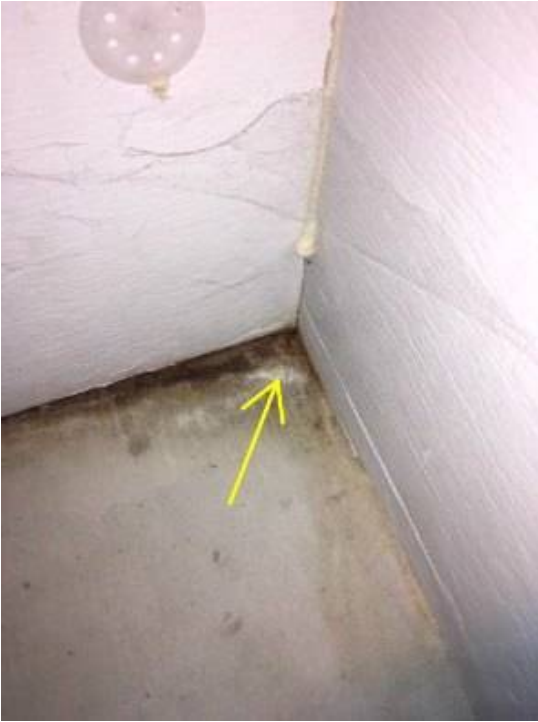
**Photo 6-1**

**6) Repair/Replace, Evaluate, Monitor** - Evidence of moisture and efflorescence were found on the slab at the southeast section of the basement. Recommend reviewing any disclosure statements available and ask the property owner about past water intrusion in this area.

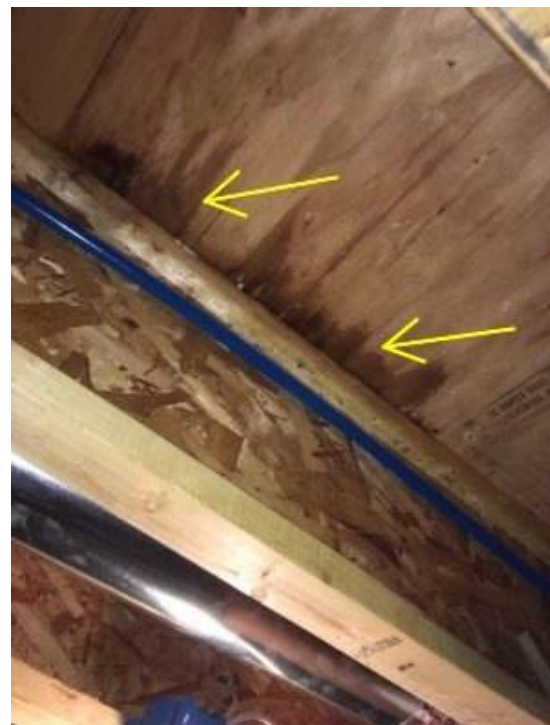
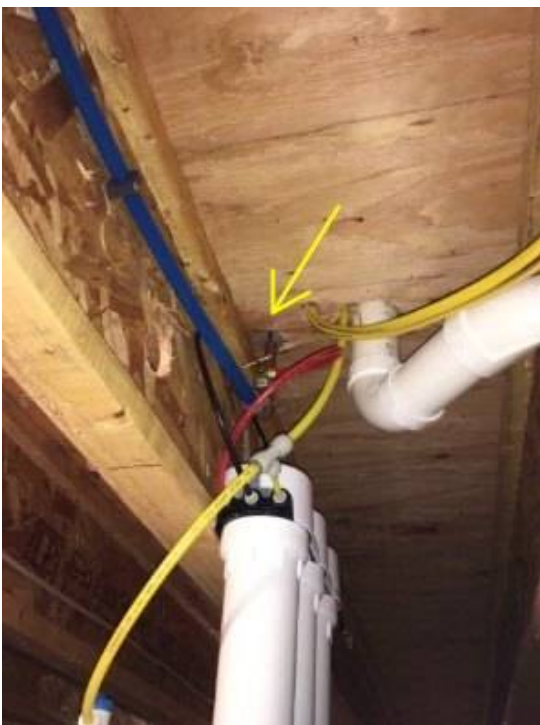
Photo 7-1

**7) Comment** - The homeowner disclosed to the inspector that after having the reverse osmosis system installed a leak was detected and repaired. There were no elevated levels of moisture at the time of inspection and repairs appeared to have been properly performed.

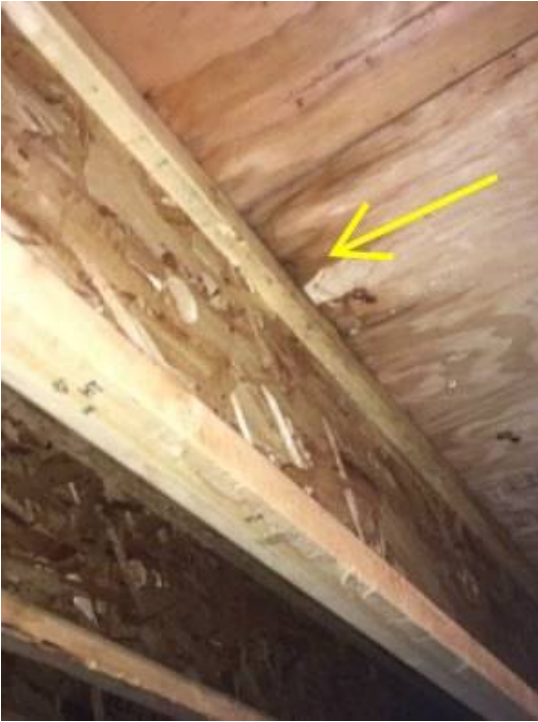
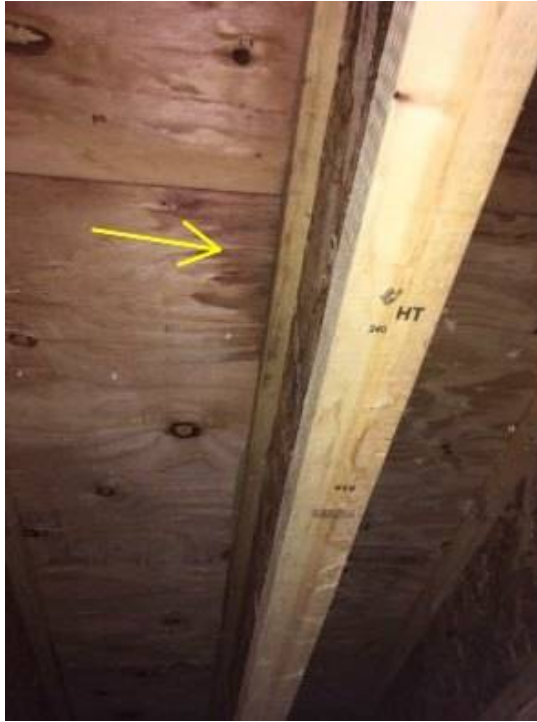
Photo 8-1

**8) Comment** - Dry stains were found at the northeast subfloor with no elevated levels of moisture present at the time of inspection. Recommend reviewing any disclosure statements available and ask the property owner about past moisture intrusion in this area of the subfloor.

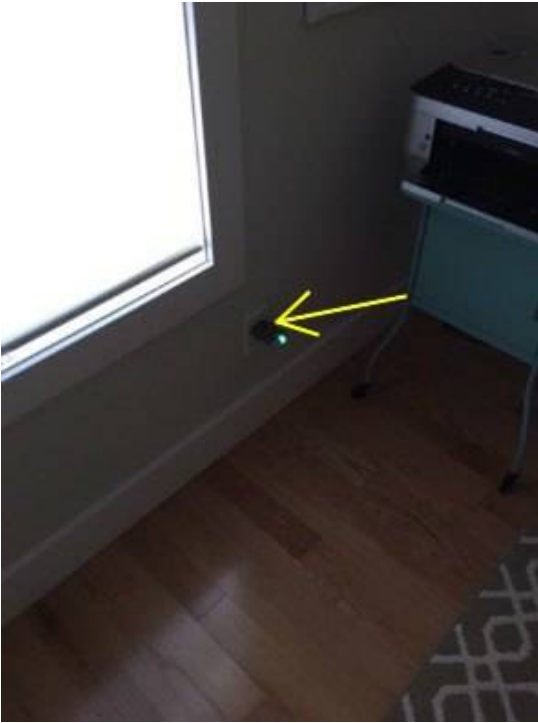
Photo 11-1

**11) Safety, Repair/Replace** - The receptacle on the south wall of the office was not securely anchored. Wire conductors can be damaged due to repeated movement or tension on wires. This is a shock and fire hazard. Recommend that a qualified electrician repair as necessary.

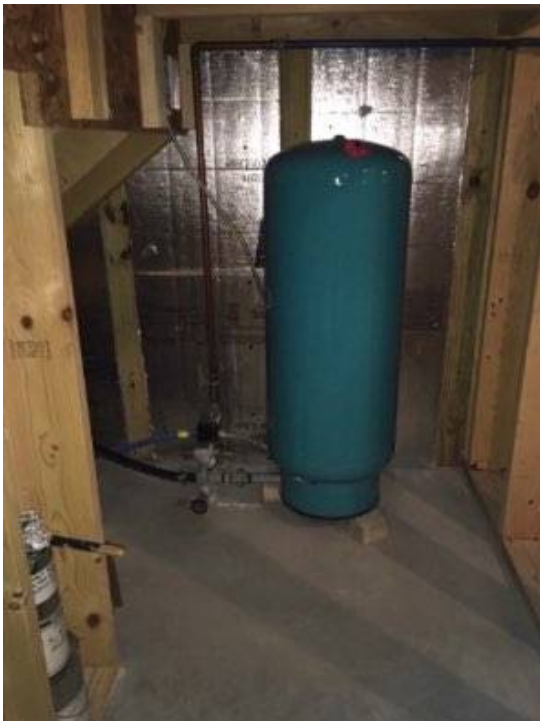
**Photo 12-1**

**12) Evaluate** - Based on visible equipment or information provided to the inspector, the water supply to this property appeared to be from a private well. Private well water supplies are specialty systems and are excluded from this inspection. Comments in this report related to this system are made as a courtesy only and are not meant to be a substitute for a full evaluation by a qualified specialist. The inspector does not test private well water for contamination or pollutants, determine if the supply and/or flow are adequate, or provide an estimate for remaining life of well pumps, pressure tanks or equipment. Only visible and accessible components are evaluated. Recommend the following:

- That a qualified well contractor fully evaluate the well, including a pump/flow test
- That the well water be tested per the client's concerns (coliforms, pH, contaminants, etc.)
- Research the well's history (how/when constructed, how/when maintained or repaired, past performance, past health issues)
- Document the current well capacity and water quality for future reference

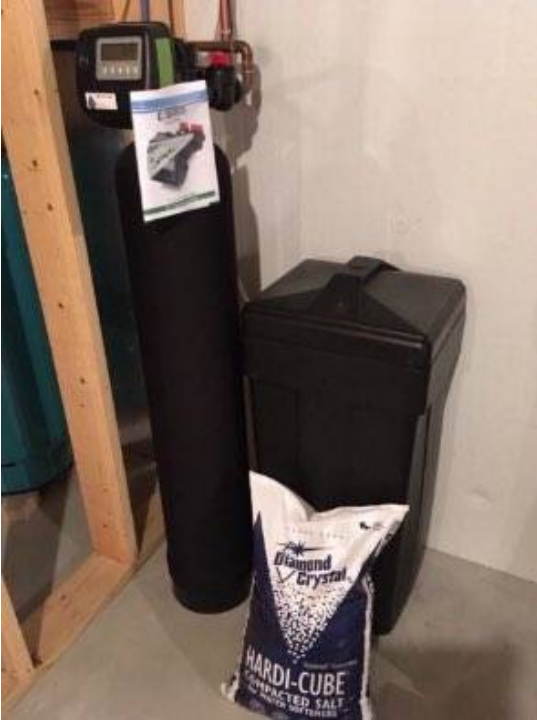
**Photo 13-1**

**13) Evaluate** - A water softener system was installed on the premises. These are specialty systems and are excluded from this inspection. Comments in this report related to this system are made as a courtesy only and are not meant to be a substitute for a full evaluation by a qualified specialist. Water softeners typically work by removing unwanted minerals (e.g. calcium, magnesium) from the water supply. They prevent build-up of scale inside water supply pipes, improve lathering while washing, and prevent spots on dishes. Recommend consulting with the property owner about this system to determine its condition, required maintenance, age, expected remaining life, etc. For more information, visit:

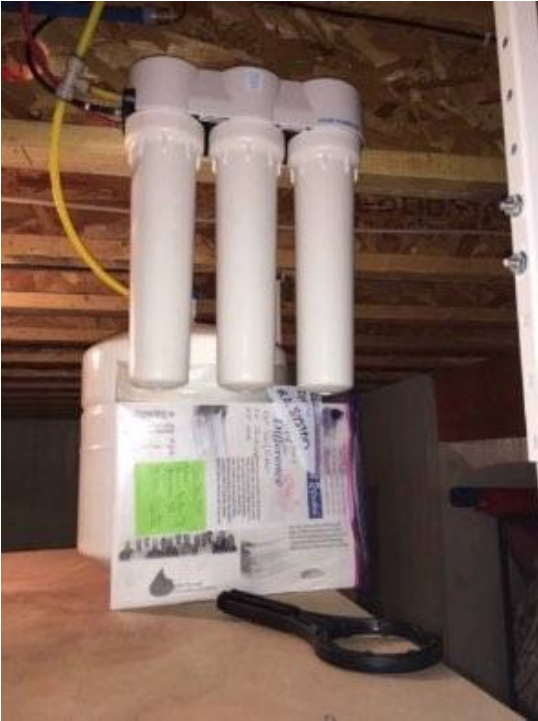
**Photo 14-1**

**14) Evaluate** - A water filtration system was installed on the premises. These are specialty systems and are excluded from this inspection. Comments in this report related to this system are made as a courtesy only and are not meant to be a substitute for a full evaluation by a qualified specialist. Filter cartridges typically need replacing periodically. Cleaning and other maintenance may also be needed. Recommend consulting with the property owner about this system to determine its condition, required maintenance, age, expected remaining life, etc. For more information, visit:

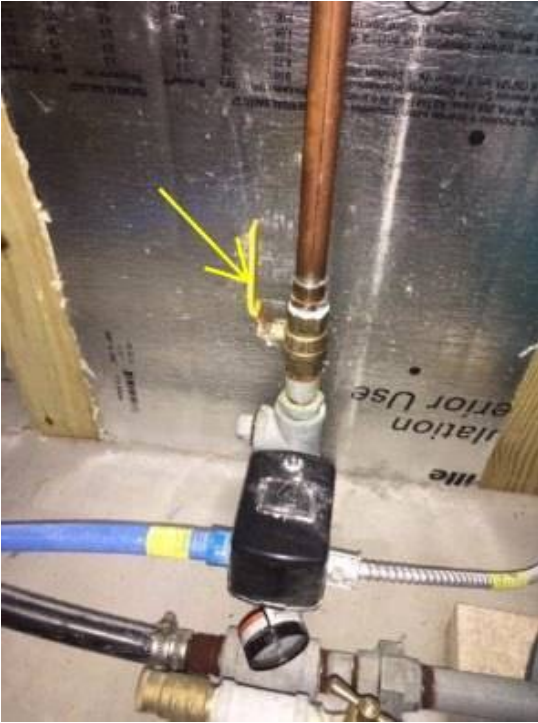
Photo 15-1

**15) Comment** - The water main shut-off valve for the home is located in the basement, under the steps on the southwest wall.

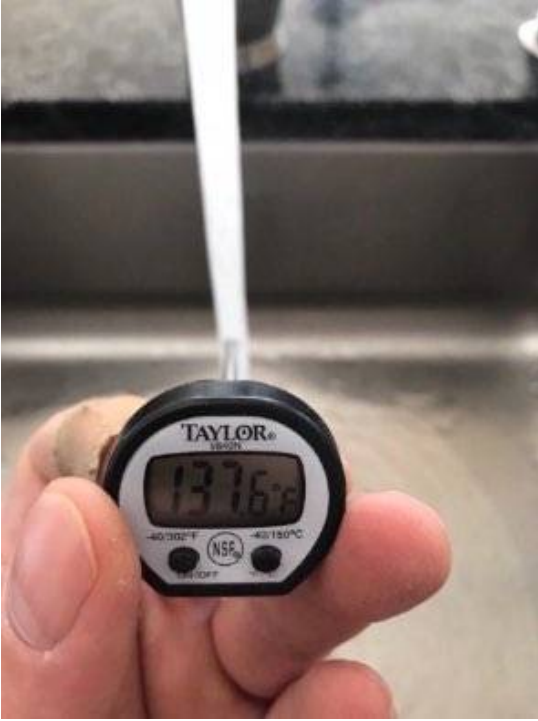
**Photo 16-1**

**16) Safety** - The hot water temperature was greater than 120 degrees Fahrenheit. This is a safety hazard due to the risk of scalding. The thermostat should be adjusted so the water temperature doesn't exceed 120 degrees. If the water heater is powered by electricity, a qualified person should perform the adjustment, since covers that expose energized equipment normally need to be removed. For more information on scalding dangers, visit:

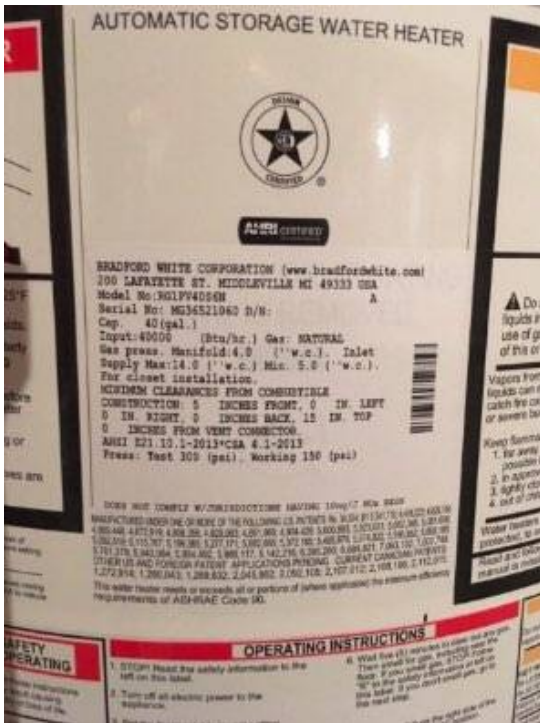
Photo 17-1

**17) Serviceable** - The water heater appeared to be serviceable at the time of inspection.

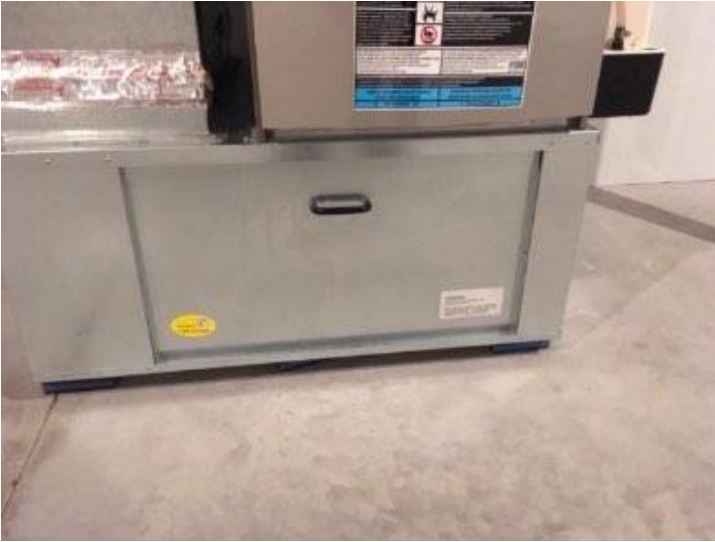
**Photo 18-1**

**18) Maintain** - Recommend that home buyers replace or clean HVAC filters upon taking occupancy depending on the type of filters installed. Regardless of the type, recommend checking filters monthly in the future and replacing or cleaning them as necessary. How frequently they need replacing or cleaning depends on the type and quality of the filter, how the system is configured (e.g. always on vs. "Auto"), and on environmental factors (e.g. pets, smoking, frequency of house cleaning, number of occupants, the season).

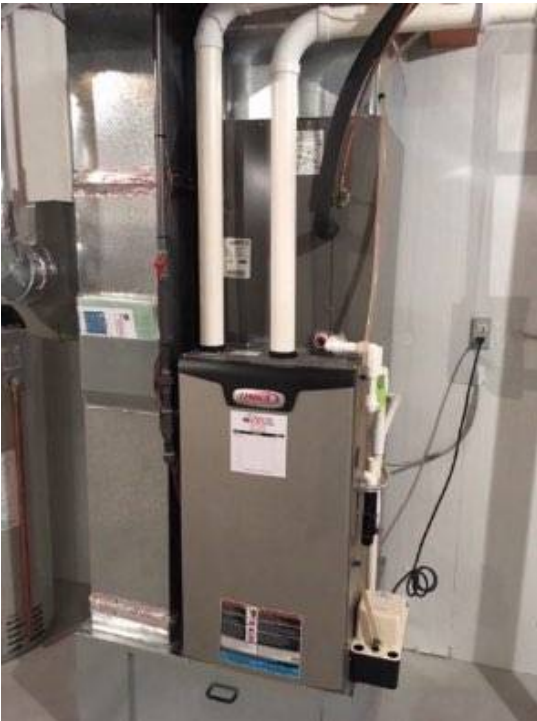
**Photo 19-1**

**19) Serviceable** - The gas-fired, forced air furnace, appeared to be serviceable at the time of inspection.

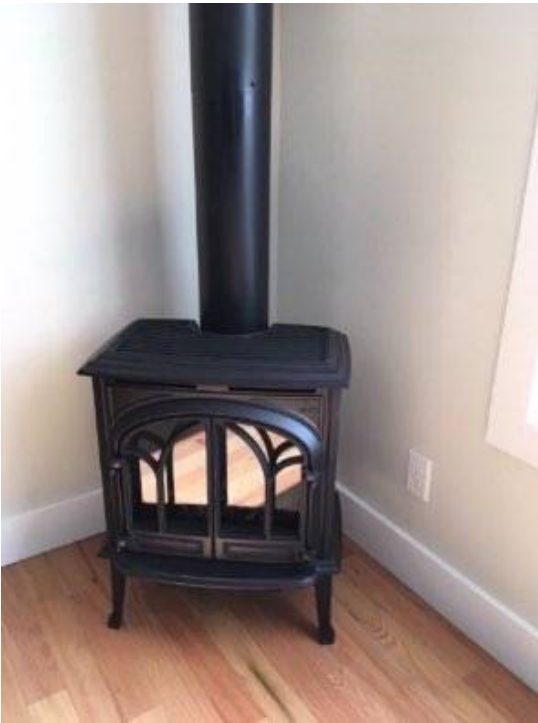
**Photo 20-1**

**20) Serviceable** - The free-standing, gas-fired stove appeared to be serviceable at the time of inspection.

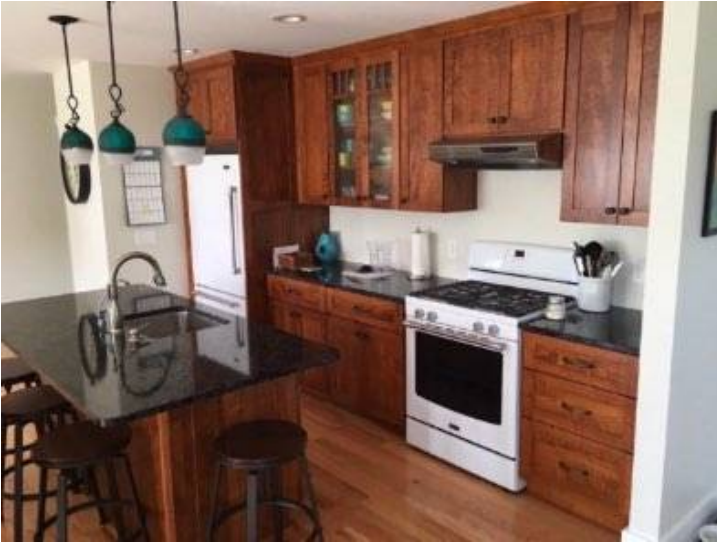
Photo 21-1

21) - The kitchen and the components therein appeared to be serviceable at the time of inspection.

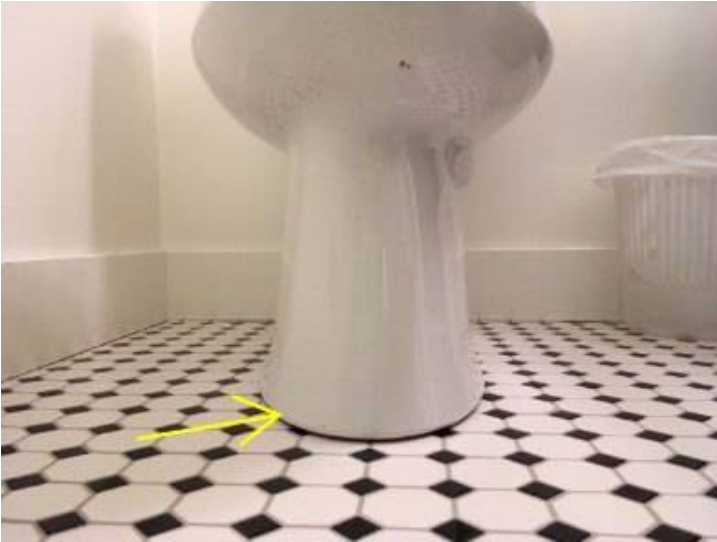
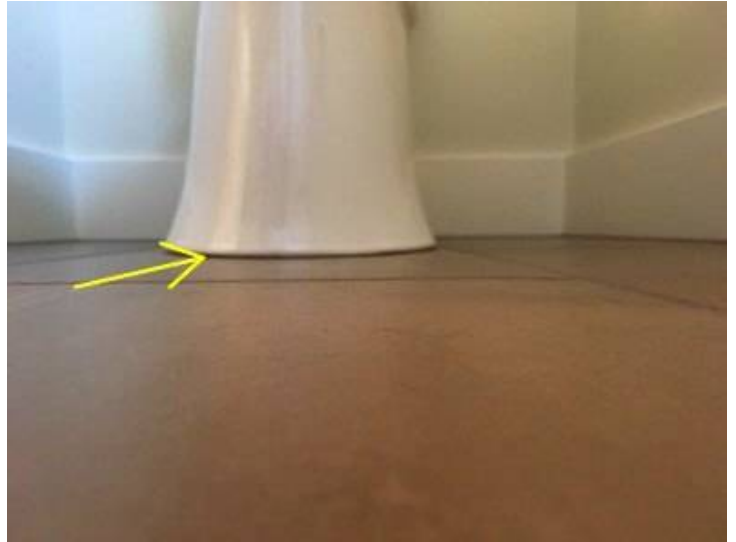
Photo 22-1

**22) Repair/Maintain** - Caulk around the base of the toilet at locations A and B was missing. Modern standards require caulk to be installed around the entire toilet base where it meets the floor for sanitary reasons. Without it, soiled water can soak into flooring and sub-floor materials if the toilet overflows. Condensation from the toilet can also soak into the flooring. Recommend that a qualified person caulks around toilet bases per standard building practices.

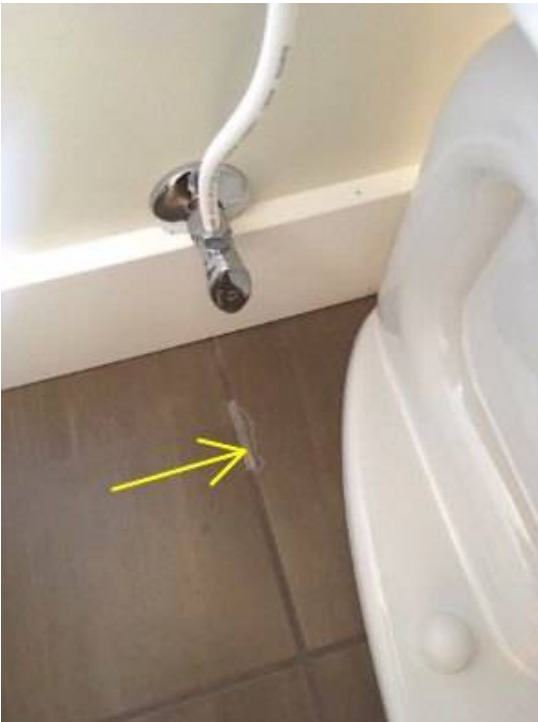
Photo 23-1

**23) Evaluate** - A dry water mark was found below the shut-off valve and supply line for the toilet at location B. Recommend an evaluation to determine the cause of the mark. Repairs, if necessary, should be performed by a qualified plumber.

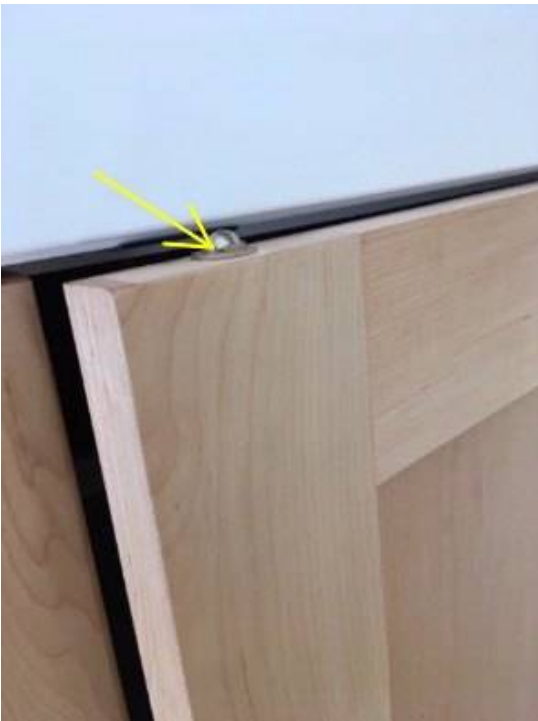
**Photo 24-1**

**24) Repair/Maintain** - The master closet door wouldn't latch. Recommend that a qualified person repair as necessary. For example, by adjusting ball catch.
