# **INTEGRATED MANAGEMENT PLAN FOR AQUATIC WEEDS FOR THE TAHOE KEYS LAGOONS**

PREPARED PURSUANT TO  
CALIFORNIA REGIONAL WATER QUALITY CONTROL BOARD  
LAHONTAN REGION  
BOARD ORDER NO. R6T-2014-0059

Prepared by  
Tahoe Keys Property Owners Association

UPDATE  
**JANUARY 2026**

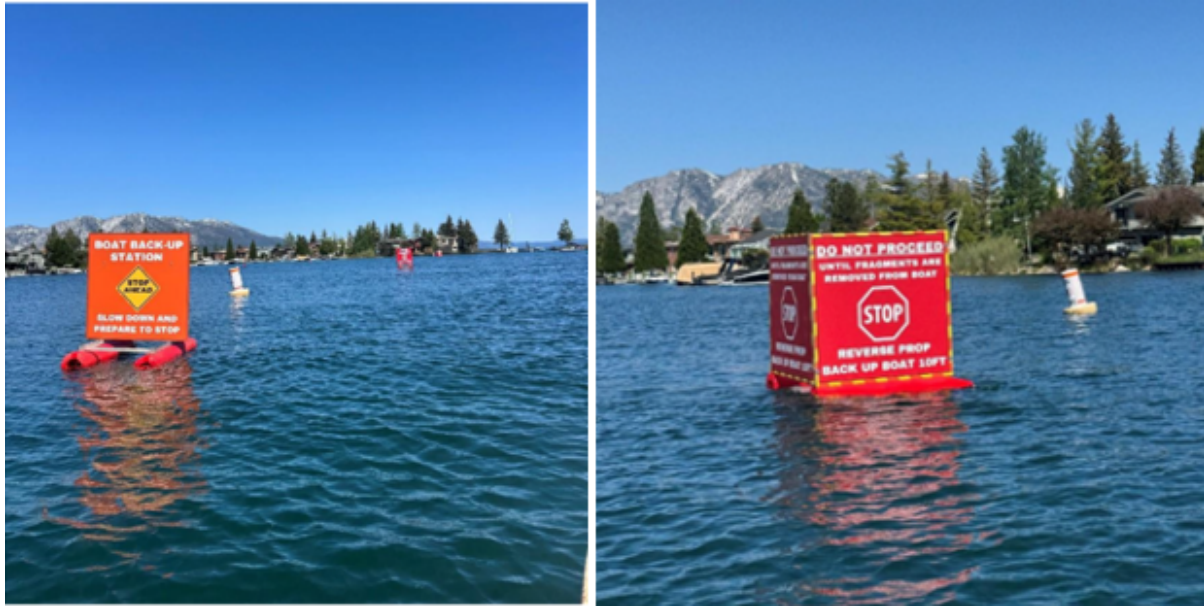
**Figure 12. Boat Back-Up Station signage.**

The buoys and directional signage were installed in the West Channel in May 2025 and removed late October 2025. For the 2025 season, TKPOA stationed a skimming vessel at the channel entrance five days a week to remove fragments that get dislodged from boat propellers and encourage all boaters to use the Boat Back-Up Station. The majority of boaters used the Boat Back-Up Station without needing prompting from stationed water quality staff. Homeowners are continuing to take more responsibility and ownership of the Boat Back-Up Station by encouraging others to adhere to it.

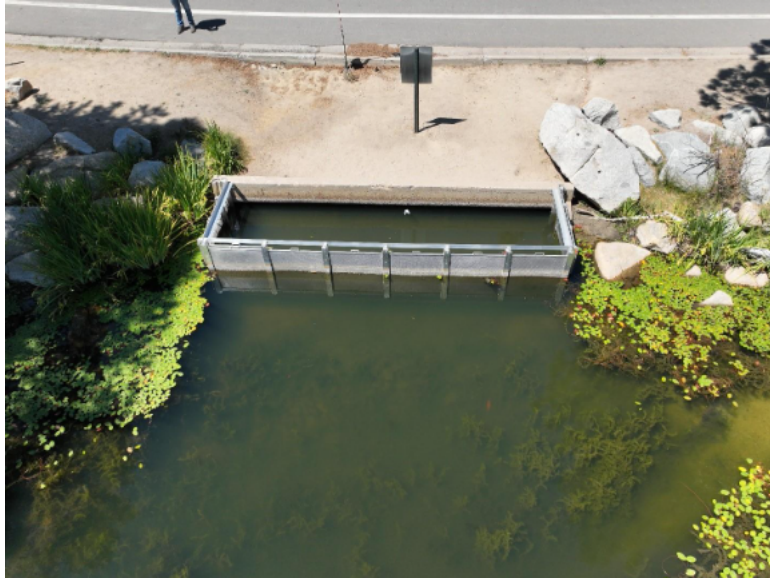
**Figure 14. The 15<sup>th</sup> Street screening system.**

The Lake Tallac to Pope Marsh connection was identified as an urgent containment point. In 2025, a custom screen system was fabricated and installed to prevent fragment transport from Lake Tallac through a culvert into the 15<sup>th</sup> St. Lagoon (Figure 14). A removable grate was later installed across the top to prevent any animals or fragments from moving up and over the screens to ensure a secure barrier. In collaboration with Tahoe Regional Planning Agency (TRPA), Tahoe Resource Conservation District (TRCD), and the United States Forest Service (USFS), screening at the weir from the 15<sup>th</sup> St Lagoon into Pope Marsh was also updated to a similar barrier. This two-screening system isolate the 15<sup>th</sup> St. Lagoon and inhibits flowing fragments from causing further infestation. This isolation is aimed to bolster future AIS eradication efforts and ultimately provide a 2-step barrier system preventing the spread of AIS into Pope Marsh. Both screening systems are checked weekly for blockages or damage.

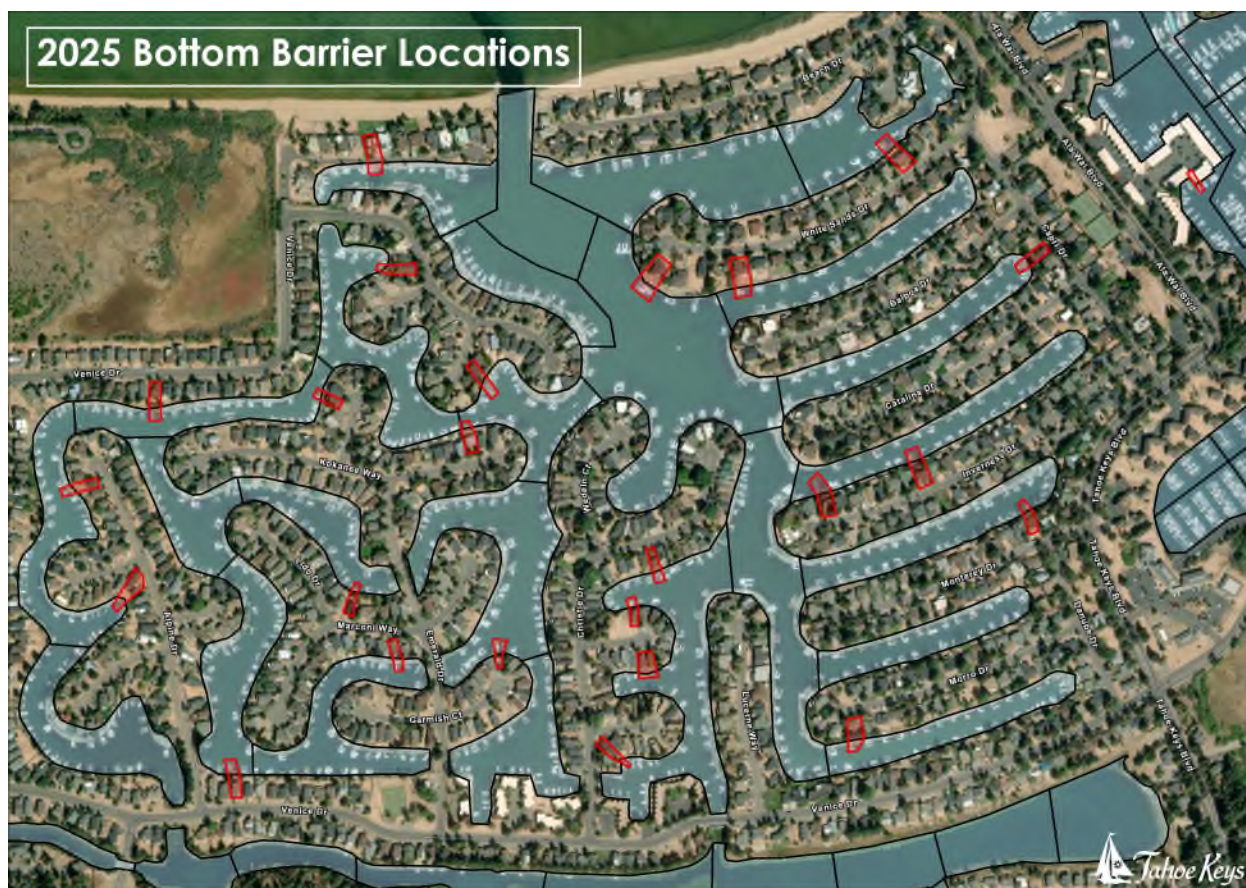
**Figure 15. Map of bottom barrier locations installed in 2025.**

In 2025, 25 homeowners installed bottom barriers around their dock space totaling more than 14,000 sq ft throughout the lagoons. Figure 15 shows bottom barrier locations. Installation was within the May through June window and removal occurred at the end of October and early November. The bottom barrier materials were 5ft x 10ft modular panels heavily weighted with metal anchors. The barriers were not staked down nor was there any loose material such as rocks used. There were no reports of lifting or maintenance needed once in place. After removal, inspection of what was underneath showed decomposing material with no signs of living plants.

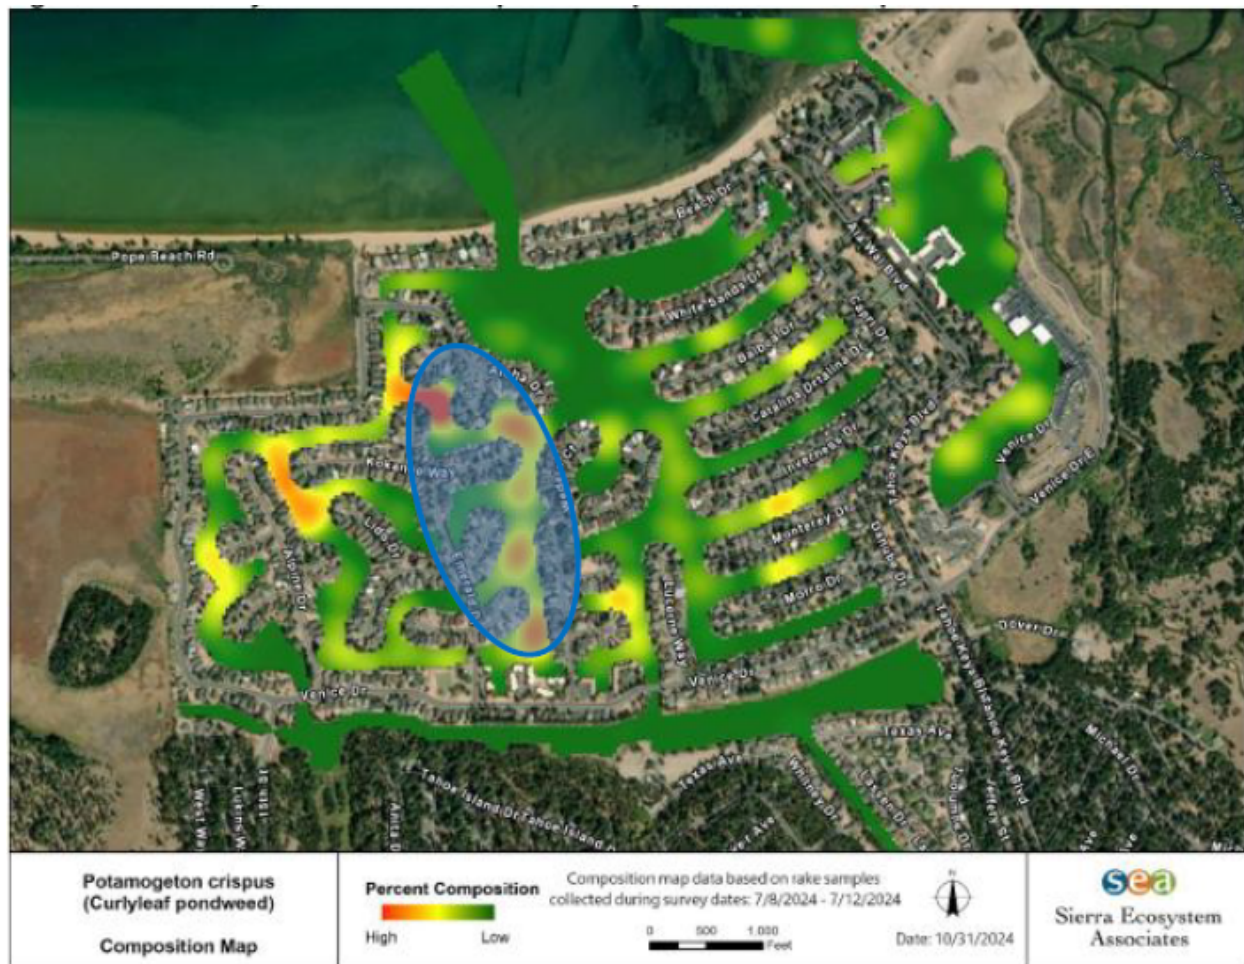
**Figure 16. Curlyleaf pondweed 2024 mid-season composition map used to identify curlyleaf pondweed 'hotspots'. Blue oval indicates area targeted for 2025 UV-C treatments.**

The 2024 mid-season (July) curlyleaf pondweed composition map (Figure 16) shows a series of ‘hotspots’ in the central and western part of the West Lagoon. In 2025, approximately 6.9 acres were treated three times (totaling 20.7 acres) with UV-C between May 5<sup>th</sup> to October 23<sup>rd</sup>, targeting the curlyleaf pondweed ‘hotspots’ that were identified in 2024. These ‘hotspots’ are shown within the blue oval area in Figure 16. This group of ‘hotspots’ was selected because it represented the greatest risk of spreading and fragment generation closest to the West Channel. Also see Figure 1, which identifies the specific zones within the West Lagoon where UV was deployed in 2025. Figure 17 shows the mid-season curlyleaf pondweed composition in 2025, indicating that by July the UV-C treatments had reduced the area and number of ‘hotspots’ in the target area.

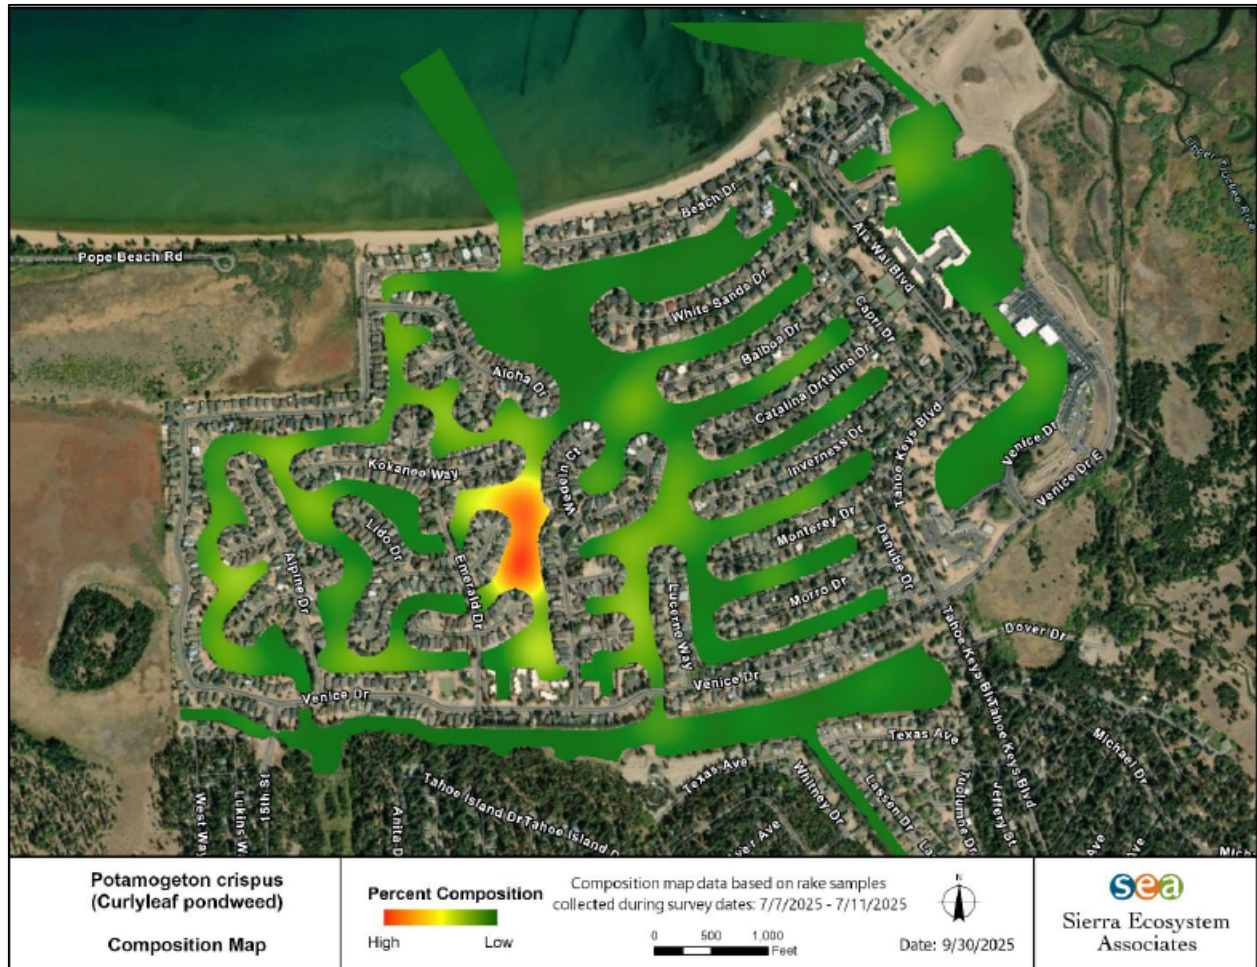
Figure 17. Curlyleaf pondweed mid-2025 season composition map used to identify curlyleaf pondweed 'hotspots'.

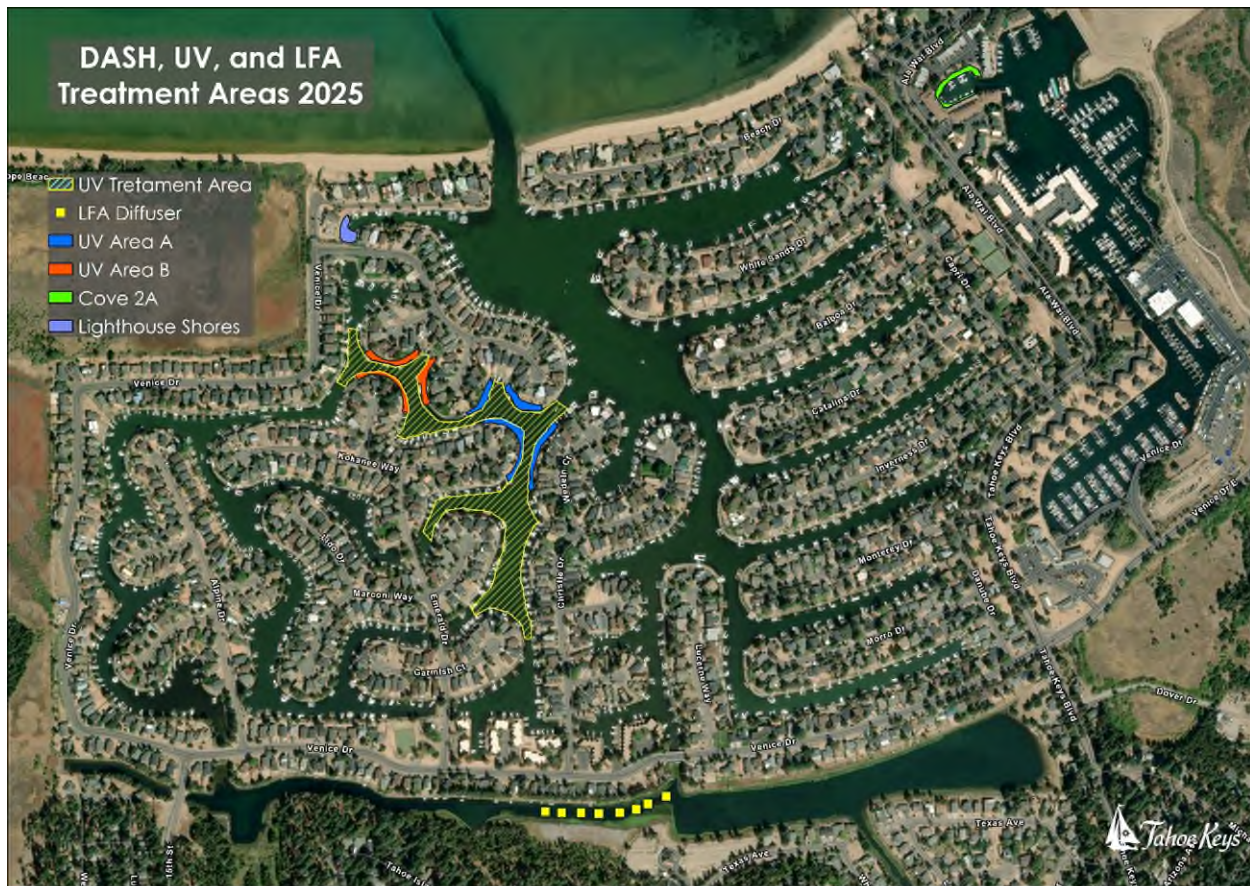
**Figure 18. Map of DASH, UV-C, and LFA treatment areas in 2025.**

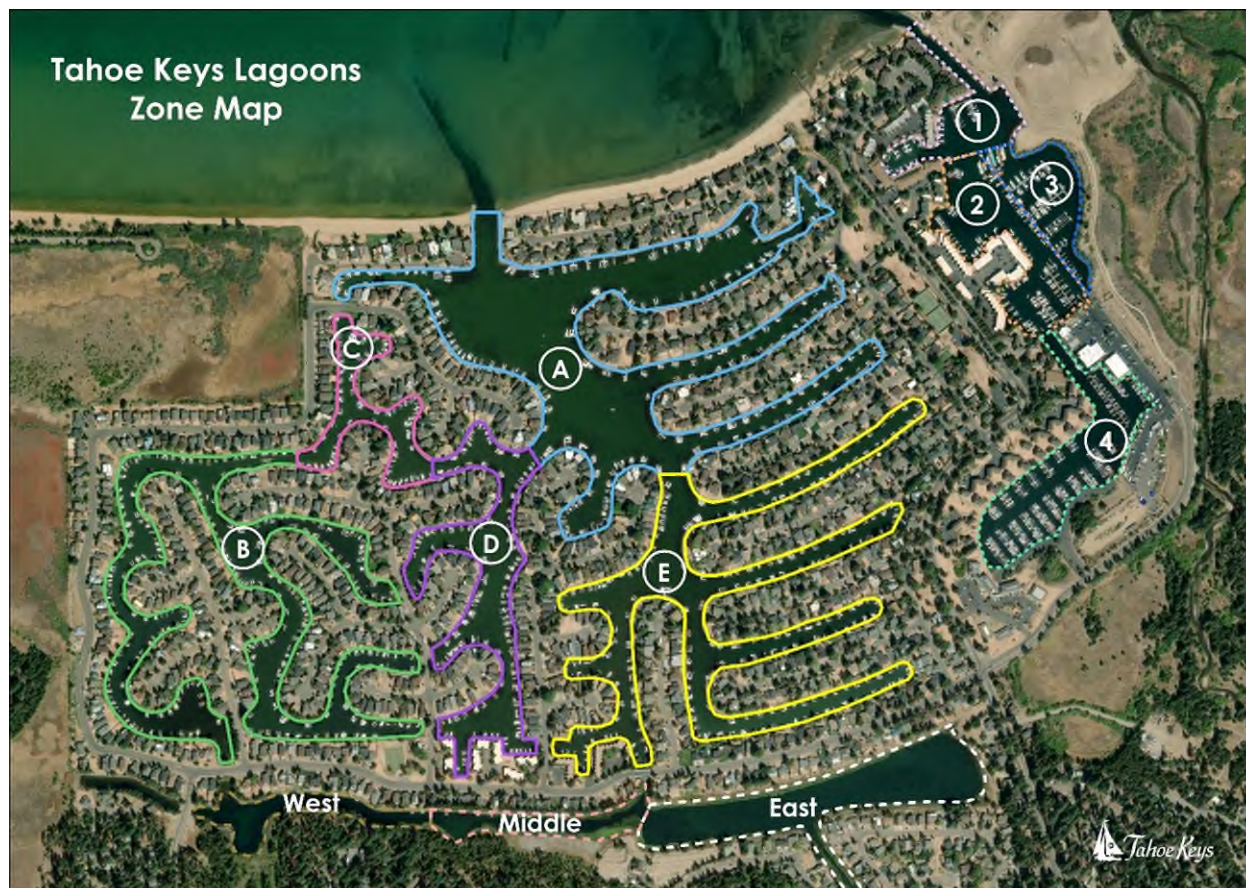
**Figure 23. Tahoe Keys Lagoons zone map created in 2025 for consistent identification and grouping of lagoon areas used in planning and percent biovolume analyses.**

In 2025, a new zone map was created to better identify the locations around the lagoons. This map will be used going forward for all future planning and composition determinations of lagoon characteristics (Figure 23). Figure 24, 25, and 26 display percent biovolume data scanned within the water column and grouped in accordance with these zones.

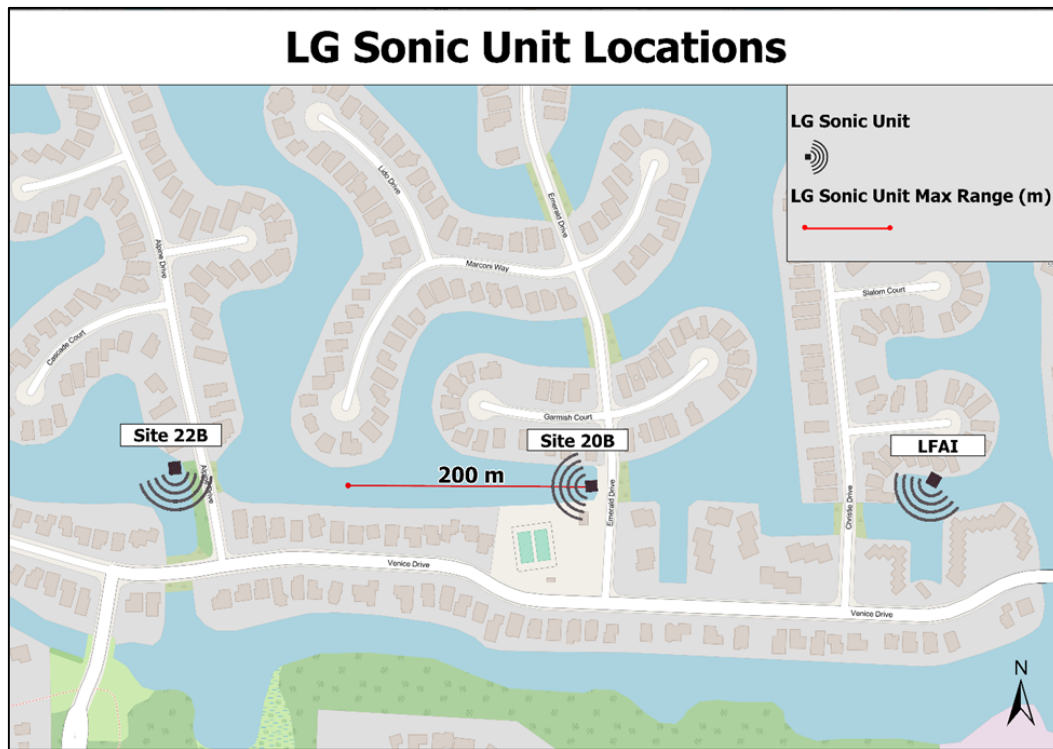
**Figure 28. LG Sonic unit locations. In 2025, units were placed in Site 20B and Site LFAI.**

Two ultrasonic units were first installed in June 2023 on a dock in CMT Site 5 and CMT Site 13, which are both dead-end areas known to have frequent cyanobacteria blooms (Figure 28). Both units were removed in October 2023. They were reinstalled in June 2024 in the same sites for consistency and again removed in October 2024. In 2025, one unit was placed in Site LFAI instead of CMT Site 5 (now called Site 22B, see Figure 29). The purpose of this switch was because TKPOA has historical HABS data in Site LFAI to better compare before and after use of ultrasound technology. Another unit was continued in CMT Site 13 (now Site 20B, see Figure 29). Before use, the units were calibrated using factory settings as instructed by the equipment manual. The device was visually monitored throughout the season and HAB sampling occurred for analysis. The device was simple to install, unobtrusive, and will continue to be used in future seasons.

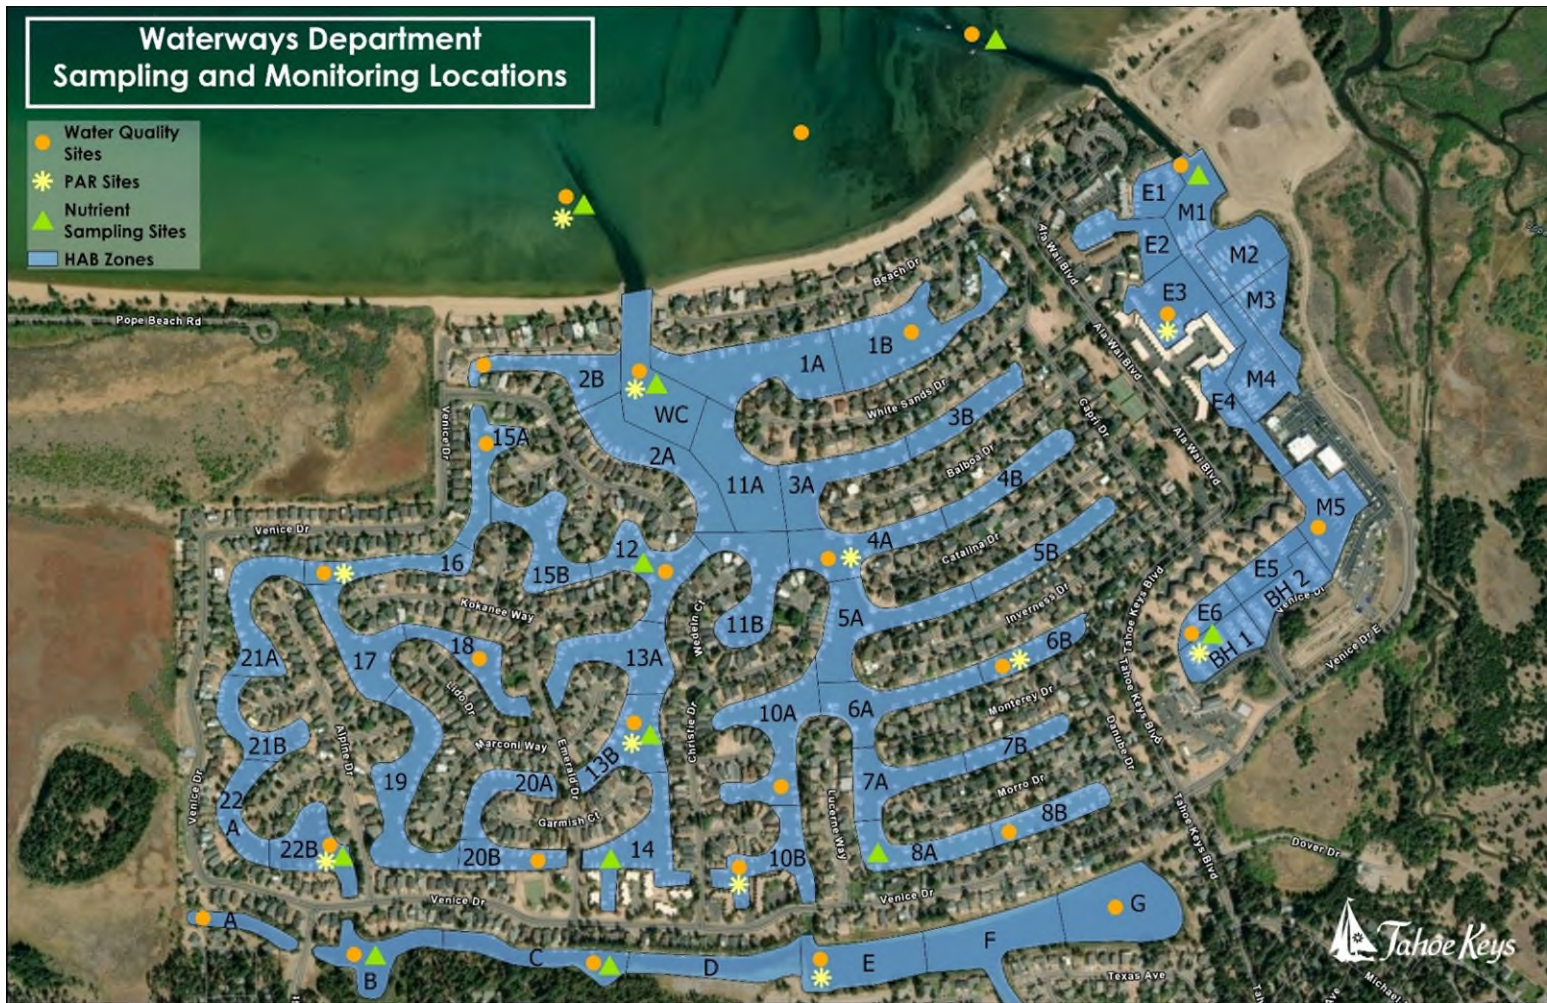
Figure 29. TKPOA Waterways Department sampling and monitoring locations for 2025.

From 2022 to 2024, water quality monitoring occurred according to the CMT monitoring schedule. In 2025, the Baseline Water Quality Sampling/Monitoring Program that began in 2016 was resumed. The original program had 16 sites, but in 2025, 11 sites were added to include more areas of each lagoon. Figure 29 shows the monitoring and sampling locations around the lagoons. Water quality data was measured at surface, middle, and bottom depths of the water column. Nutrient samples were taken three times on June 23, September 9, and October 23 of 2025. Results for nutrients are reported in the Nonpoint Source (NPS) Annual Report submitted by TKPOA (2026) as part of the NPS component of the WDR. In addition to water quality monitoring and nutrient sampling, TKPOA continued its photosynthetically active radiation (PAR) monitoring, initiated in the CMT, on a monthly basis. Results are separated by water body; West Lagoon, East Lagoon, Tahoe, and Lake Tallac.

In 2025, TKPOA operated LFA in one location in the Lake Tallac Lagoon that was installed in December 2022 (now known as Site D, see Figure 29).

After 6 years at the longest-running site (Site 10A and 10B, see Figure 29), there was no measurable change in the organic sediment layer. There was no evidence to suggest that these systems effectively reduce plant growth or organic sediment accumulation. In fact, evidence to suggest that the LFA converts nutrients to a more readily available form is most likely occurring (EMKO, 2025a). Visual observations of denser plant growth around aerators support this.

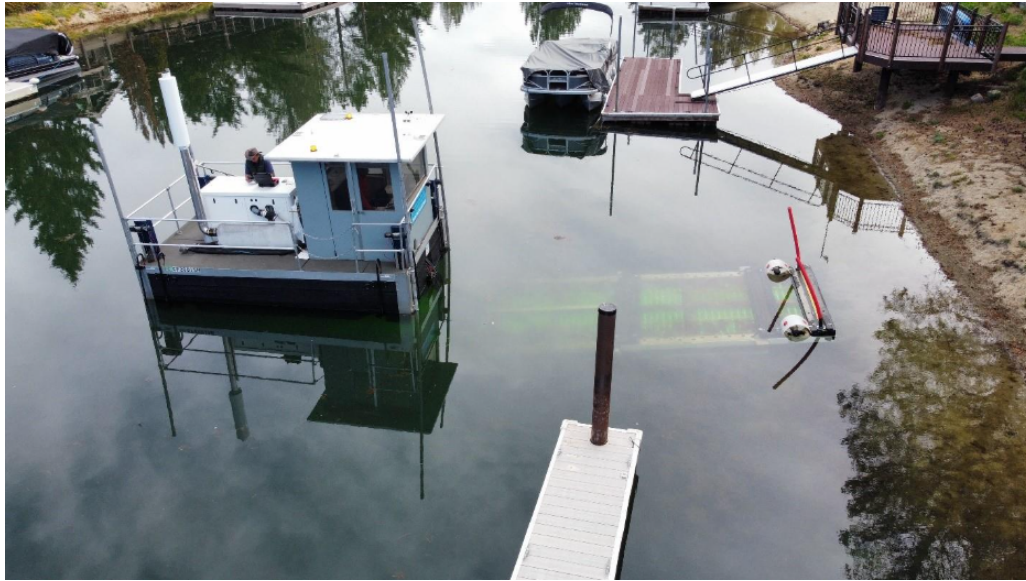
**Figure 39. UV-C treatment vessel. Photo credit: John Paoluccio, Inventive Resources, Inc.**

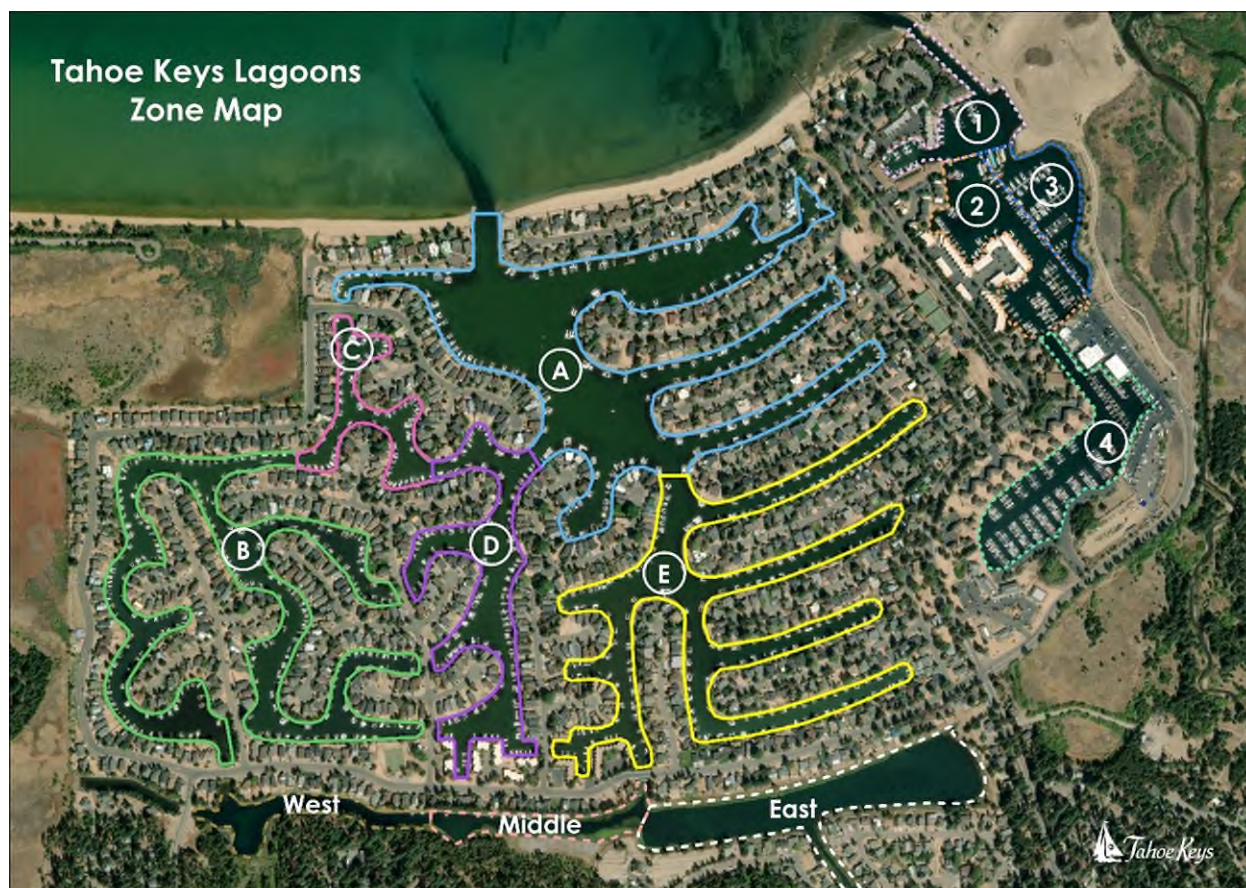
Figure 40. Tahoe Keys Lagoons zone map, created in 2025.

Vessel Hull Clearance was calculated using data from hydroacoustic scanning described in section 3.2. The scans provide depth to top of plant canopy and depth to lagoon bottom values along the scan track. These numbers are averaged within each zone and plotted on graphs. With dense weed growth, depth to lagoon bottom values become inaccurate as the transducer has difficulty scanning all the way through the plant mass. The water column depth values on these graphs are therefore an estimation and water level should be checked against established staff gauges for accurate depth readings. Depth to top of plant canopy has not shown signs of inconsistency and can be considered true value.

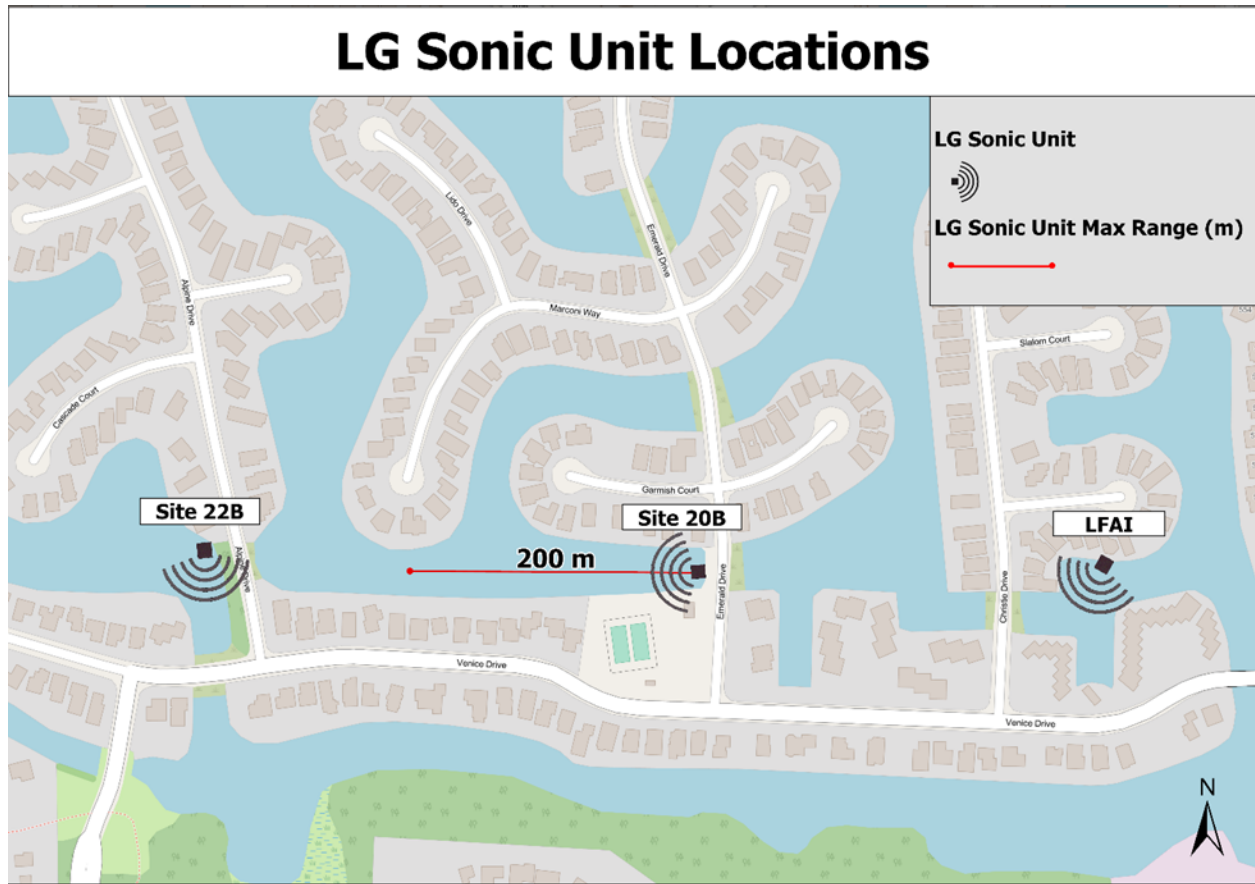
**Figure 53. LG Sonic Unit Locations**

Two ultrasonic units were first installed in June 2023 on a dock in Site 22B and nearshore in Site 20B. Both units were removed in October 2023. They were reinstalled in June 2024 in the same sites for consistency and again removed in October 2024. In 2025, one unit was placed in Site LFAI instead of Site 22B. The purpose of this switch was because TKPOA has historical HABs data in Site LFAI to better compare before and after use of ultrasonic technology. Another unit was continued in Site 20B.

Site 22B and Site 20B were initially determined optimal test sites due to their dead-end locations as well as previous years' HABs occurrences. In 2025, Site LFAI also became an optimal site for testing ultrasonic technology. Site 20B had a power source close by from the TKPOA Pumphouse and homeowners gave permission to use their dock and electricity in Site 22B and LFAI. Site locations are shown in Figure 1.

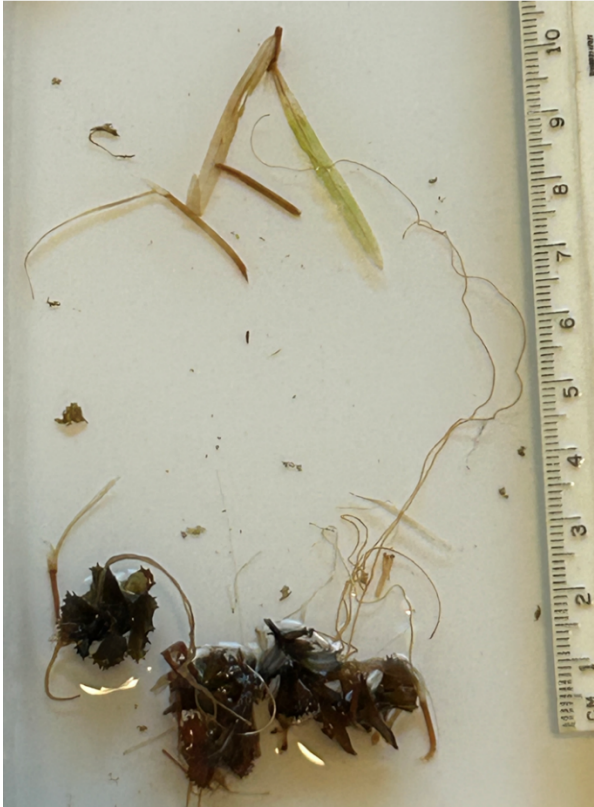
Figure 60. Plant Length measurement method

- Curlyleaf pondweed turions were collected from CMT Control Sites (September 2024)
- Sprouted for 10-12 days (October 5-15 (Figure 1))
- Three separate mesocosms were used: Controls (no ProcellaCOR); 5 ppb ProcellaCOR; 10 ppb ProcellaCOR
- Three replicate treatments occurred for each of the three separate mesocosms
- Temperature recorded hourly
- Plant lengths were measured, number of leaves formed were counted, and plants were photographed for each mesocosm and replicate

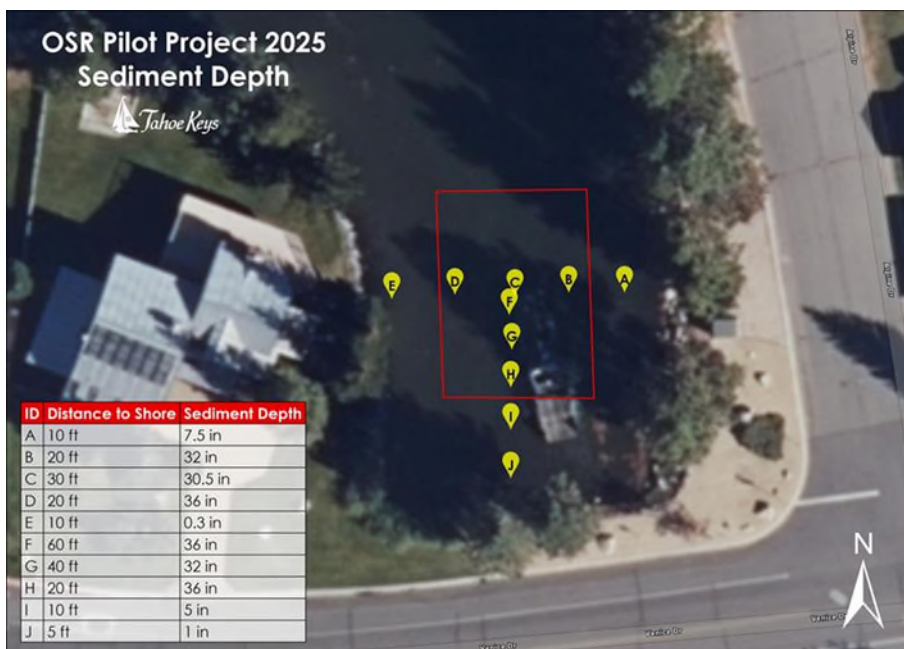
Figure 1. Sediment depths at dredging site of OSR Pilot Project

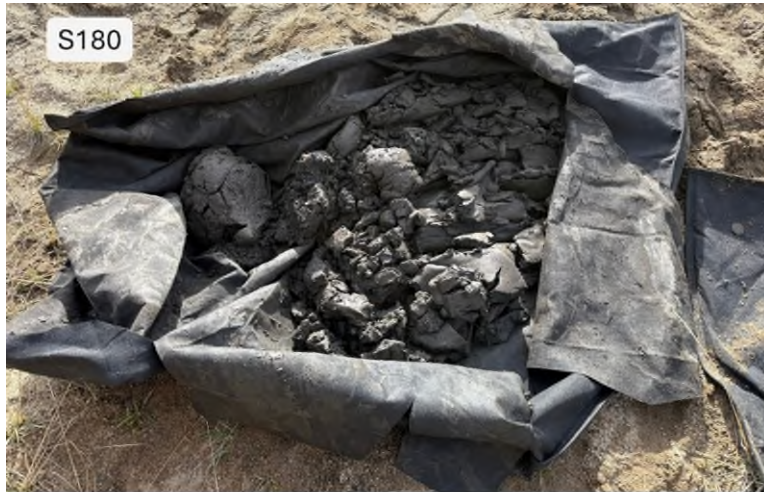
Figure 2. Sediment captured in S1.80

Two hundred seventy-five gallons of sediment-water mixture from the IBC totes were gravity fed through the 80 US Sieve dewatering bag. Weights were placed on top of the bag to press out the water. Fifty gallons remained in the dewatering bag and 200 gallons of filtrate were collected. Organic sediment captured in the dewatering bag had a thick clay-like consistency with no turions observed (Figure 2).

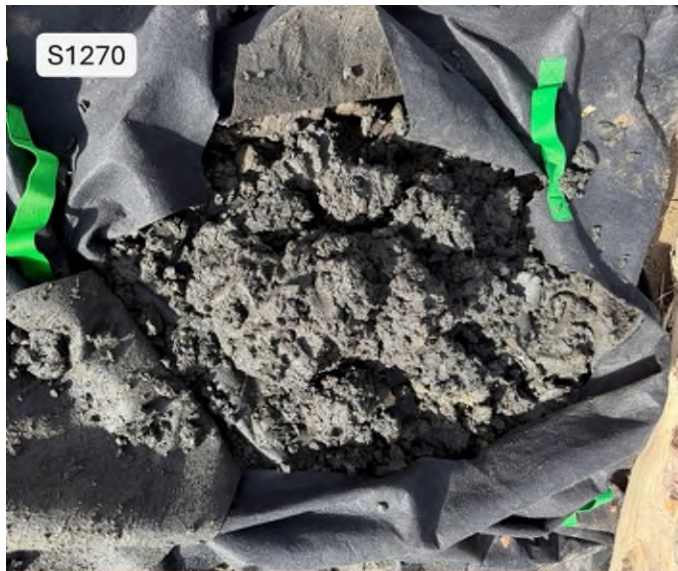
**Figure 3. Sediment captured in S1.270**

Two hundred seventy-five gallons of sediment-water mixture from the IBC totes were gravity-fed through the 270 US Sieve dewatering bag. Initially, 80 gallons of filtrate were collected. Organic sediment captured in the dewatering bag had a thick clay-like consistency with no turions observed (Figure 3).

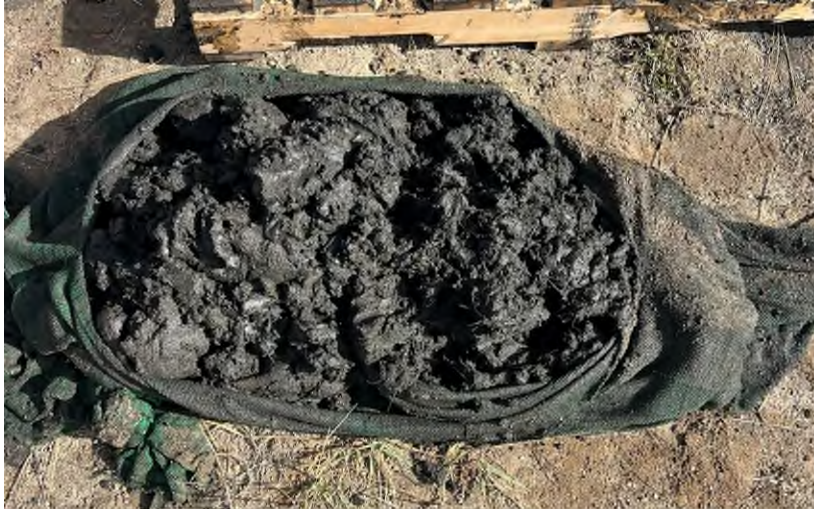
**Figure 4. Sediment captured in S2.270.net**

Two hundred seventy-five gallons of sediment-water mixture from the IBC totes were gravity fed through the 1/8-inch hole netting. Organic sediment captured in the netting contained plant fibers, rocks and approximately ten turions (Figure 4).

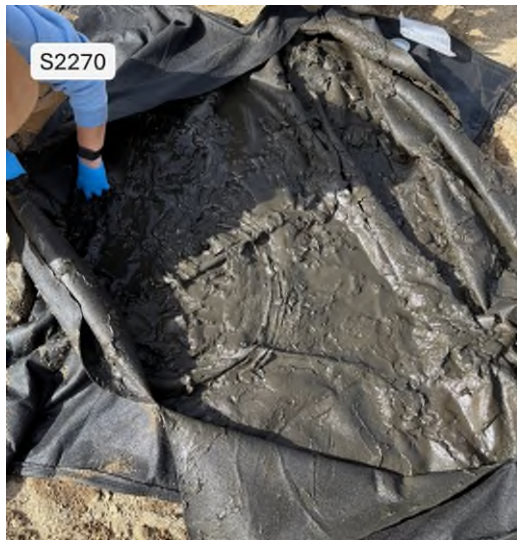
**Figure 5. Sediment captured in S2.270**

The filtrate from the 1/8-inch hole netting was gravity fed through the 270 US Sieve dewatering bag. Organic sediment captured in the dewatering bag had a fine clay texture with no turions observed (Figure 5).

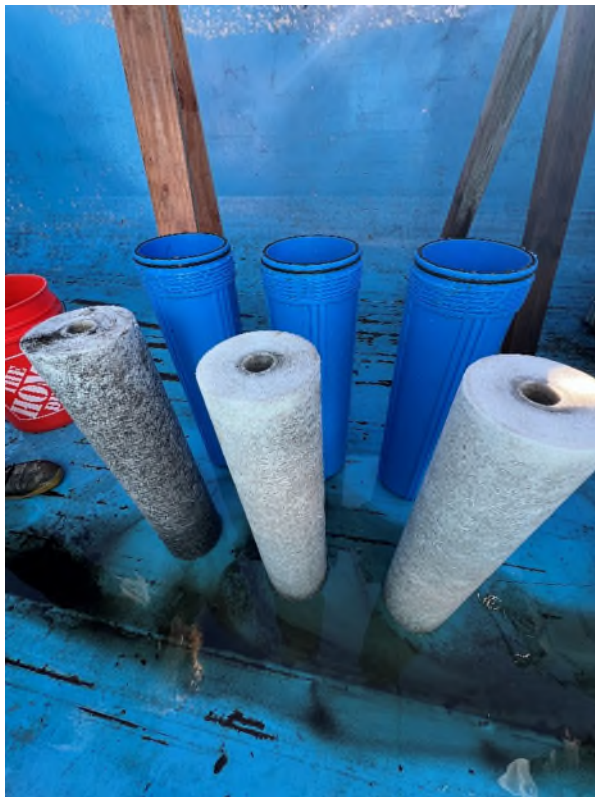
**Figure 6. Sediment captured in the three 500 US Sieve filter cartridges**

The filtrate from S1.80.v2 was pumped through three 500 US Sieve filter cartridges. There were no solids collected as the material was completely retained within the cartridges (Figure 6).

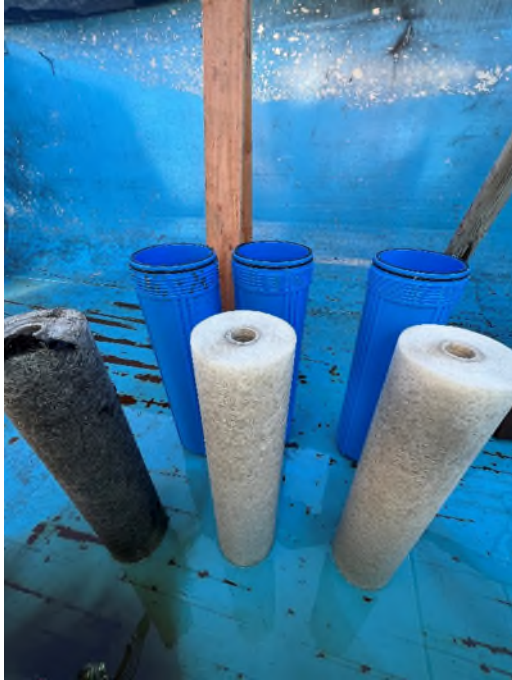
**Figure 7. Sediment captured in the three 500 US Sieve filter cartridges**

The filtrate from S1.270 was pumped through three 500 US Sieve filter cartridges. There were no solids collected as the material was completely retained within the cartridges (Figure 7).

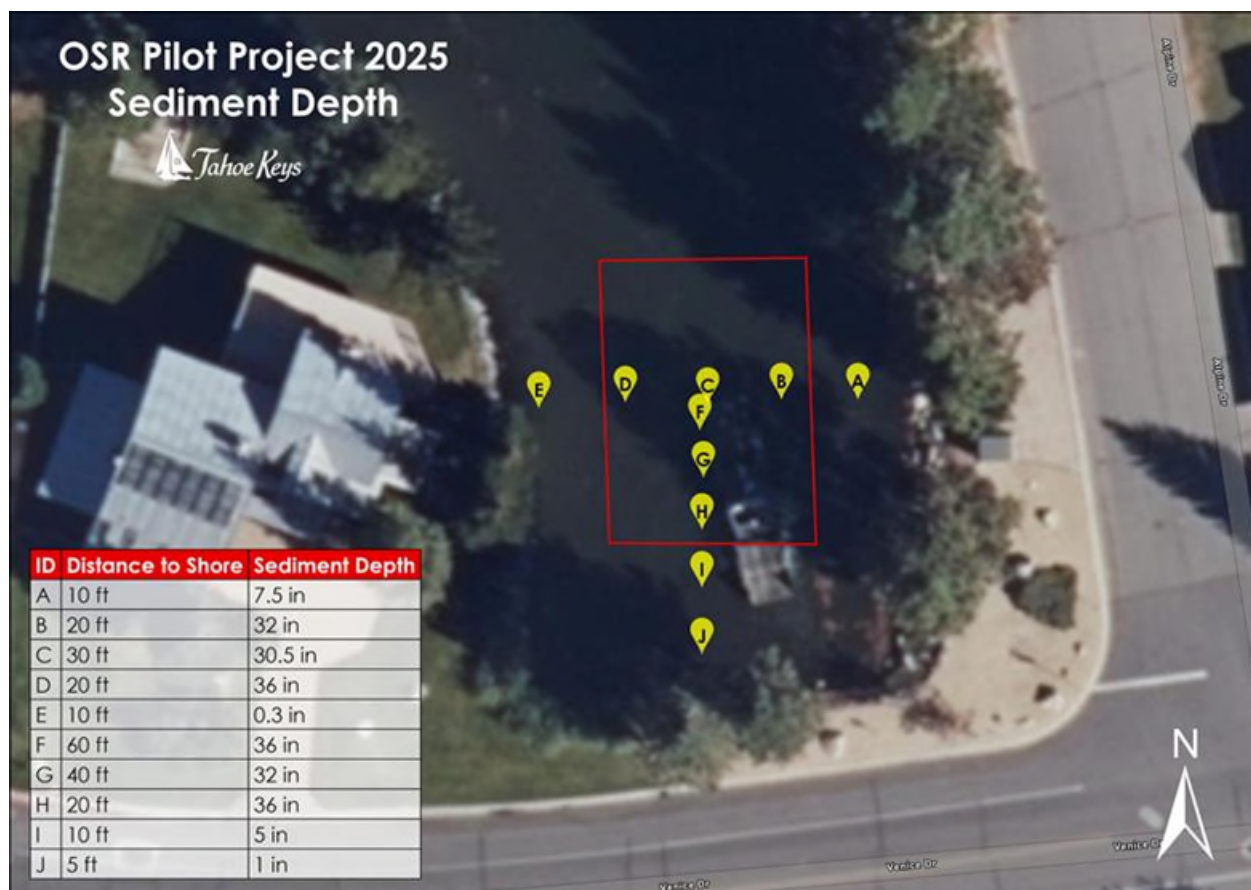
**Figure 66. OSR Pilot Project 2025 Sediment Depth**

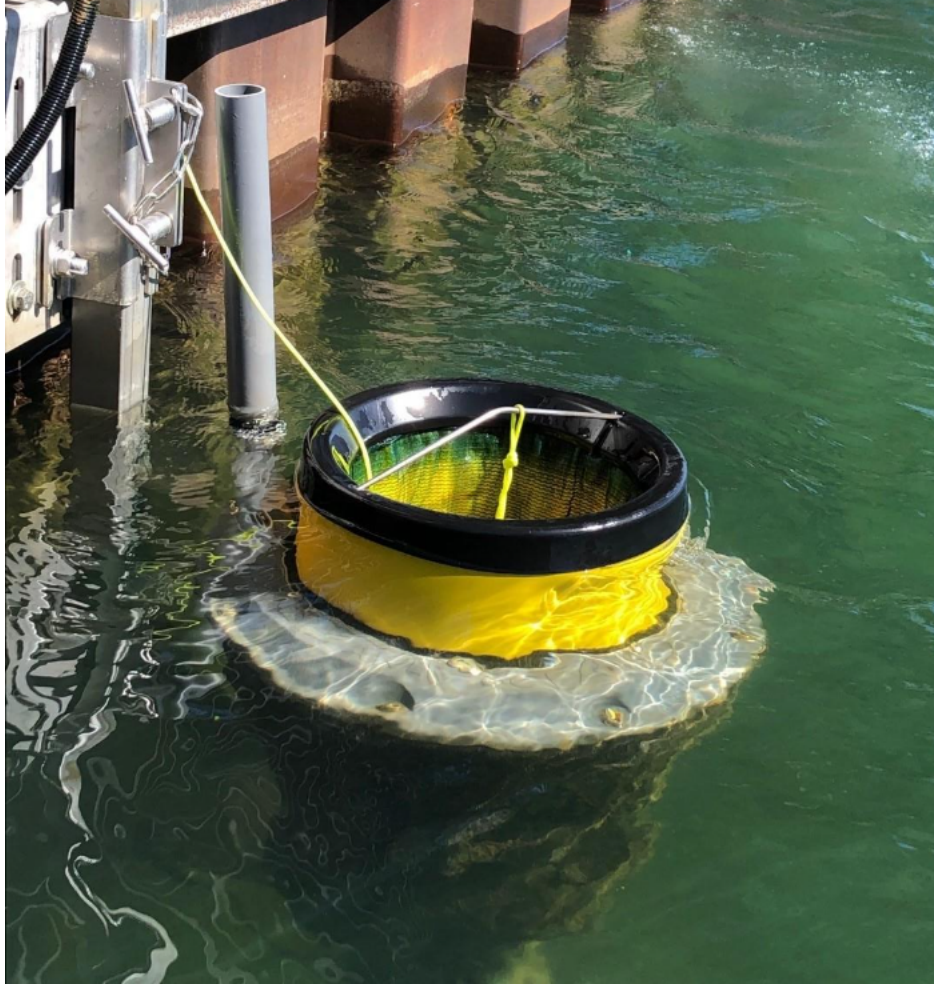
**Figure 67. Seabin attached to the West Channel bulkhead.**

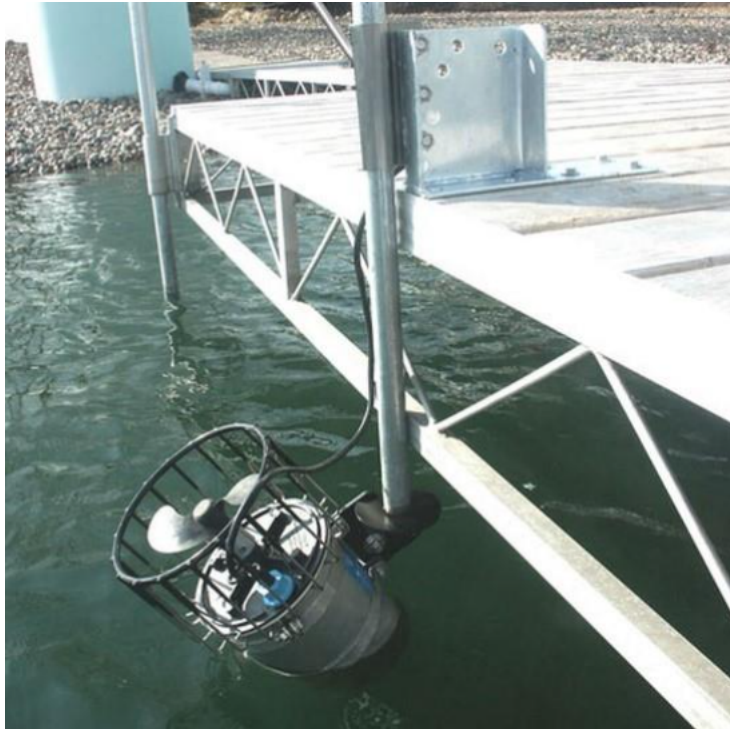
**Figure 68. Example of a dock bubbler**

In 2020, TKPOA began researching the potential use of dock bubblers to manage algae within the Keys Lagoons. This concept was first proposed to TKPOA's WQC in 2018-2019 by TKPOA residents. The 2020 TKPOA Water Quality Special Assessment ballot initiative included funding for the purchase of five dock bubblers (e.g., Figure 68) for installation in the West Lagoon. Installation of dock bubblers in Spring 2021 was postponed due to a combination of low water and limited staffing.

In 2022, TKPOA temporarily installed a type of dock bubbler on homeowners' docks in CMT combination UV-C/herbicide treatment sites to assist with mixing and dissipation of herbicides. No data was collected, and the bubblers were removed in late 2022. Deployment of dock bubblers is planned in future years in areas that may be prone to algal blooms. Dock bubblers were not employed starting in 2023 but may be used in the future.

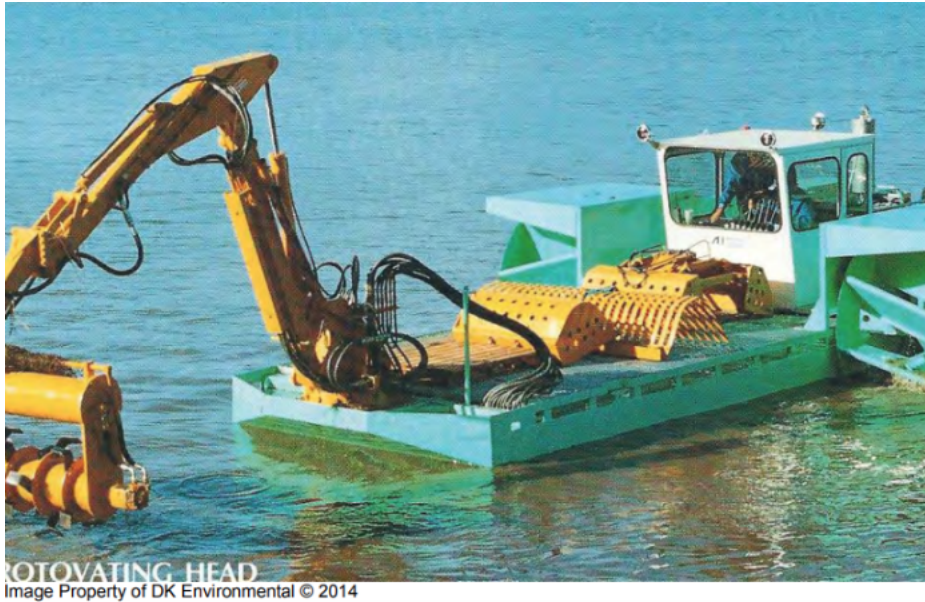
**Figure 69. Rotovator**

Rototilling underwater or rotovating describes underwater tillage of aquatic plants. Like tilling on land, rototilling tills the hydrosol to remove plants, particularly roots and rhizomes. This requires specialized machinery that can access aquatic weeds either from shore, or more typically, from a barge. The depth that the unit tills depend on the size of the tines used and typically rotovators till eight to 10 inches into the sediment or hydrosol. Rotovators (Figure 69) are not usually fitted to collect fragments of plants or rhizomes created by tilling.
