Supplemental Interim CMT Year 2 Report:  
**Bottom Barriers**  
Prepared by: Dr. Lars Anderson

## INTRODUCTION

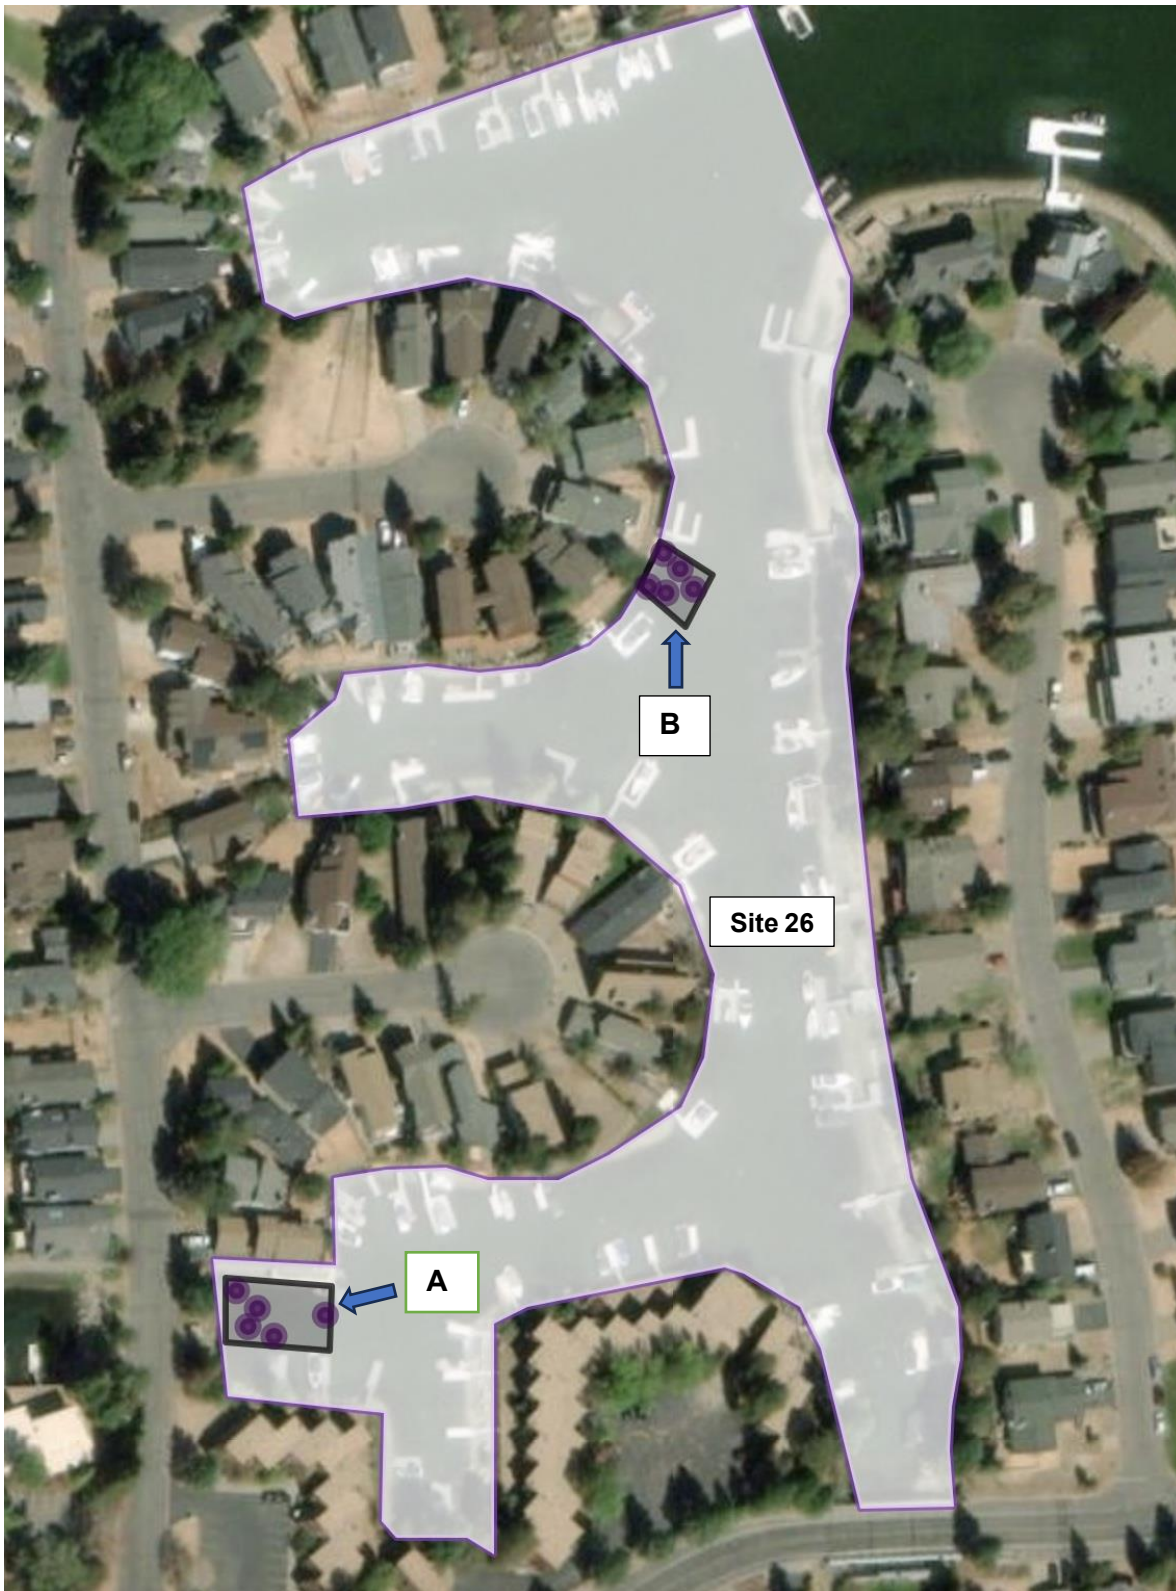
**Figure 2. Example of Bottom Barrier macrophyte rake sample points from a single monitoring event: A, Site 26a Bottom Barrier Area; B, Site 26b Bottom Barrier Area (Purple dots represent each rake sample taken within the respective Group B area.)**

The Bottom Barriers were in place from 46 to 104 days, but most were in place for approximately 3 months (Table 1). To prevent damage to the Bottom Barriers, rake sampling was only done as a “Pre-install” assessment of AIP and at the end of the summer when Bottom Barriers were removed (see Table 2). Each Bottom Barrier area was sampled for the presence and abundance of AIP before installations and after removal of Bottom Barriers in fall, 2023. Within 1 to 7 days after a Bottom Barrier was removed, physical rake samples were taken in the uncovered areas and additional surveys were made in subsequent weeks to determine the AIP abundance [Rake Fullness (RF)] and species present [Species Relative Abundance (SRA)]. The Bottom Barrier areas were surveyed several times in October and in early November. The rake sampling methods for Group B sites are described in the October 16 Interim Report and consisted of multiple physical rake samples in each bottom barrier area. It should be noted that the standard number of CMT macrophyte rake samples taken is 30 per CMT Site. Since the Bottom Barrier areas were small compared to the Sites in which they were installed (Figures 1, 2), the number of rake samples per square foot in each Bottom Barrier area was increased compared with the entire Site and ranged from 4 to 10 per area. An example of Bottom Barrier areas in Site 26 is shown in Figure 2. (Note the cluster of 5 sample points in each area.) A summary of Bottom Barrier areas, installation and removal dates, and turbidity monitoring results is provided in Table 1.
