Subject: EIR/EIS Mitigation Monitoring and Reporting for Control Methods Test  
Project – SPRING 2024 Routine Monitoring Ecotonal Report for the Tahoe  
Keys Lagoons Aquatic Weed Control Methods Test

# **SPRING 2024 ROUTINE MONITORING ECOTONAL REPORT FOR THE TAHOE KEYS LAGOONS AQUATIC WEED CONTROL METHODS TEST**

PREPARED PURSUANT TO  
CALIFORNIA REGIONAL WATER QUALITY CONTROL BOARD LAHONTAN REGION  
MITIGATION MONITORING AND REPORTING PROGRAM NO. R6T-2022-0005

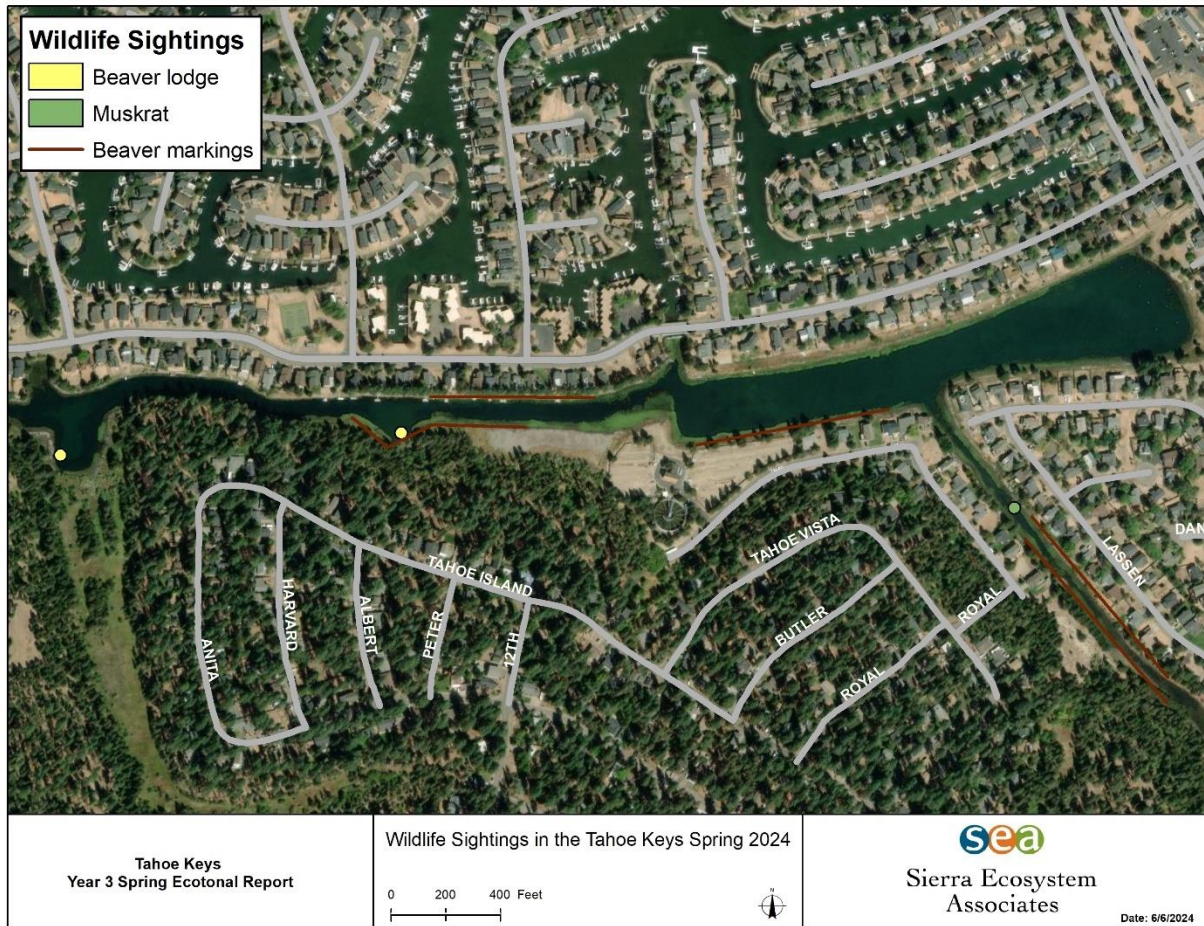
**Figure 4. Wildlife Sightings**

Figure 4 shows the wildlife sightings from the April 9<sup>th</sup> field survey. All the notable wildlife sightings were in Lake Tallac Lagoon area which included a muskrat (*Ondatra zibethicus*), beaver dens and beaver markings. Other common species were observed such as American coot, mallard duck, stellar jay and sandhill crane. Based on observations from Year 2 (2023) field crew forms of the CMT Project, there were multiple sightings of deceased fish, mainly catfish and bluegill, throughout the Tahoe Keys. There was no trend or pattern in terms of the sites/treatment areas and location of the deceased fish.

Beaver markings on trees have also been noted mainly in the outflow channel for Lake Tallac (west end), which is an area of the Tahoe Keys that has minimal disturbance and residential structures. The locations of the markings and beaver lodges are shown in Figure 4. They usually select deciduous trees such as willow, aspen, and birch over aquatic species, grasses, and agricultural crops, however selection and diet vary seasonally and depend on availability (Pejstrup 2023). Beavers are excellent ecological engineers that can create freshwater habitats by building dams from locally sourced wood (Orazi 2022). The North American beaver tends to migrate to areas in which their preferred food sources exist. Past beaver activity in Lake Tallac was common as beavers feed on both terrestrial and aquatic vegetation. Beaver activity tailed off in the following 8 to 10 years with minimal activity. This cyclical migratory nature of beavers is evident here in Lake Tallac Lagoon.

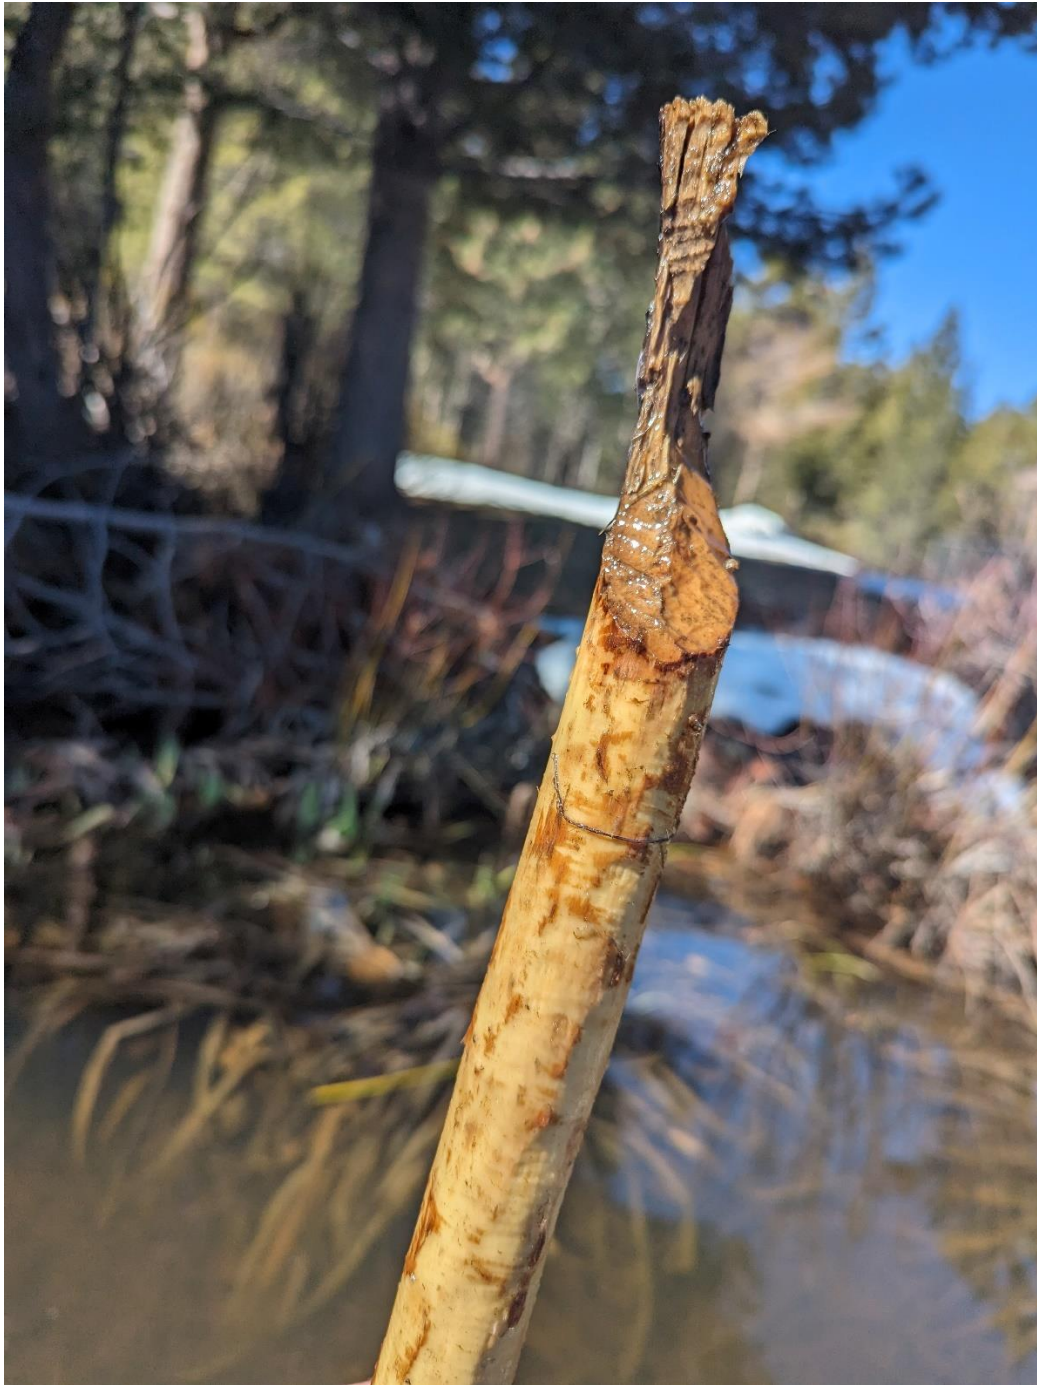
**Photo 1. Beaver Activity - Lake Tallac**

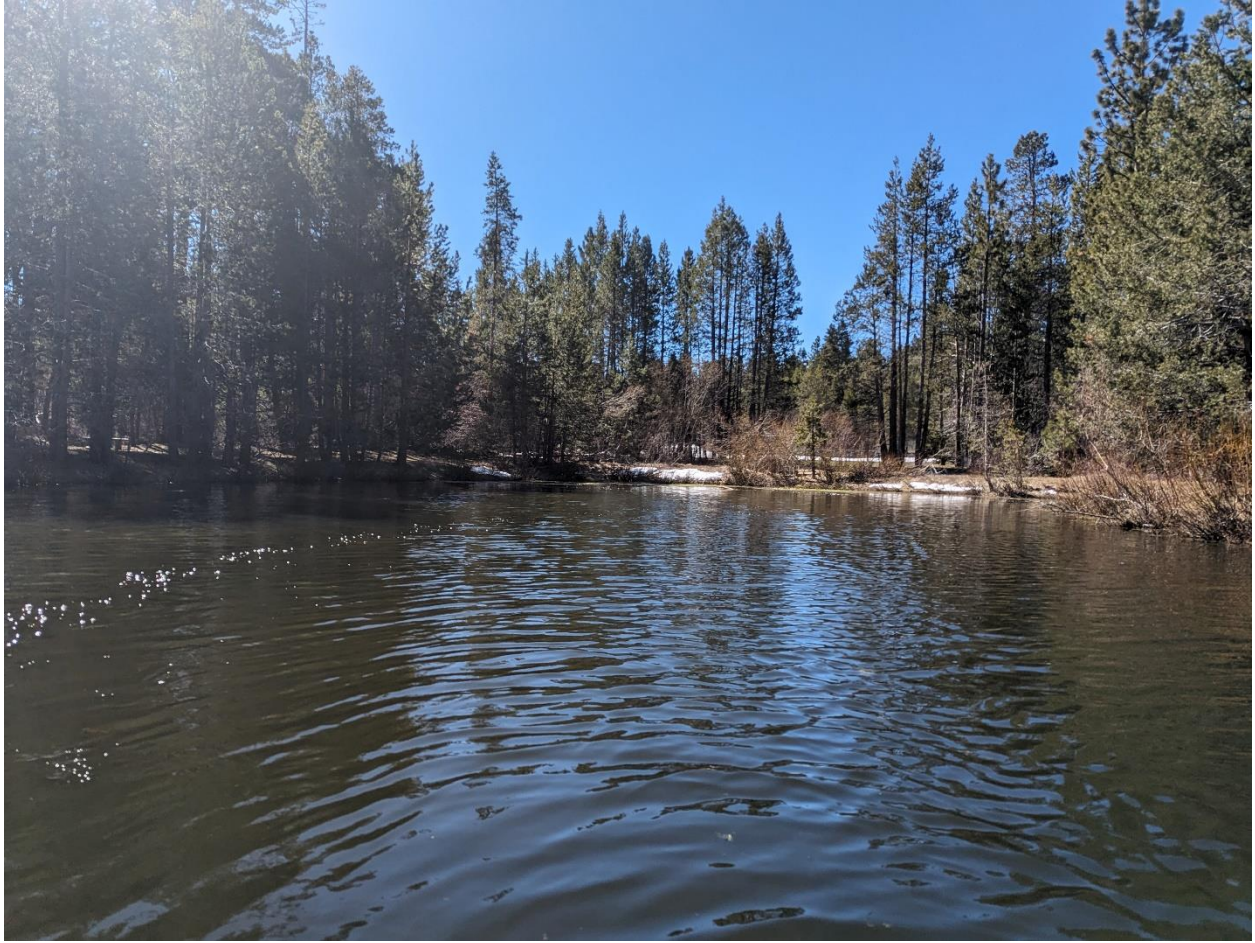
**Photo 2. Beaver Activity – Lake Tallac**
