DESERT HOME INSPECTORS, LLC.

YOUR HOME INSPECTION REPORT

Home Inspection Full Report by Desert Home Inspectors.

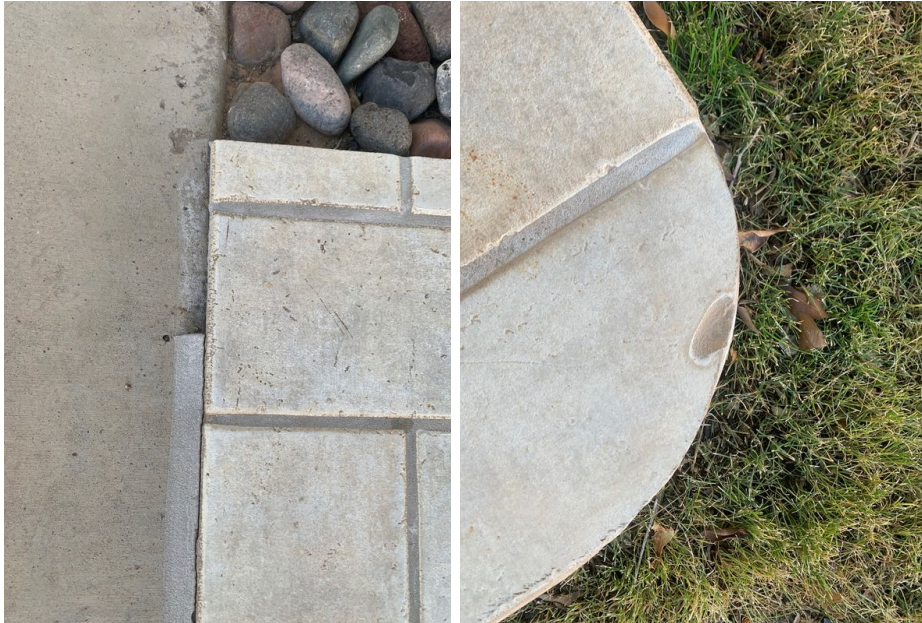
Walkways: Minor Damage Noted

There is damage and chipping noted on some walkway areas. I recommend service as you feel necessary.

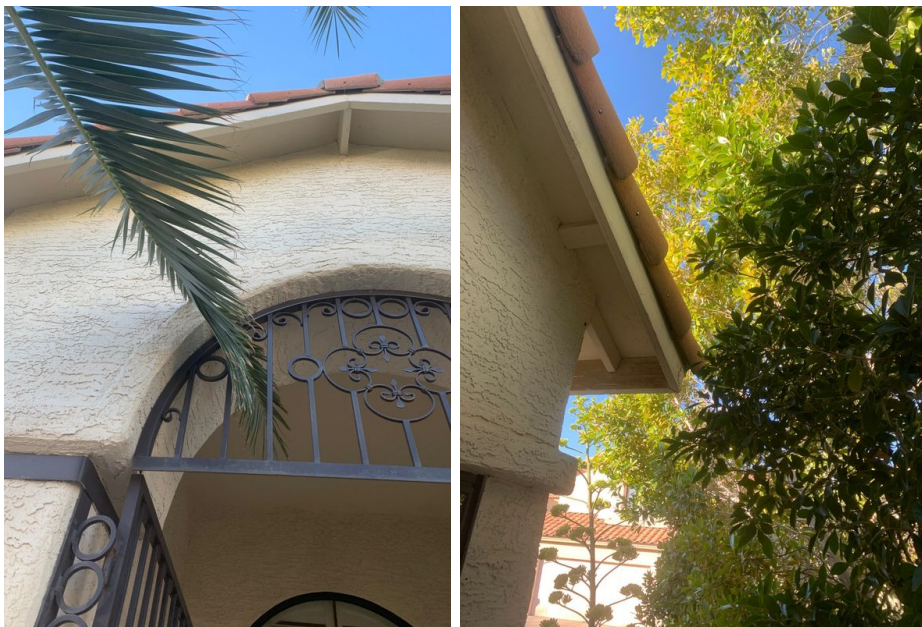
Landscaping: Vegetation Encroaching

Vegetation is encroaching on the structure, and should be kept a minimum of twelve inches away for the general welfare of the walls and foundation.

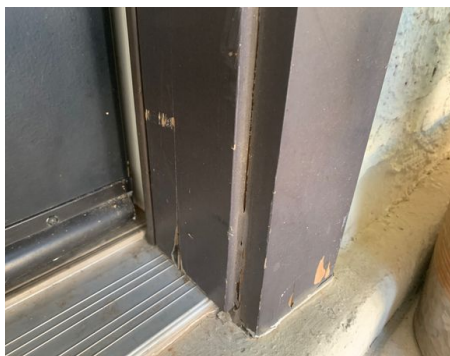
House Wall Finish: Satisfactory Overall

The exterior house wall finish is in acceptable or satisfactory condition, unless otherwise specifically noted. Normal or typical wearing was noted.

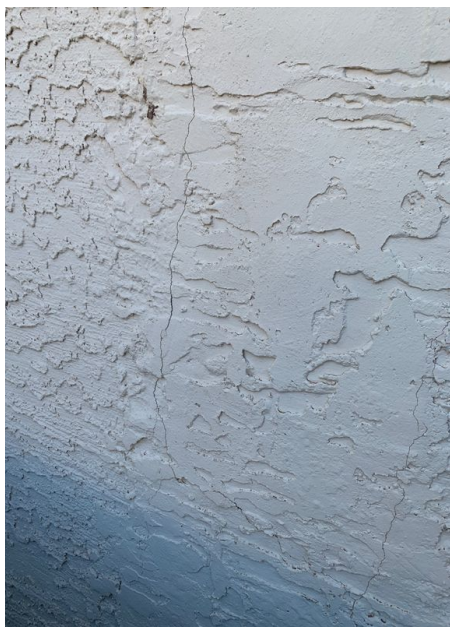
House Wall Finish: Typical Stucco Shrinkage Cracks

There are typical shrinkage type cracks observed in the stucco, which you should view for yourself. All cracks result from movement, and are structural in that respect, but the vast majority of them have only a cosmetic significance. Most people do not realize that structures move, but they do and sometimes more or less continuously. Therefore, stress, settlement or shrinkage type fractures can reappear after they have been repaired, and particularly if they have not been repaired correctly. I recommend that all exterior cracks and gaps, if present, are properly covered or sealed to help prevent possible moisture or pest intrusion. However, you may wish to have this confirmed by an appropriate specialist. Most stucco homes are recommended to be repainted about every 10 years or so.

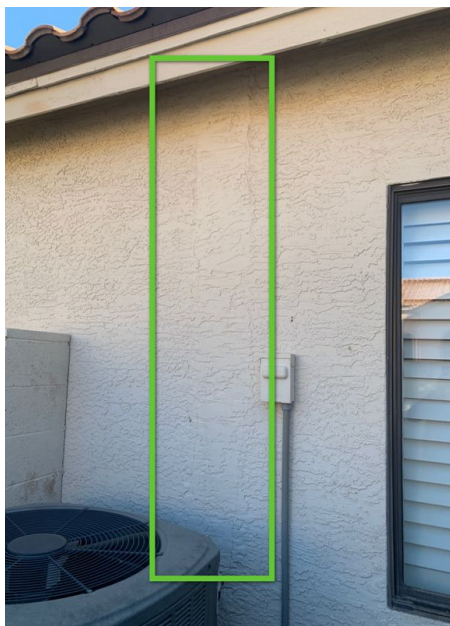
House Wall Finish: Previous Repairs Noted

There are obvious areas of previous exterior wall repair. I recommend asking the seller for more detailed information or having this evaluated further by a qualified contractor.

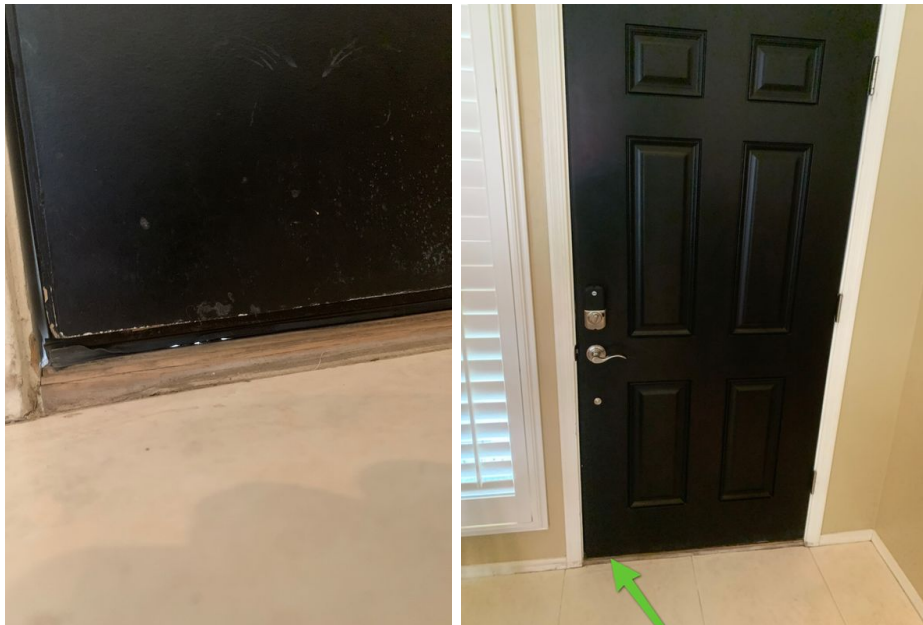
The front entrance door(s) are solid, security type doors. Also noted adequate weather stripping, thresholds, door sweeps and deadbolts. They function properly and are in acceptable condition, unless otherwise noted. There is a little light at the bottom of this door and weather stripping replacement or adjustment may be necessary for pest intrusion and for energy efficiency.

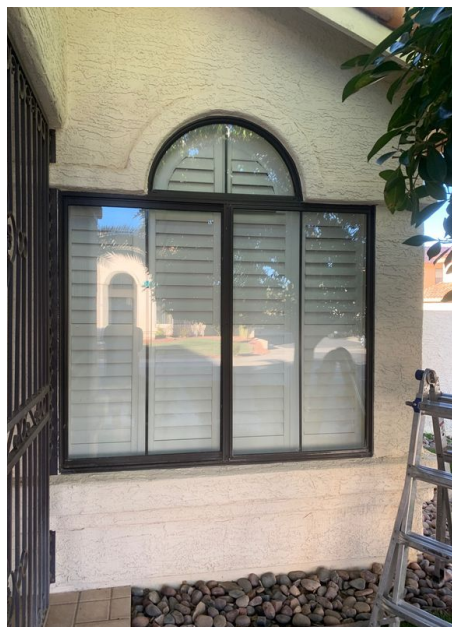
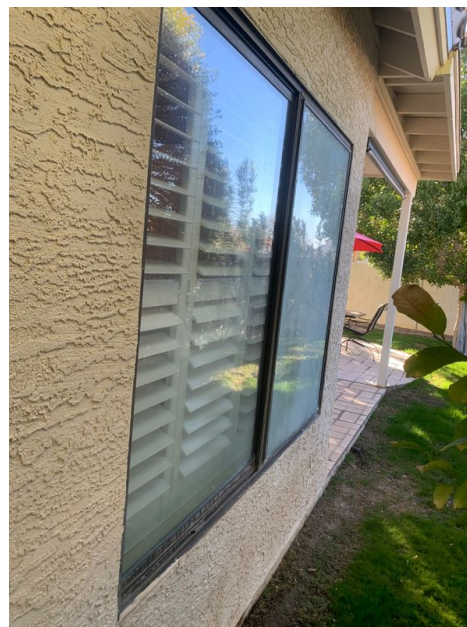
Screens: Some Missing

Some of the window screens are missing. Screens are often removed for aesthetic reason, but you may want to have them installed. I recommend asking the seller for more details or if they have them in storage.

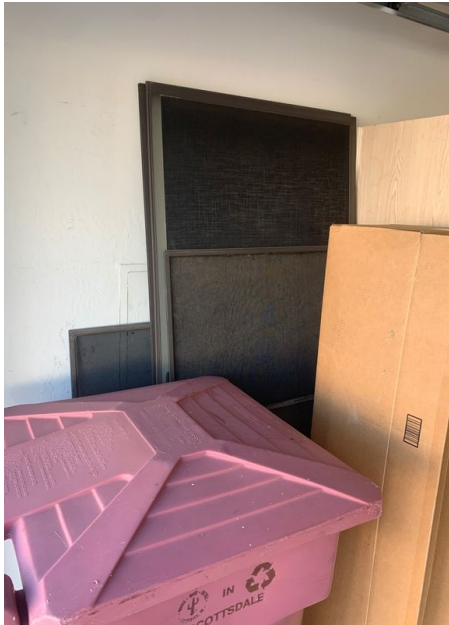
Screens: Not in Place on Windows

The window screens are not in place on the windows. Many were noted in the garage. Screens are often removed for aesthetic reason, but you may want to have them reinstalled.

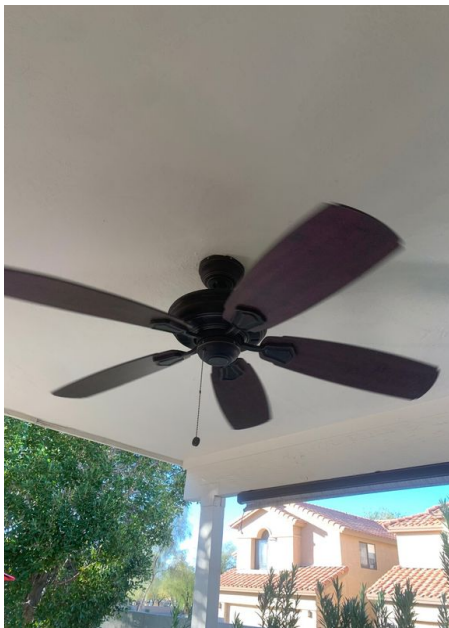
Ceiling Fans: Patio Fans / Acceptable

The patio fans that were tested are functional and respond on demand. It does not appear to be an outdoor type and should be replaced with appropriate blades.

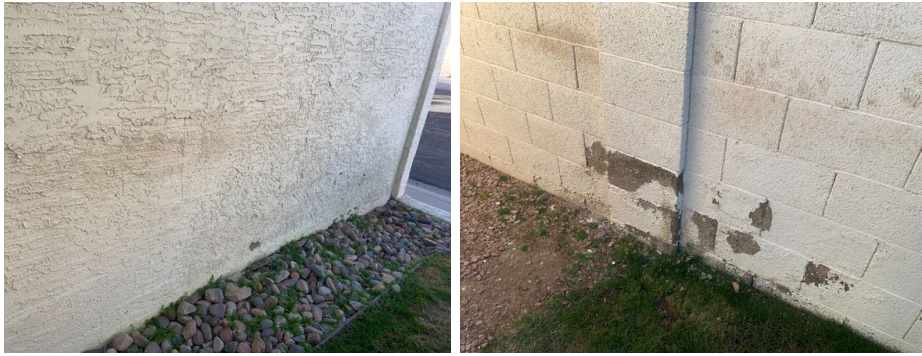
Fences & Gates: Fence / Satisfactory

The exterior yard fences are satisfactory. Some fence areas could use paint service from sprinkler overspray. I also recommend having the sprinklers adjusted so they don't hit the fence or house.

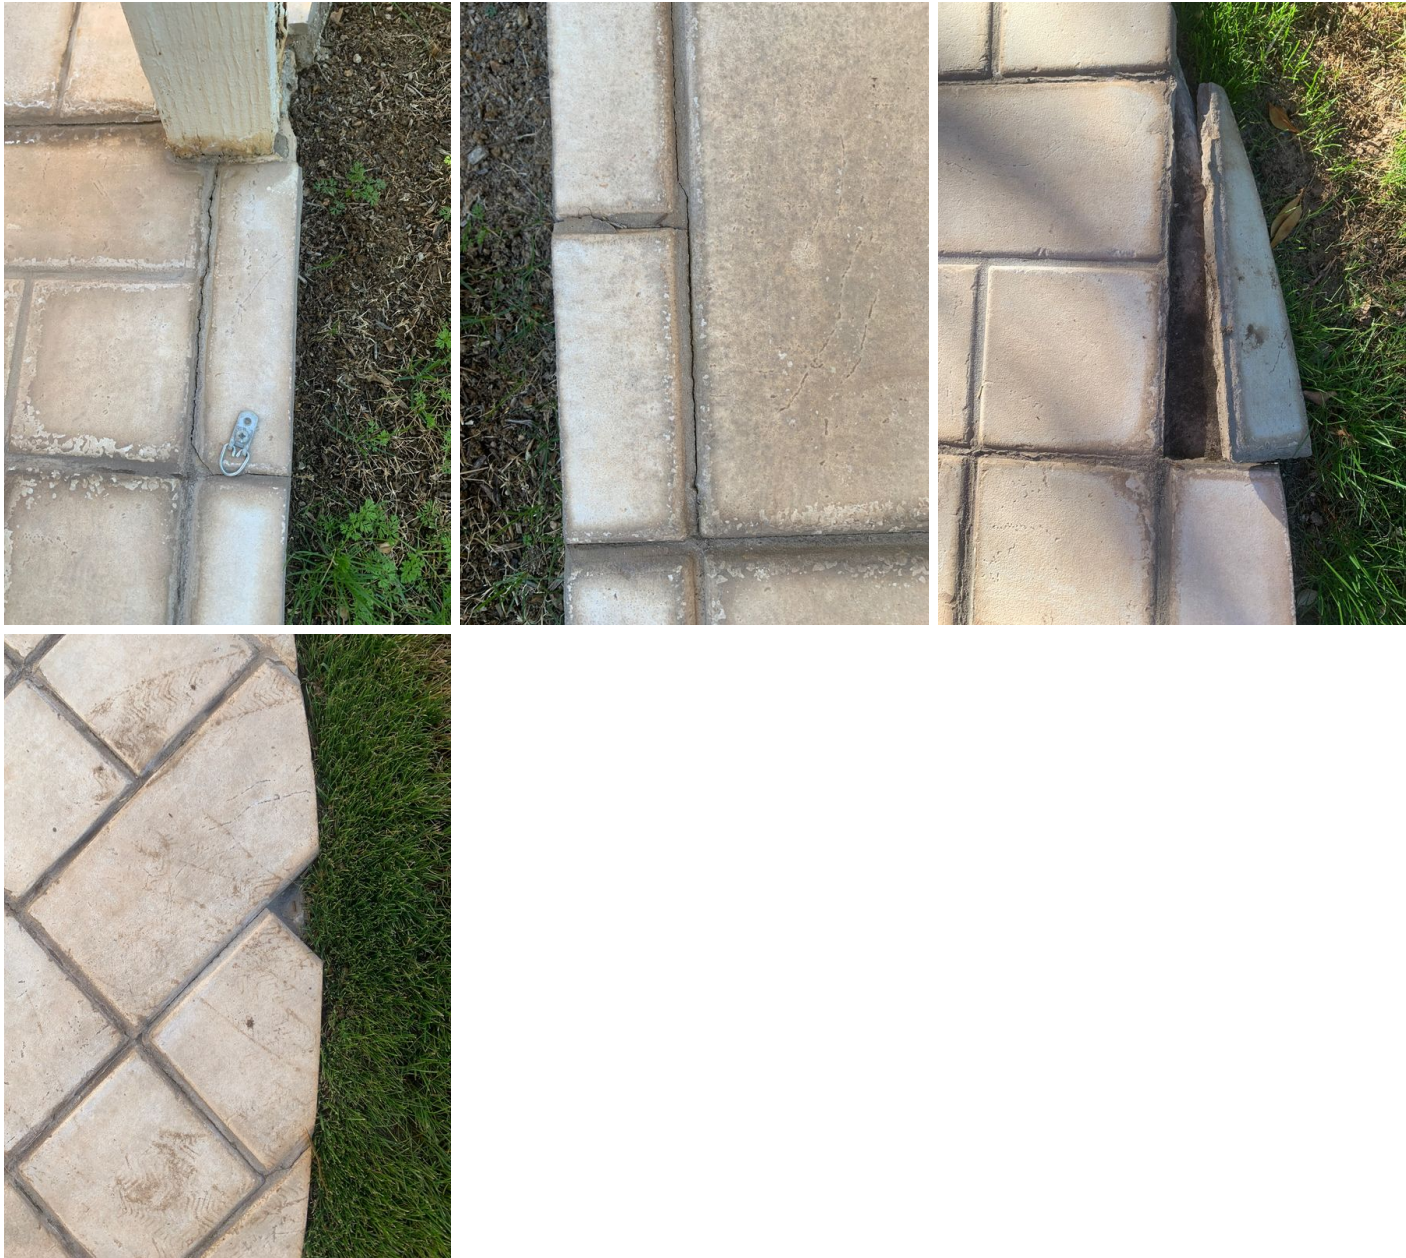
Patio Floor / Patio Cover(s): Patio Floor / Typical Cracking Noted

There are typical and minor cracks in the rear patio floor and loose or missing tile that you should view for yourself and correct as desired.

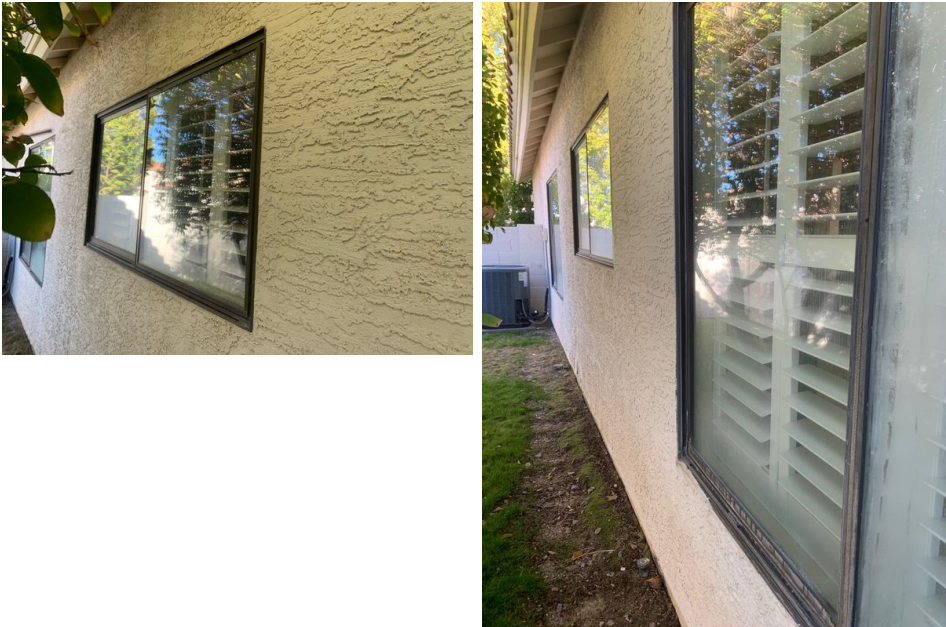
The residence windows are dirty or dusty on the interior and exterior glass panes. This makes evaluating the windows for broken hermetic seals more difficult. I recommend having the windows properly cleaned and further evaluated as you feel necessary.

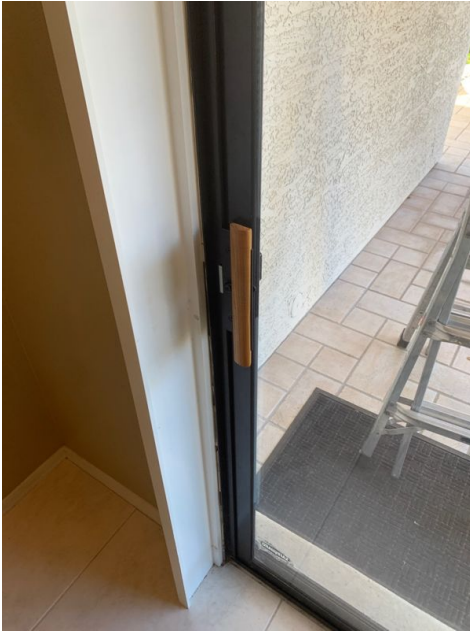
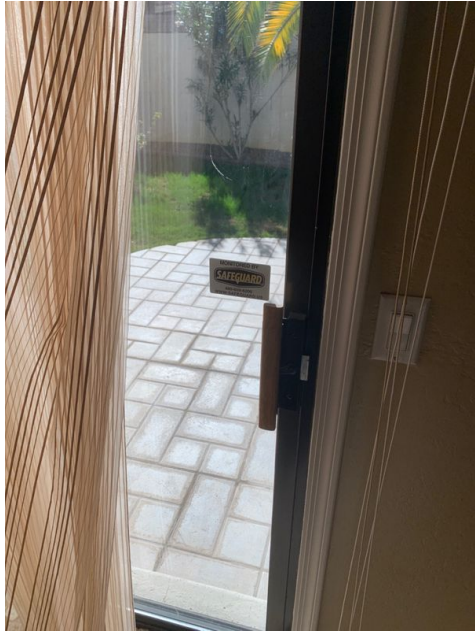
2.9.1 Exterior Doors

The sliding glass door handle on the doors do not lock and hold closed properly. (Both the kitchen and master bedroom) If the door is pulled somewhat hard, it opens right up. It should be serviced as necessary by a qualified contractor.

Recommendation
Contact a qualified handyman.

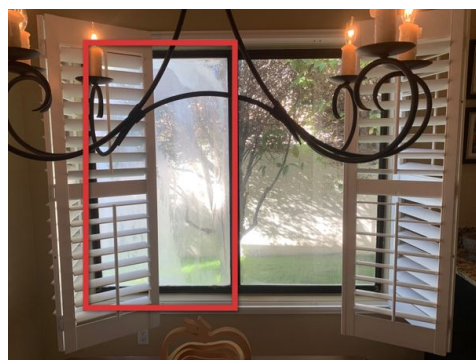
Kitchen

BROKEN DUAL PANE SEALS NOTED

Contact a qualified window repair/installation contractor.

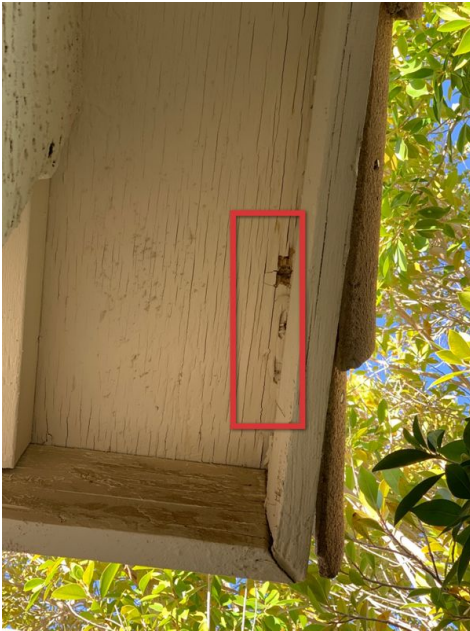
Front house corner

2.16.1 Fascia / Trim / Soffits / Eaves

Contact a qualified professional.

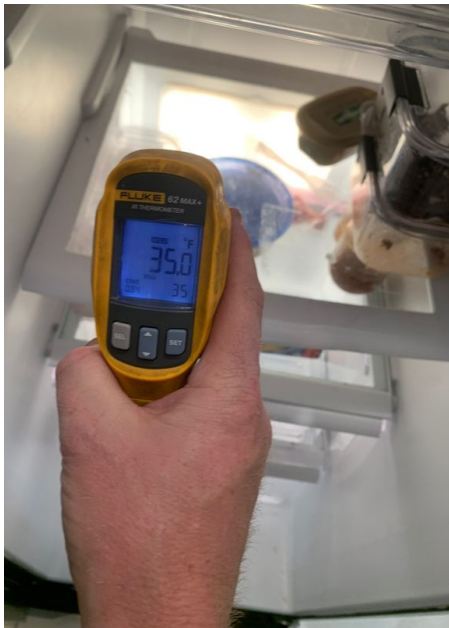
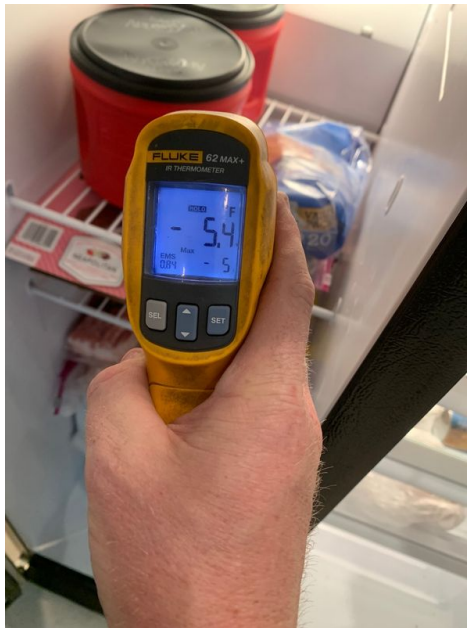
Refrigerator: Satisfactory / Temps Ok

The refrigerator was functional and achieved acceptable temperatures. This is a limited courtesy inspection and you should ask the seller about its full operation. You should make sure to set your fridge at appropriate temperatures as needed. I do not know if this appliance is staying with the property or not. I recommend you should plug the refrigerator into its own dedicated outlet and not into a GFCI protected outlet.

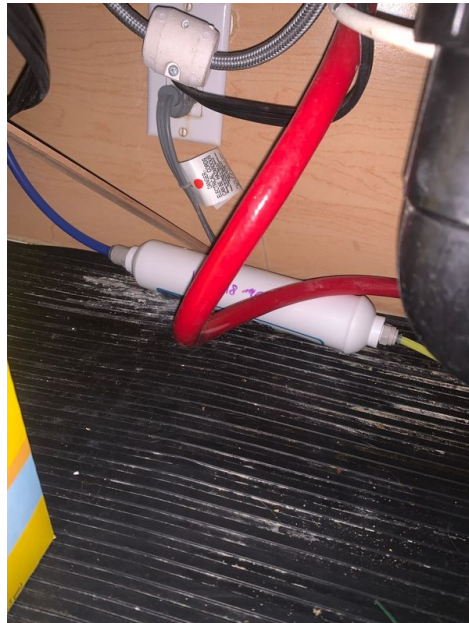
The water filter supply faucet at the sink was activated and water came out. This is a very limited courtesy check and not a full inspection of the reverse osmosis system which is beyond the scope of this home inspection. I recommended you should consult with a specialist on maintenance and water quality as these systems can fail at any time. Especially when they are not being used.

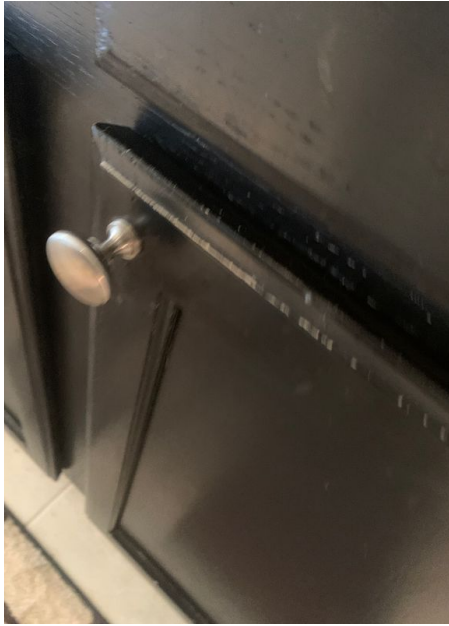
Cabinets & Pantry: Cosmetic Issues Noted

The cabinets have typical and minor cosmetic damage, often consistent with time and use. I recommend you should view these areas for yourself and correct as desired.

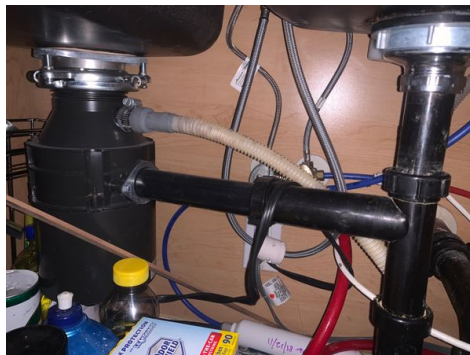
NO HIGH LOOP

The dishwasher drain line was installed without a visible "high loop" to prevent cross contamination. I recommend further evaluation from a qualified contractor for service as necessary.

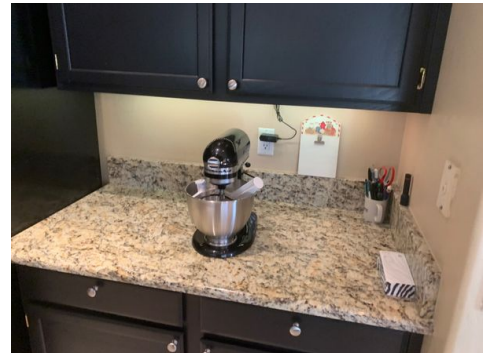
UPGRADE KITCHEN OUTLETS TO GFCI

All the outlets in the kitchen do not have GFCI protection. You should upgrade the entire kitchen to have modern GFCI protection for safety reasons.

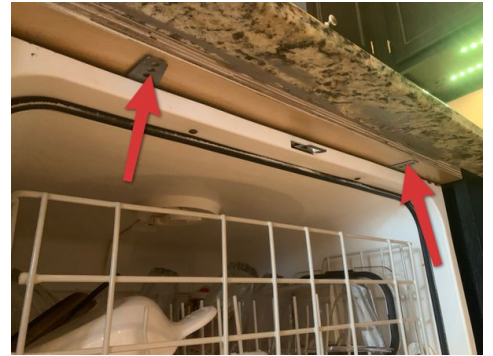
4.4.1 Dishwasher

The dishwasher is not secured to the countertop. It is currently loose in place. I recommend service as necessary from a qualified contractor.

Contact a qualified professional.

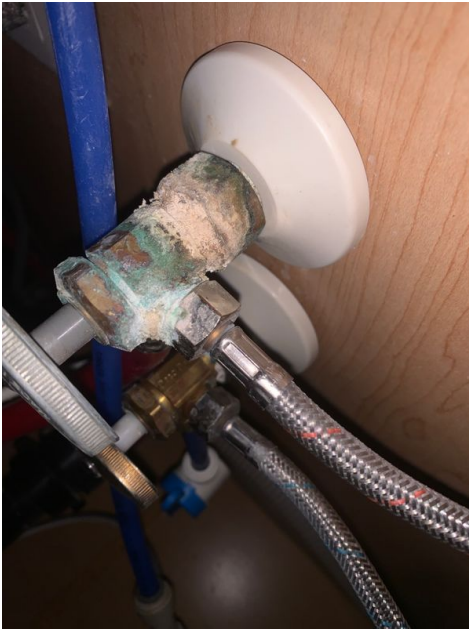
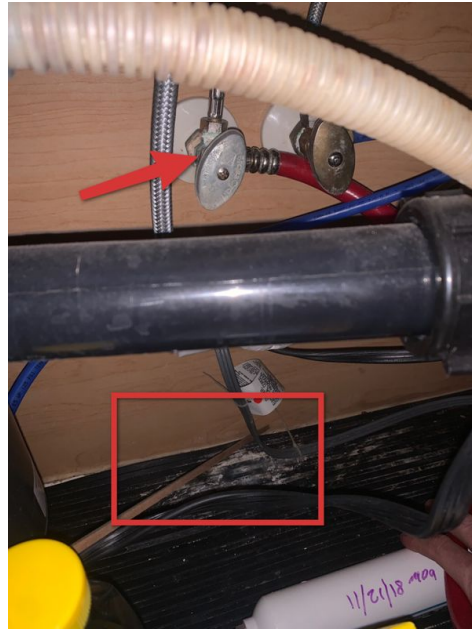
CORROSION / LEFT VALVE

Corrosion and/or mineral build-up was observed on the kitchen left side water shut-off valve. This corrosion or build-up may prevent the shut-off valve from working properly, especially if emergency shut-off is needed. It also indicates previous leaking. I recommend a qualified contractor should evaluate and repair or replace this valve or connection as necessary.

Contact a qualified professional.

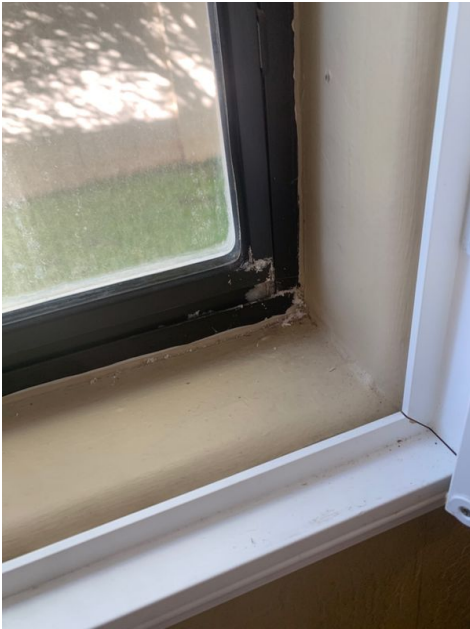
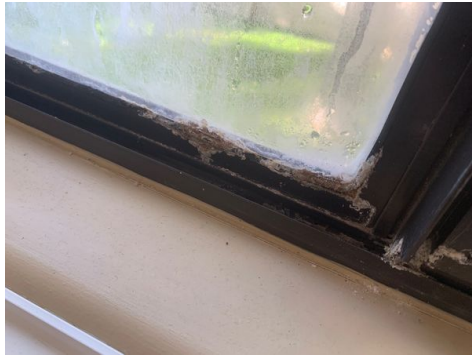
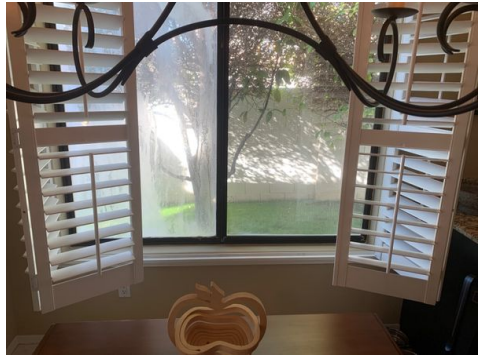
4.15.1 Walls and Ceiling

MOISTURE STAIN / WINDOW / DRY

There is corrosion on the kitchen window frames and they are currently dry. They were not wet to the touch or soft during the inspection. It appears to be coming from the lawn irrigation sprinkler spraying on the house. I recommend further evaluation from a qualified contractor for more detailed information and service as determined necessary.

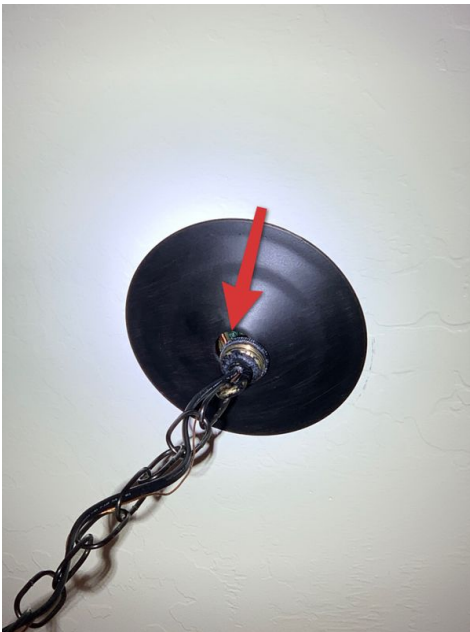
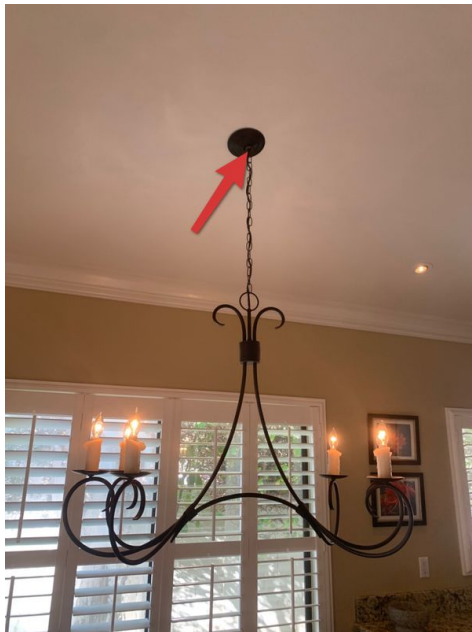
4.19.1 Lights / Wall Switches

CEILING LIGHT / LOOSE

A kitchen ceiling light mount is loose in place or shifted and should be serviced as necessary by a qualified contractor.

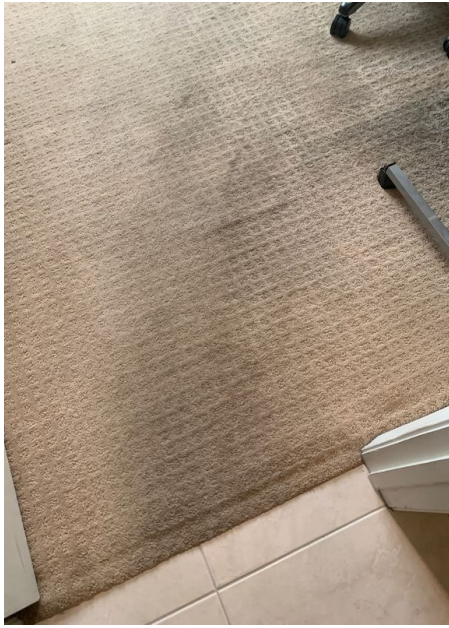
The floor covering is worn or cosmetically damaged in some areas, which you should view for yourself and correct as desired. It appears it may need to be re-stretched again.

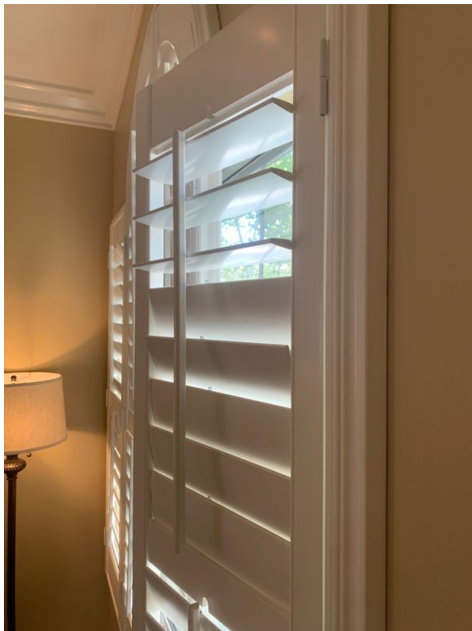
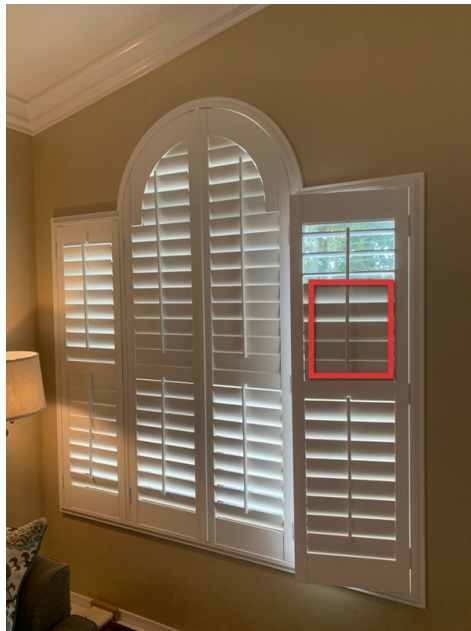
BLINDS DAMAGED

I noticed that one of the blinds is damaged or not properly connected. I recommend service as you feel necessary.

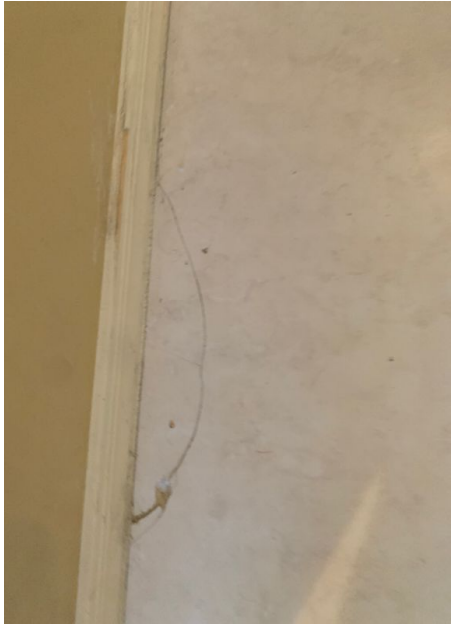
There are minor and typical cracks in the floor tiles or grout lines, which you should view for yourself. They are likely to have been caused by normal settlement, but you may wish to seek the opinion of a specialist; especially if you are concerned or desire more information.

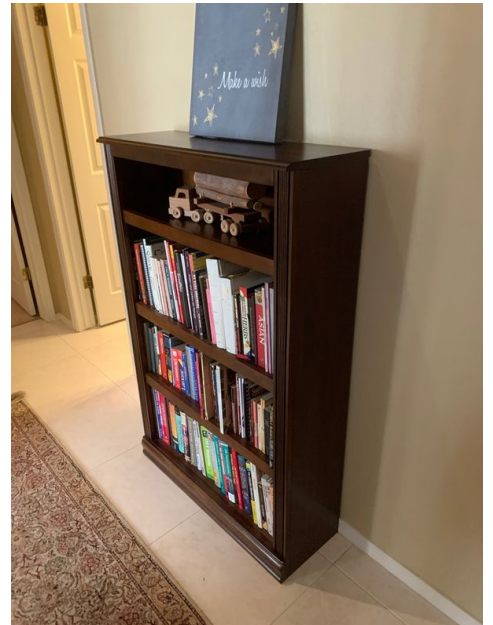
ACCESS BLOCKED OR RESTRICTED

I was unable to access all outlets in this residence during the inspection due to furniture, storage or personal items. I recommend checking any of these outlets once access is available.

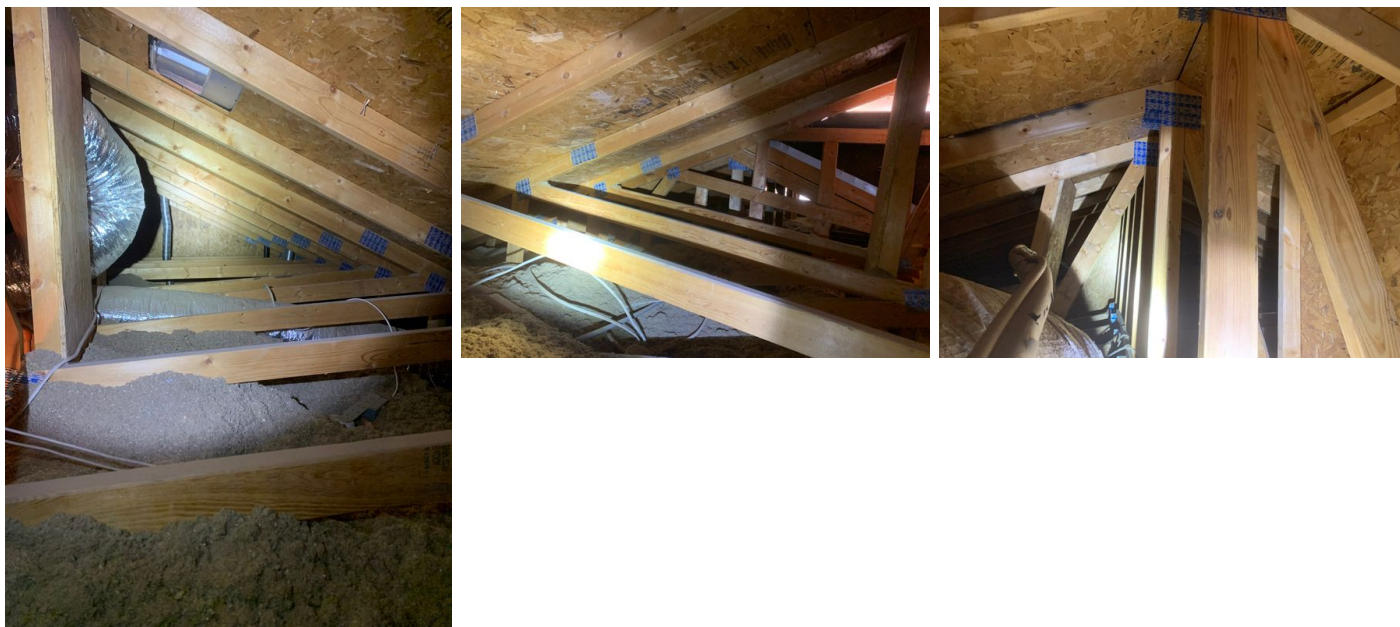
Framing: Framework Pictures

Framing: Factory Wood Truss / Satisfactory

The wood roof framing is in satisfactory condition. The roof framing consists of a factory- built wood truss system, comprised of components called chords, webs, and struts that are connected by metal gussets nailed in place. Each component of the truss is designed for a specific purpose, and cannot be removed or modified without compromising the integrity of the entire truss. The lowest component, which is called the chord and to which the ceiling is attached, can move by thermal expansion and contraction and cause creaking sounds, which are more pronounced in the mornings and evenings along with temperature changes. Such movement has no structural significance, but can result in small cracks or divots in the drywall or plaster.

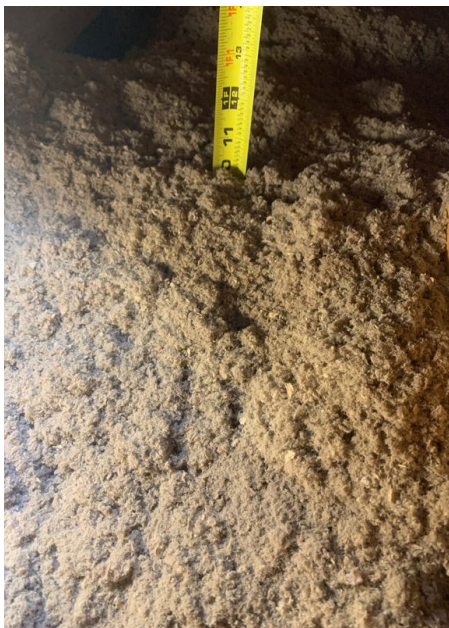
Insulation: Blown Loose Cellulose / 10 inches +

The attic floor is adequately insulated with blown loose cellulose insulation. I observed approximately 10 inches depth in various floor areas, which should provide a minimum insulation rating of R-38. Insulation prevents viewing some attic areas.

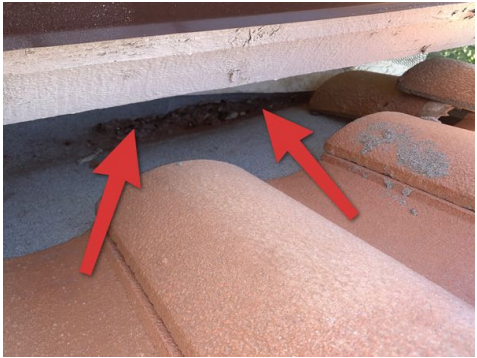
9.8.1 With Flat Roofed Sections
CLEAR FLAT ROOF OF DEBRIS
ON THE SIDE OF THE FRONT ENTRANCE

The flat roof needs to be cleared of any tree debris such as leaves/sticks etc. This build-up can restrict drainage and lead to moisture intrusion and moisture damage if not corrected. The roof should then be reevaluated. once properly cleared of debris, and serviced if determined necessary. Further evaluation of this roof is recommended for service as necessary.

Recommendation
Contact a qualified roofing professional.

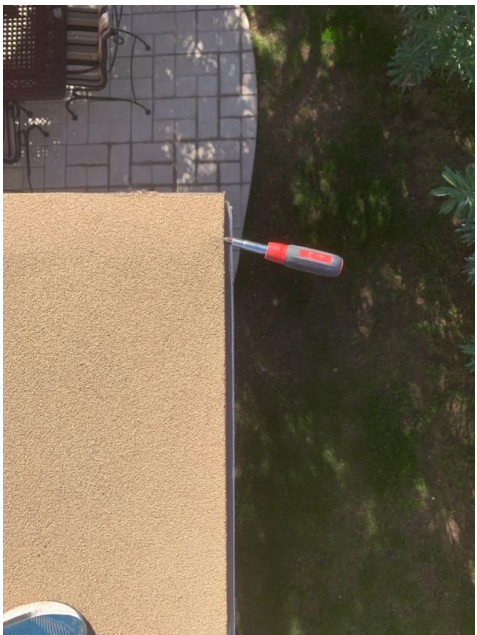
9.8.2 With Flat Roofed Sections
RAISED EDGES
REAR PATIO

There are two areas on the composition rolled roofing that are raised or lifted up near the corner. These spots should be evaluated by a qualified contractor and sealed to prevent moisture intrusion issues.

Recommendation
Contact a qualified professional.

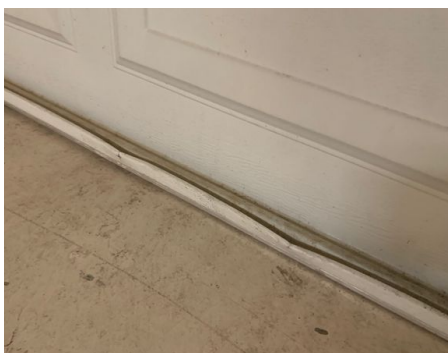
Garage Doors & Hardware: Minor Door Damage Noted

There are small areas of cosmetic type damage to the sectional garage door. These areas are not affecting the operation of the door. I recommend further evaluation as you feel necessary.

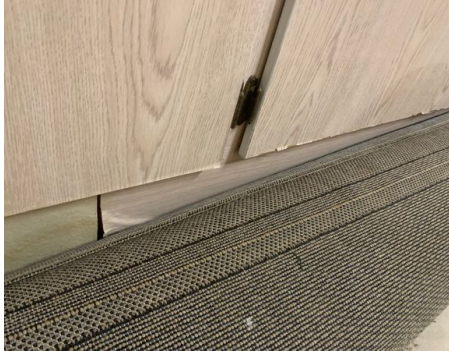
Cabinets / Drawers / Shelves: Obvious Wear/Damage Noted

There is obvious wearing and minor damage to the cabinets, drawers and shelves in the garage. I recommend having them serviced as you feel necessary.

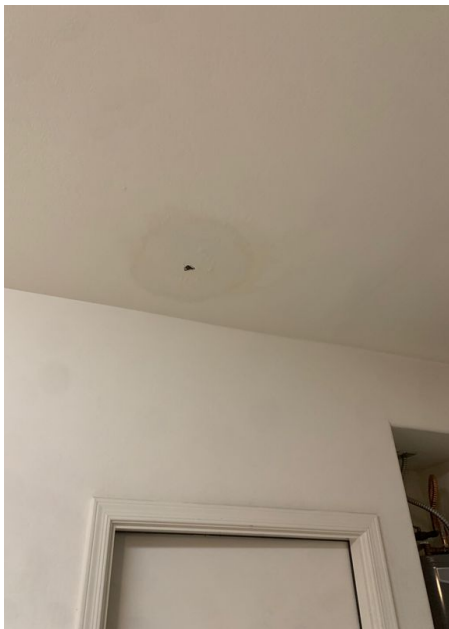
**Firewall Separation: Satisfactory / Most**

Most of the garage firewall separating the garage from the residence appears functional and in good condition. The hole in the ceiling should be repaired.

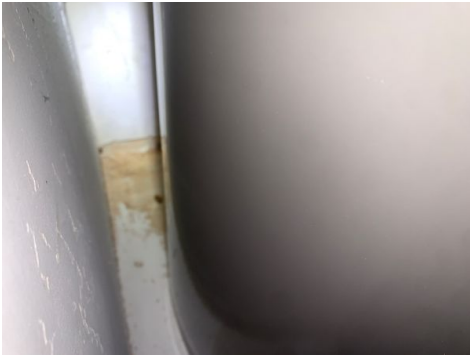
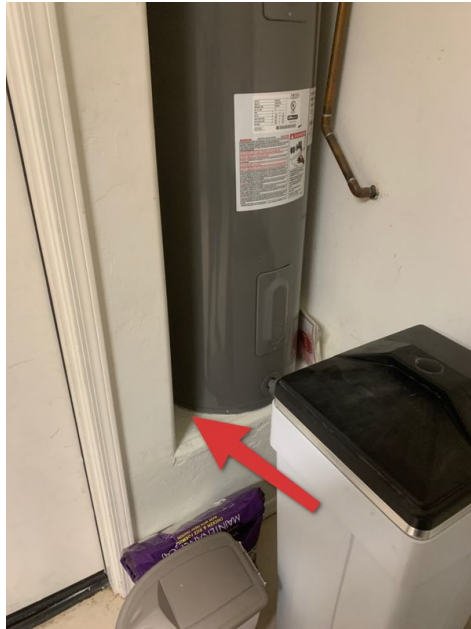
WALL / MOISTURE STAINING / WATER HEATER

There are moisture stains on the walls, specifically near the water heater, that should be further evaluated and serviced as necessary. Likely from a previous water heater leak? I recommend at least locating and correcting the leak source and repairing affected areas as necessary. These areas were not soft or wet to the touch during the inspection.

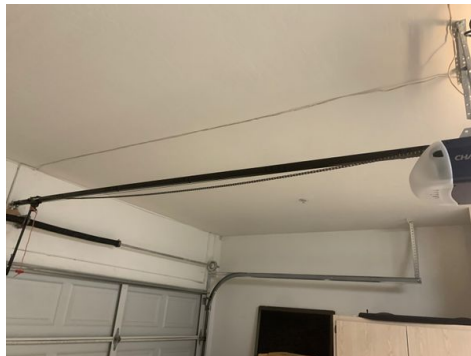
11.8.1 Automatic Openers

CHAIN OR BELT / LOOSE

The garage chain or belt drive for the automatic opener is loose and should be serviced as necessary by a qualified contractor.

Tighten Garage door chain or belt

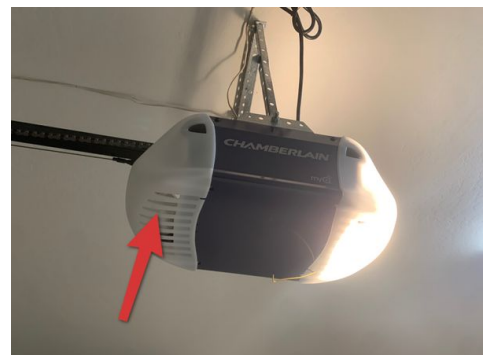
11.14.1 Lights / Wall Switches

OPENER LIGHT / NO RESPONSE

Contact a qualified professional.

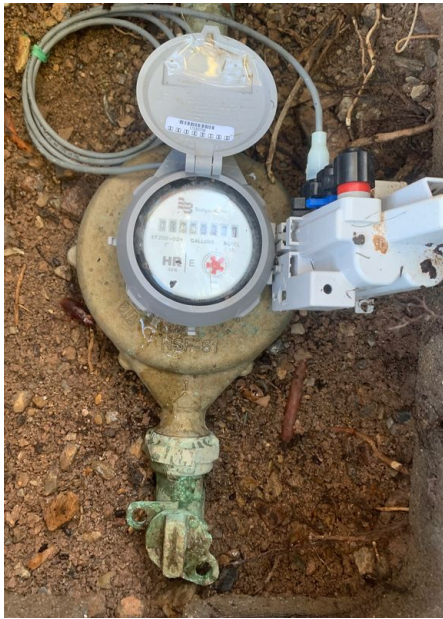
City Water Meter: City Water Meter-Picture

All three street or city water meters were observed for a short while, with no water was running on the property. The meter or dial was not spinning or moving, or the digital display reads 0.00. This is a good indication of no water leaking underground between the water meter and residence. However, this is not an exact determination and further evaluation may be necessary if you desire more detailed information or are concerned about the possibility of an underground water leak. Following up with the water company is a good idea so you are aware of potential normal water usage at this residence. I recommend getting an emergency water or plumbers key from a hardware store in case of emergency so you can easy shut off this meter if needed.

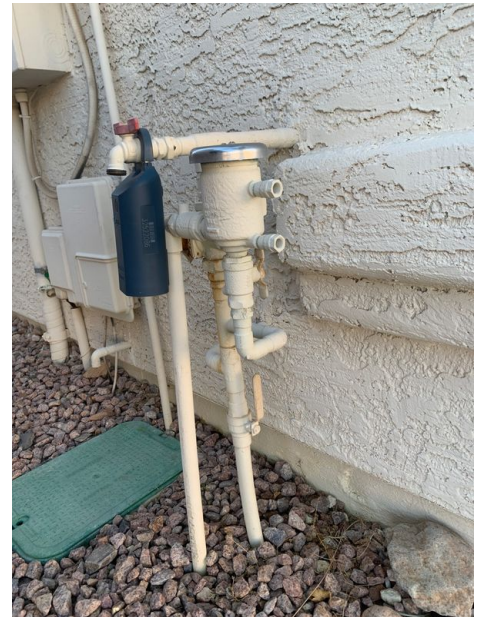
House Water Shut-Off Valve / Supply: Picture

Picture of the main house water shut-off valve.

Location of the house water shut-off valve. This valve appears to be in satisfactory and functional condition, unless noted otherwise.

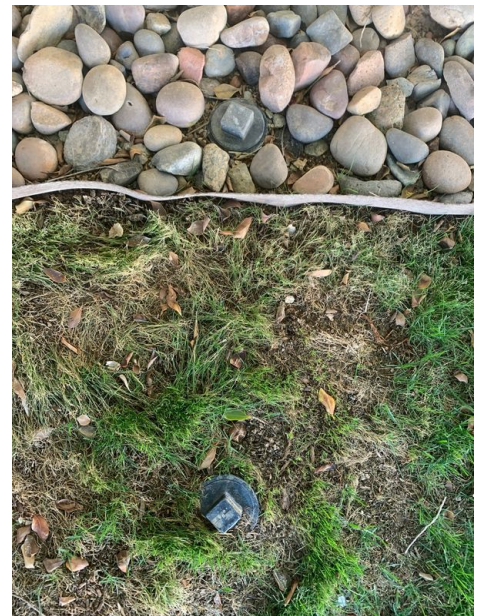
Wall Cleanouts, Front Yard

Location of the plumbing drain clean outs.

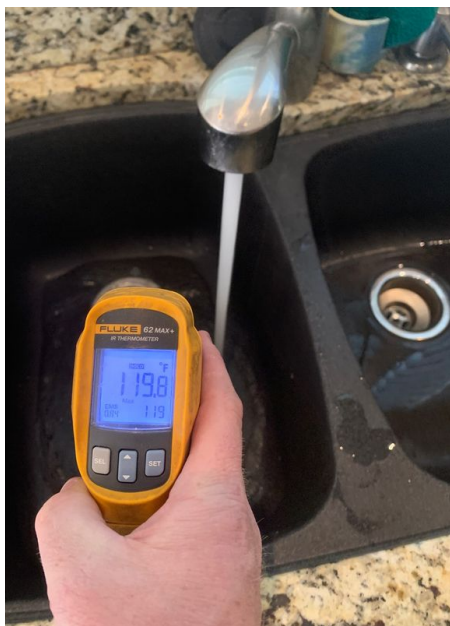
Electric Water Heater: Hot Water Temperature Noted

116 - 120

The residence hot water heater water temperature was noted as satisfactory during the home inspection. Hot water temperature supply was verified at all sinks, tubs, showers etc; unless otherwise noted. The hot water temperature is recommended to be set at a minimum of 110 degrees Fahrenheit to kill microbes and a maximum of 140 degrees Fahrenheit to prevent scalding. Hot water temperature can also be raised or lowered as desired at the water heater.

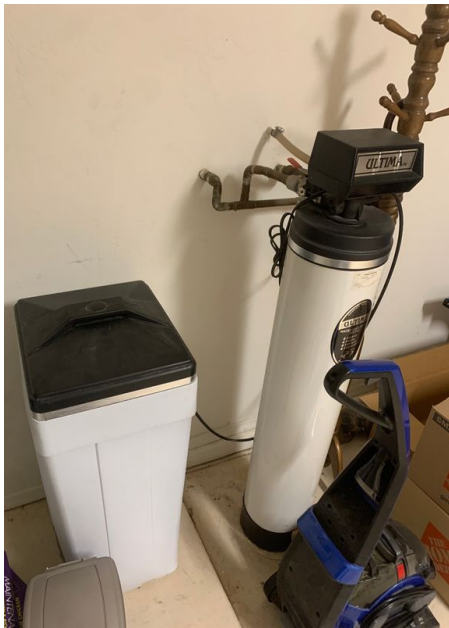
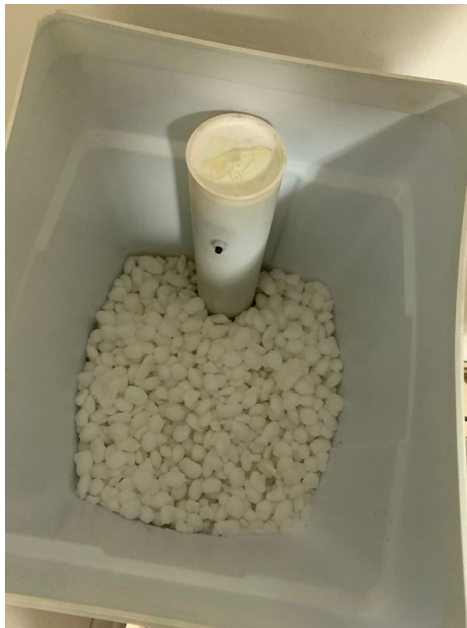
Soft Water System: Picture

Water treatment systems such as soft water systems were not evaluated during this inspection. They were viewed for obvious signs of leaking and damage only. I recommend contacting the manufacturer or a qualified contractor for more information, demonstration or further review.

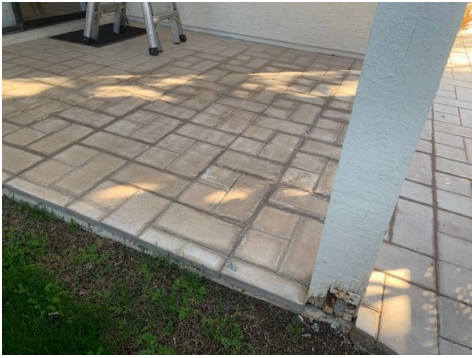
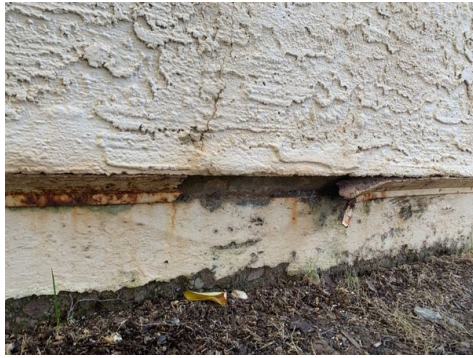
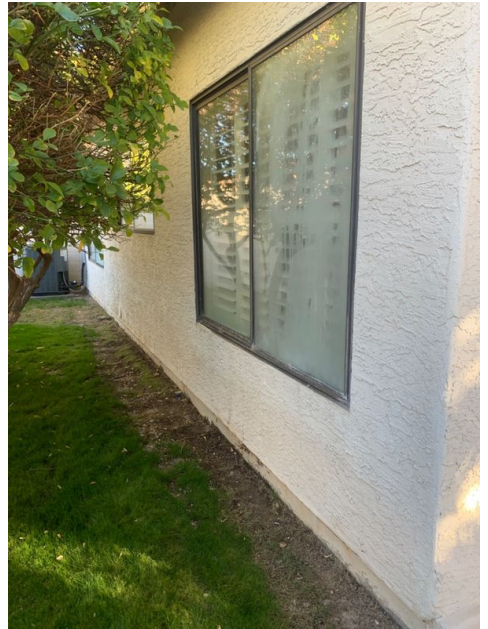
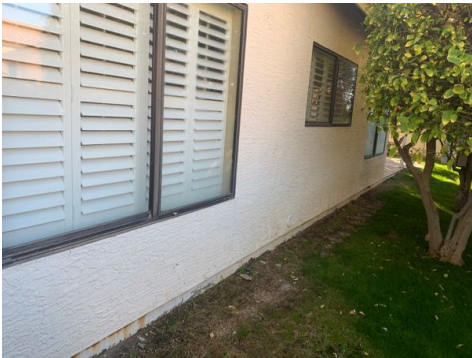
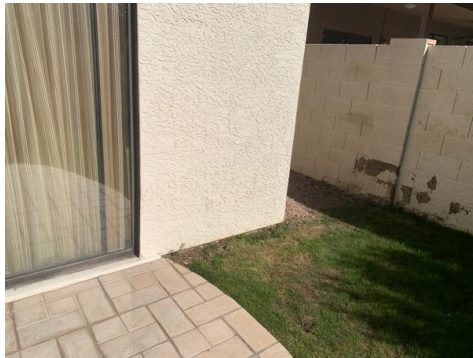
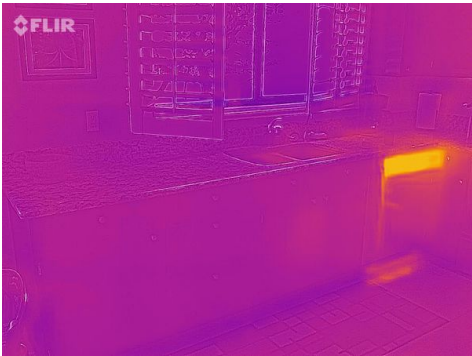
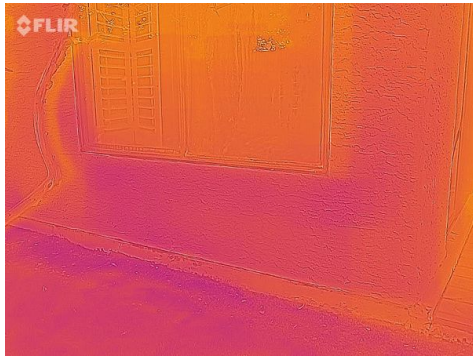
12.11.1 Irrigation

The lawn sprinklers are over-spraying onto the house walls and should be serviced. This is important to help prevent moisture intrusion and moisture damage issues. It has damaged two window, a small section of weep screed and rusted the bracket for the rear patio column. I recommend further evaluation and service as necessary from a qualified contractor.

Recommendation

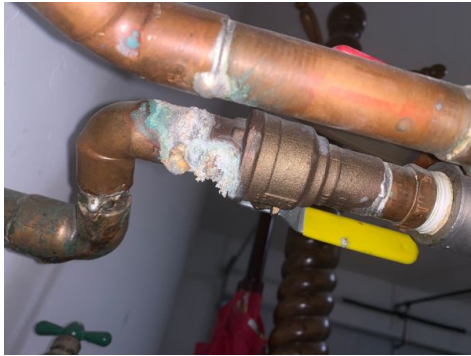
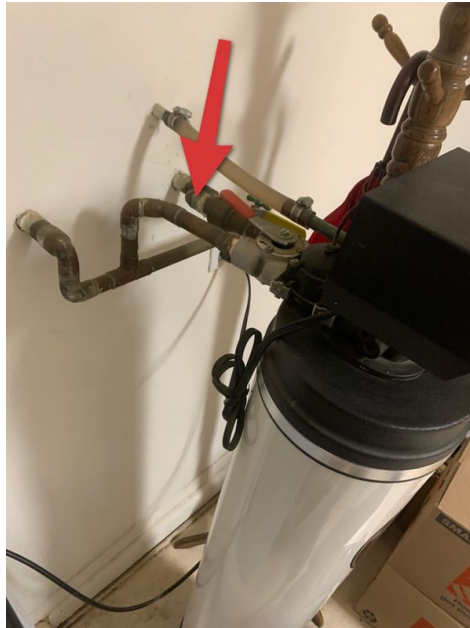
12.13.1 Soft Water System

CORROSION NOTED / WATER LINE

There is corrosion around a water line at the soft water system. This needs further review and service if determined by necessary from a qualified contractor.

Recommendation
Contact a qualified professional.

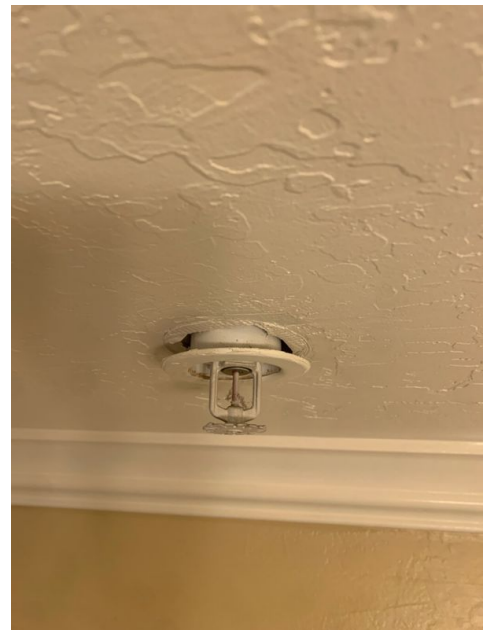
12.16.1 Fire Suppression System

FIRE SPRINKLER / DISPLACED HEAD

A fire sprinkler head is slightly displaced or pulling away from the ceiling. It no longer sits flush up against the ceiling. This indicates a possible issue with the sprinkler head. I recommend further evaluation from a qualified contractor for more detailed information and service if necessary.
