DESERT HOME INSPECTORS, LLC.

YOUR HOME INSPECTION REPORT

Home Inspection Full Report by Desert Home Inspectors.

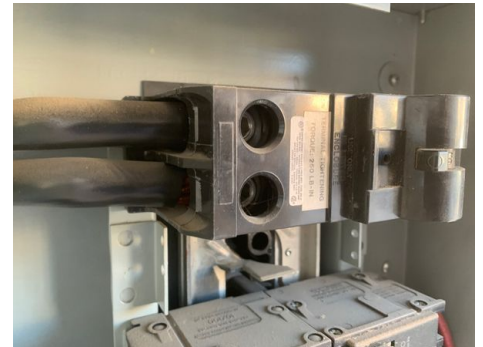
Copper Wire

Type of service conductor material.

Service Conductor: Satisfactory

The service conductor is in satisfactory condition.

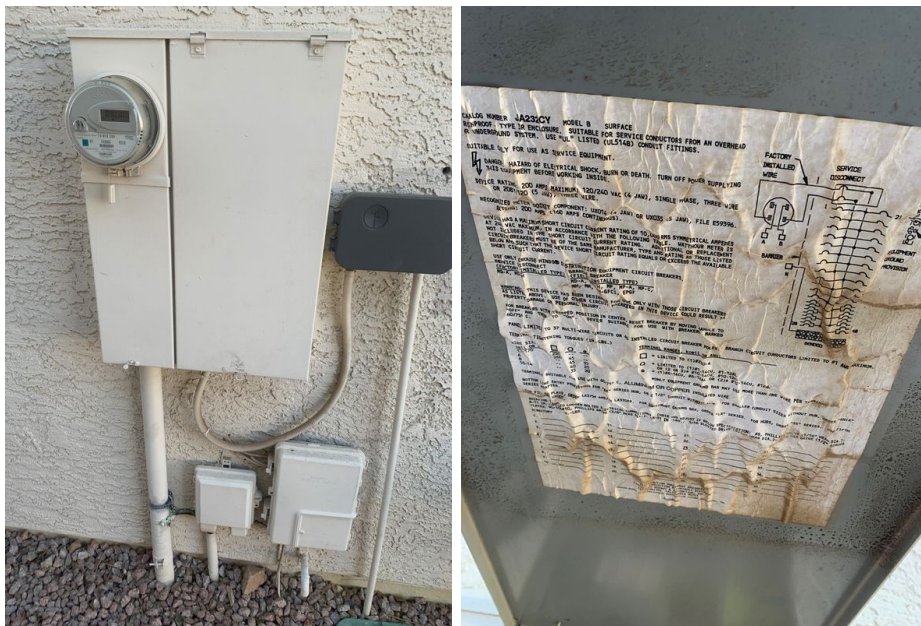
Panel Size & Location: Picture / Manufacturer Label

Panel Size & Location: Amperage

Unable to Determine

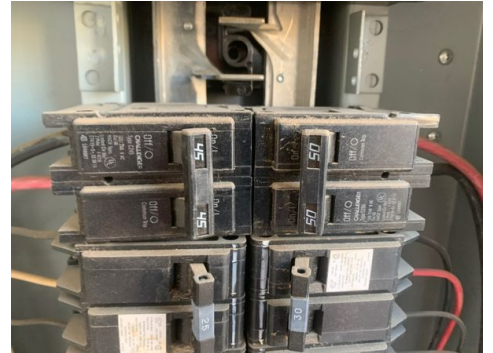
BREAKERS OTHER THAN MANUFACTURER

One or more breakers within this panel were made by other manufacturers. Replacement of these breakers, with the same manufacturer and type as indicated on the manufacturer label, is recommended.

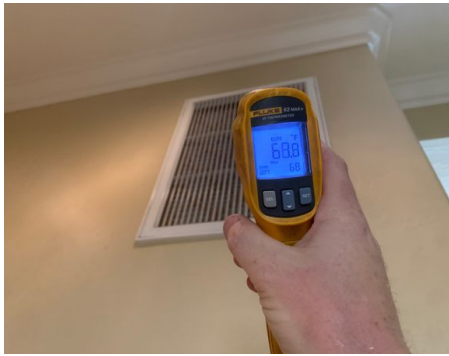
Cooling Differential Temperature Readings: Air Return Temperatures / As Noted

69

Air return temperatures in degrees Fahrenheit for this residence were as noted.

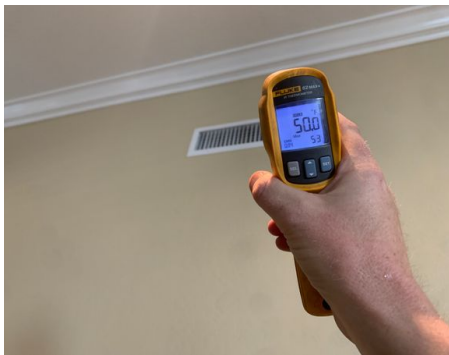
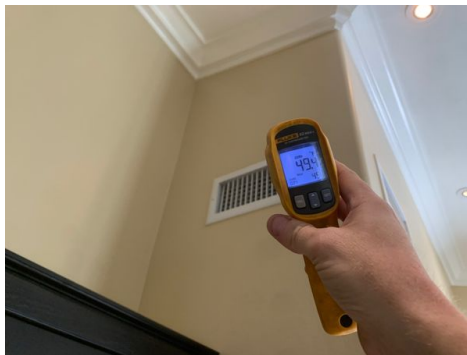
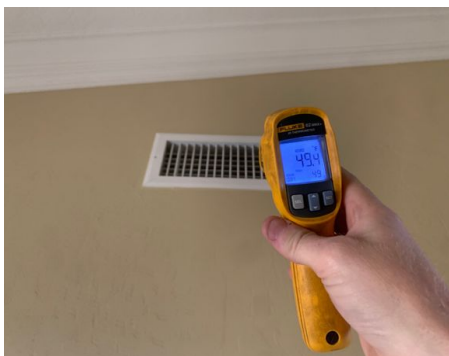
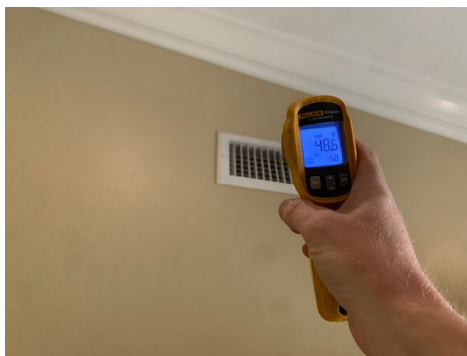
Cooling Differential Temperature Readings: Air Supply Temperatures / As Noted

50, 49

Air supply temperatures in degrees Fahrenheit for this residence were as noted.

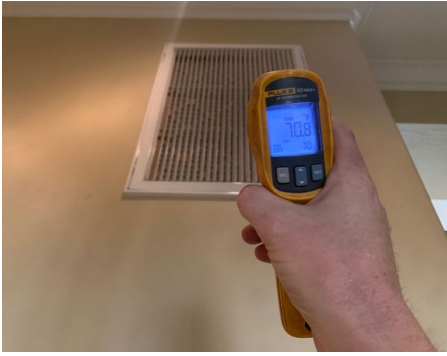
Heating Differential Temperature Readings: Air Return Temperatures / As Noted

70

Air return temperatures in degrees Fahrenheit for this residence were as noted.

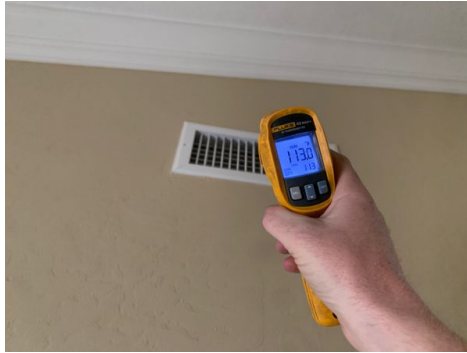
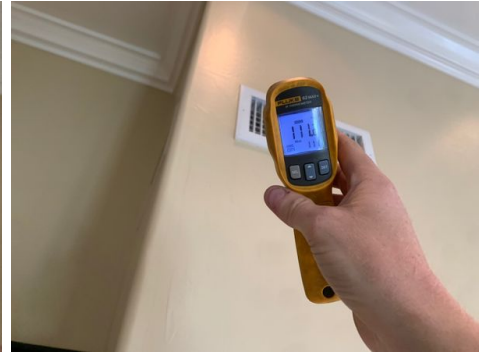
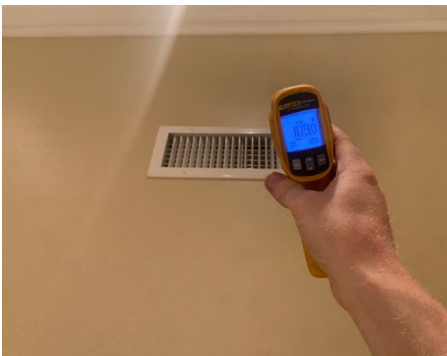
Heating Differential Temperature Readings: Air Supply Temperatures / As Noted

109-113

Air supply temperatures in degrees Fahrenheit for this residence were as noted.

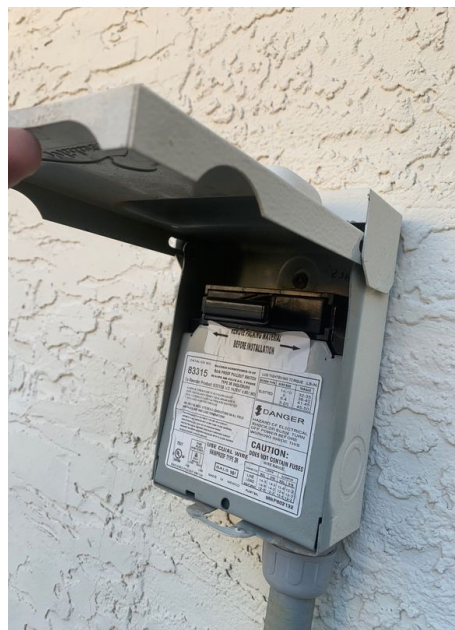
Condensing Coil Disconnect: Not Tested

The electrical disconnect(s) at the condensing coils are present and appear functional; however they were not activated or tested at the time of inspection.

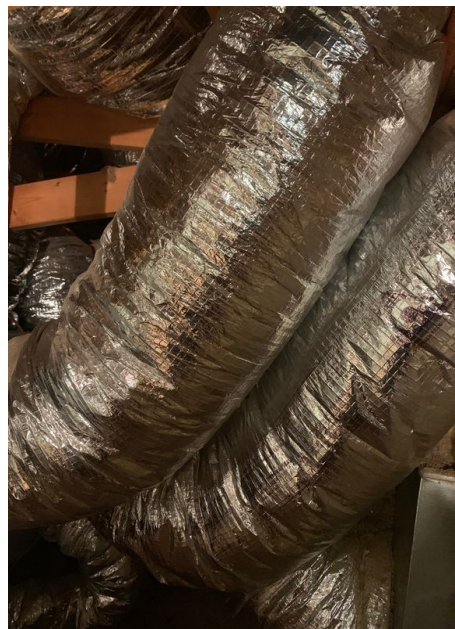
Flexible Ducting

The visible HVAC ductwork appears to be in satisfactory condition, unless otherwise noted.

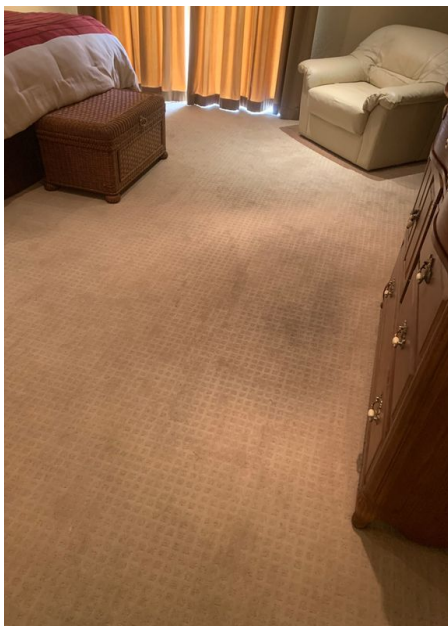
Flooring: Worn Or Cosmetically Damaged

The flooring is worn or cosmetically damaged, which you should view for yourself and correct as desired. A couple of areas could be re-stretched as you feel necessary.

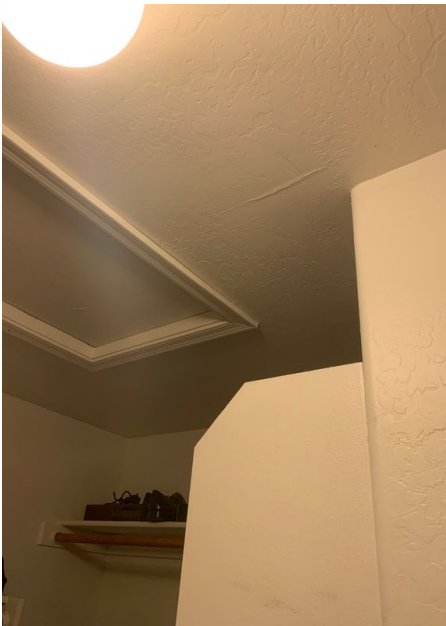
Walls and Ceiling: Typical Settlement Cracking Noted

There are typical and minor settlement type cracking noted on some walls and ceilings in the livable spaces.

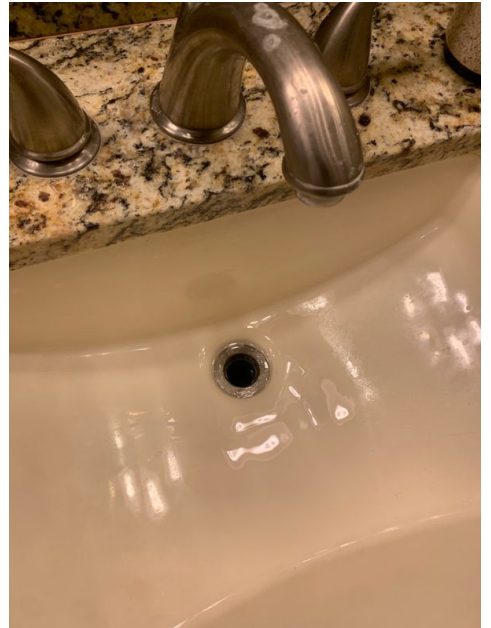
MECHANICAL STOPPER / MISSING

The mechanical sink stopper is missing and should be replaced.

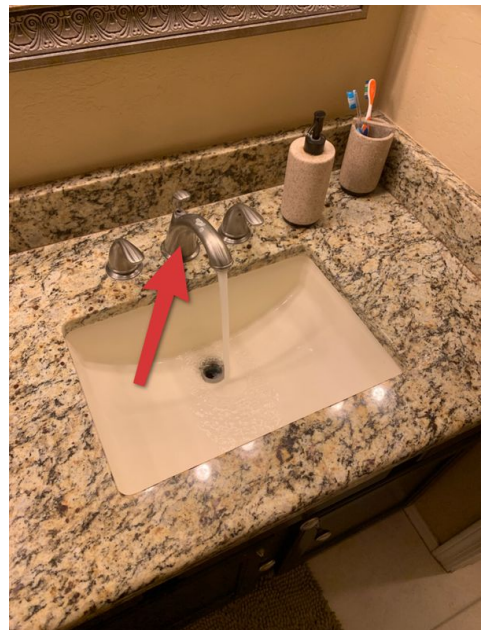
16.3.2 Sink and Faucet

FAUCET / LOOSE IN PLACE

A bathroom faucet is loose in place and should be secured or repaired as necessary. Service is important to help prevent damage or leaking.

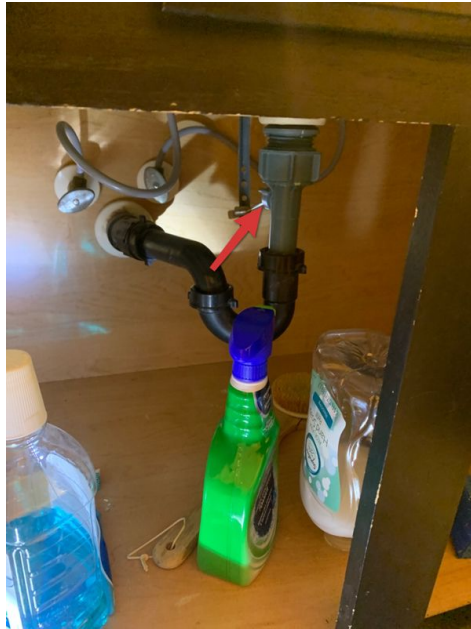
16.3.3 Sink and Faucet

MECHANICAL STOPPER / LEAKING

The master bathroom mechanical sink stopper leaks beneath the sink. I recommend evaluation and service as necessary from a qualified contractor.

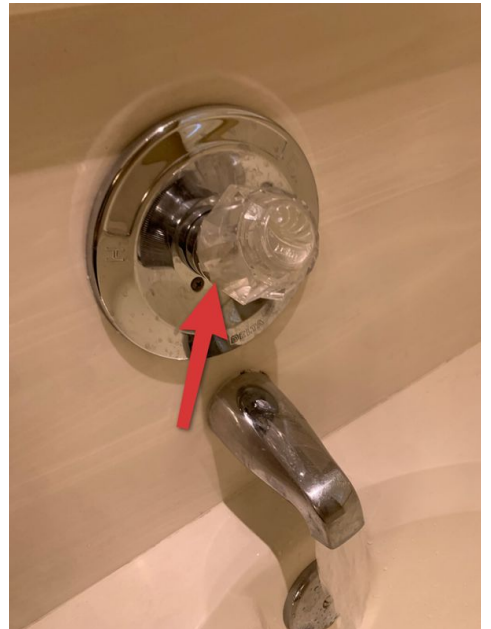
16.4.1 Tub/Shower

VALVE / LEAKS DURING USE

The master bathroom tub valve drips or leaks while in use. This should be further evaluated by a qualified contractor for service as necessary.

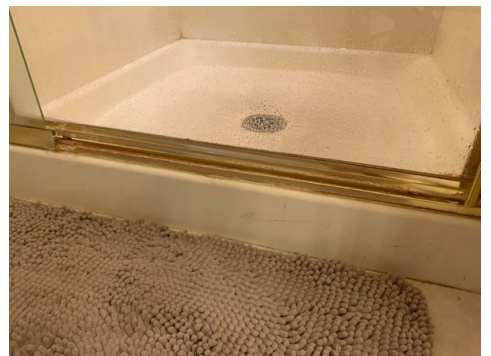
16.4.2 Tub/Shower

SHOWER DOOR / BAD SEAL

The shower door seal is missing and the surround may need caulking due to water stains on the exterior of the enclosure. It should be serviced and/or caulked as necessary.

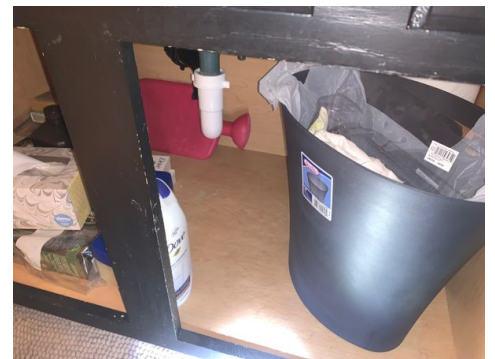
CABINET / STAINING OR DAMAGE / MINOR

The floor of the master bathroom sink cabinet is functional but slightly moisture stained or moisture damaged. I recommend you should view this and correct as desired.

Contact a qualified professional.

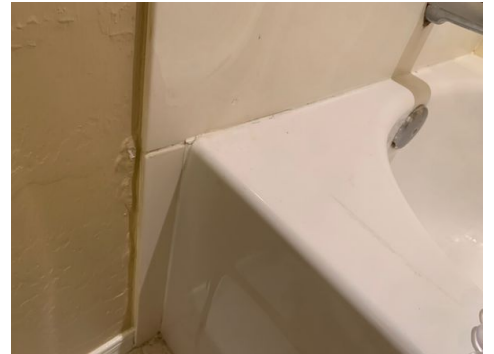
WALL DAMAGE NEXT TO SHOWER

There is minor moisture damaged drywall adjacent to the hallway bathroom tub/shower, which is not uncommon but should be repaired. This area was not soft or wet to the touch during the inspection. I also recommend correcting the leak source to help prevent future moisture damage. Further evaluation is recommended from a qualified contractor as you feel necessary.

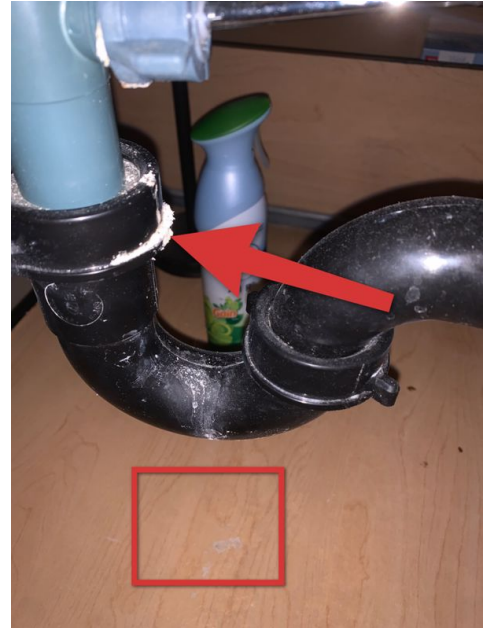
17.5.1 Trap and Drain

DRAIN LINE / CALCIUM DEPOSITS
