# TAHOE KEYS PROPERTY OWNERS ASSOCIATION

## TAHOE KEYS LAGOONS AQUATIC WEED CONTROL METHODS TEST

### DRAFT FINAL REPORT

**APRIL 2025**

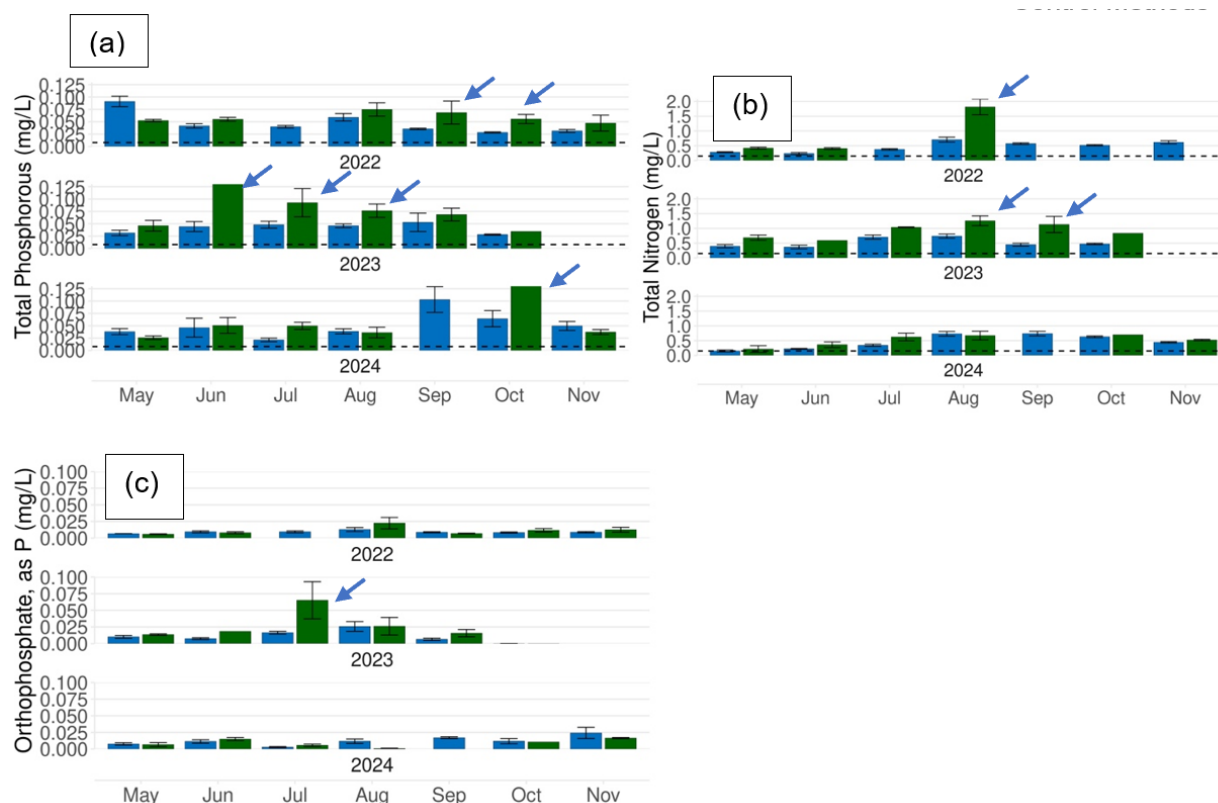
**Figure 5-13. Nutrient levels during the CMT in Triclopyr Only sites (green bars) Compared to Untreated Control sites (blue bars): (a) TP;(b) TN; (c) OP. Arrows show incidences of elevated nutrients levels.**
