# Performance Solution Scenario

## Automated Swing Entry Door

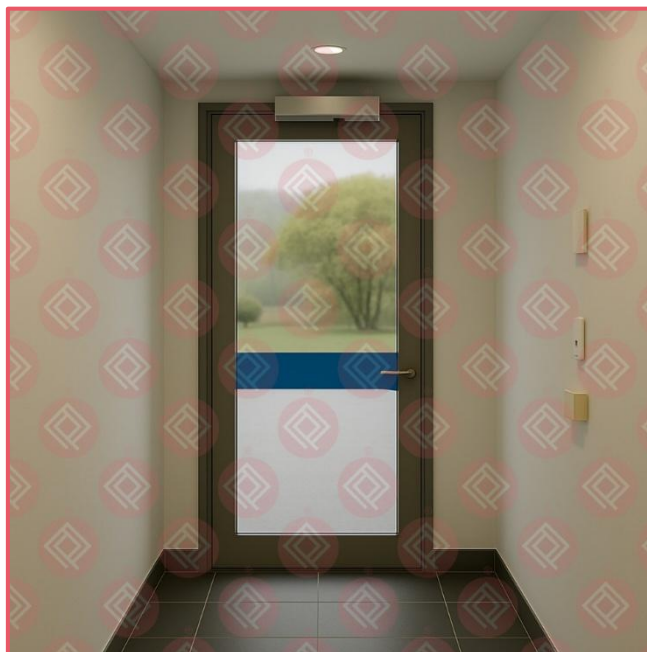
A landing between the swing door and ramp will not be provided.

Due to the spatial constraints within the building, a 1450mm deep landing will not be provided between the swing door and the commencement of the ramp.

The swing door will be automated with a power-operated device meeting AS 5007 to offset the reduced landing. This solution further enhances accessibility by removing the need for manual door operation.
