# Performance Solution Scenario

## Step Ramp Longer than 1900mm

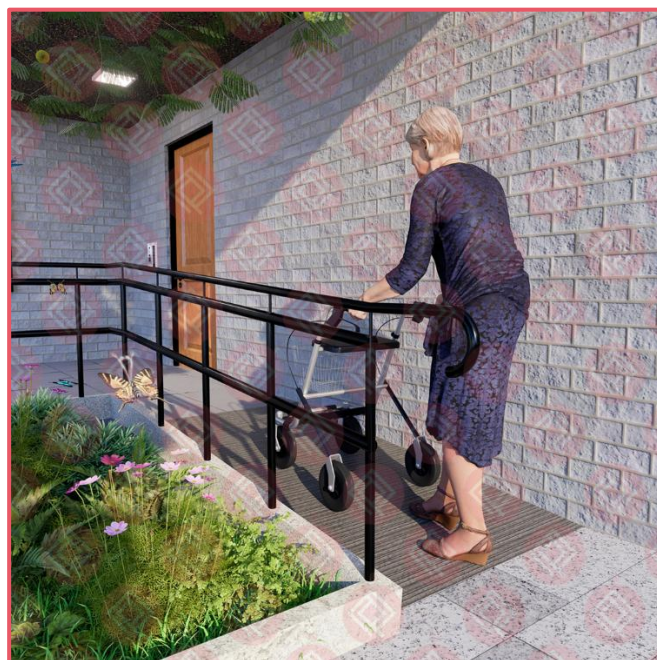
Due to the existing ramped entrance design, the upgraded step ramp will exceed 1900mm in length.

While the increased length of the step ramp design will be accepted, the step ramp will be upgraded to comply where possible. Enhanced features can also include handrail extensions, a contrasting surface, lighting, or an increased landing area.
