# Performance Solution Scenario

### Step Ramp Longer than 1900mm

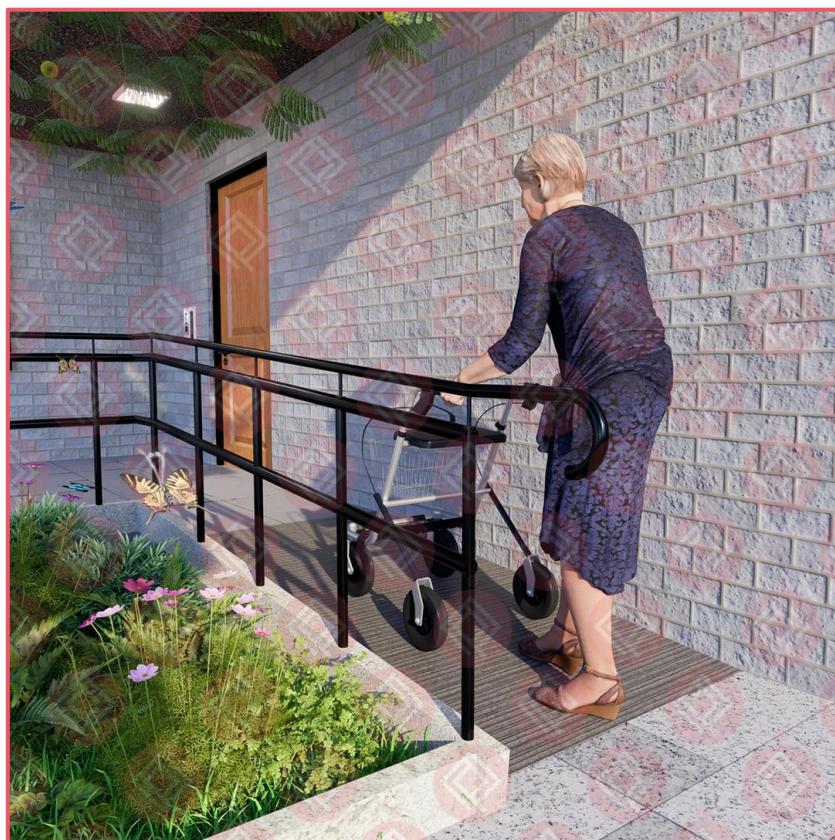
The step ramp has an increased length.

Due to the existing ramped entrance design, the upgraded step ramp will exceed 1900mm in length.

While the increased length of the step ramp design will be accepted, the step ramp will be upgraded to comply where possible. Enhanced features can also include handrail extensions, a contrasting surface, lighting, or an increased landing area.
